Customer Information 03/2010

Control of Prerotator pulley small

MANDATORY

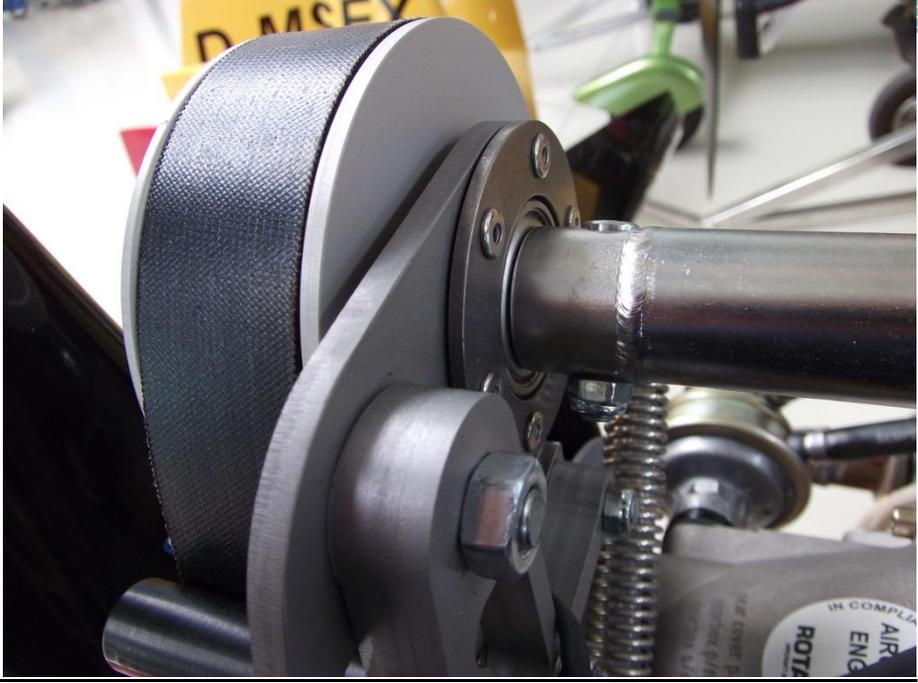
4.1	Picture shows the connection between prerotator pulley and drive shaft

3.2	Instructions	1. Secure gyroplane with park brake on 2. Secure control stick in full forward position 3. Adjust flight/brake switch to "brake" 4. Apply full pressure 5. Secure rotor system 6. Remove prerotator drive shaft (photo 4.1) 7. Check for a second hole through the pulley shaft and remove if affected 8. Install new pulley with Loctite 638 9. Install prerotator drive shaft and check for alignment of the hole through pulley / drive shaft 10. Use new nylock nut and Loctite 243 11. If the prerotator assembly is worn, replace with new assembly M.PR01

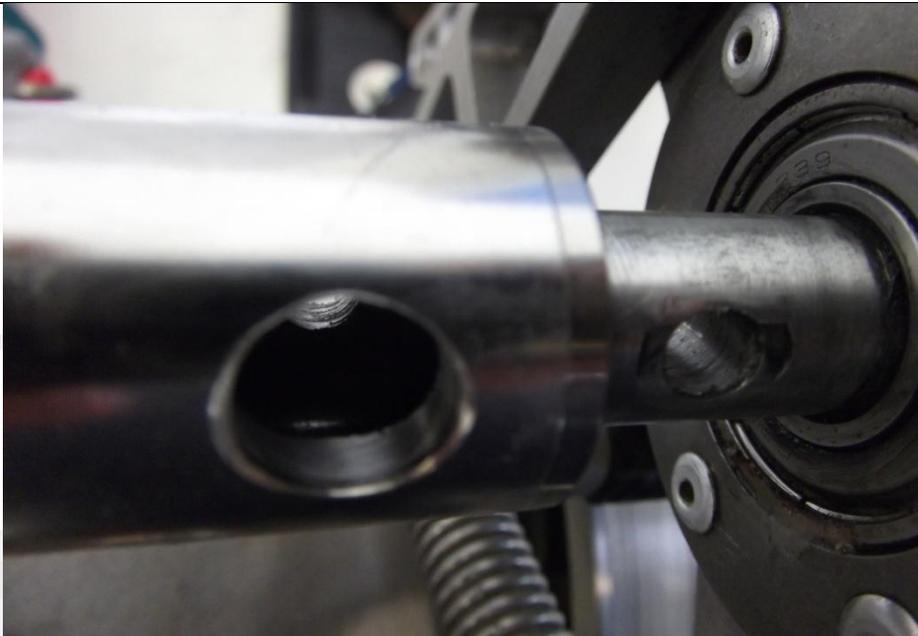
A close-up photograph showing the connection between a prerotator pulley and a drive shaft. The pulley is a large, dark, textured wheel mounted on a metal shaft. The shaft is secured with a nut and washer. In the background, a yellow sign with the text "D. M. SEY" is partially visible. A label on the machinery reads "IN COMPLIANCE WITH EN ISO 9001 ROTZ AIR ENIG".
4.2	Picture shows the prerotator pulley shaft with correct hole

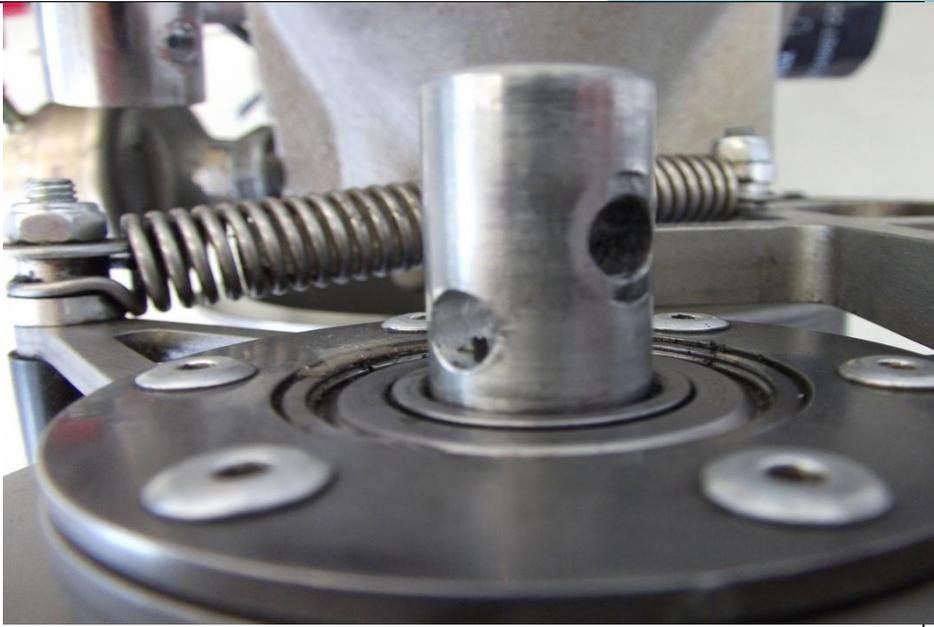
1.1	Gyroplane affected	MT 03: all models built until December 2007
1.2	Reason	Damage of prerotator pulley. The reason is a second hole 90 degrees through the shaft
1.3	Subject	Replacement of prerotator pulley small
1.4	Compliance	At next preflight check Before next flight
1.5	Approval	The technical content is approved under the authority of AutoGyro GmbH
1.6	Manpower	Estimated working time for the replacement is approximately 0.5h
1.7	Mass data	No change
1.8	Electrical load data	No change
1.9	References	In addition to this technical information refer to current issue of: - spare part catalogue www.auto-gyro.com
1.10	Other publications affected	None
1.11	Interchangeability of parts	All old parts are not reusable and have to be sent back to AutoGyro or the authorized distribution partners.

4.3	Picture shows the prerotator pulley shaft with incorrect holes
