Customer Information 04/2010

Control of AutoGyro Rotor Systems

MANDATORY

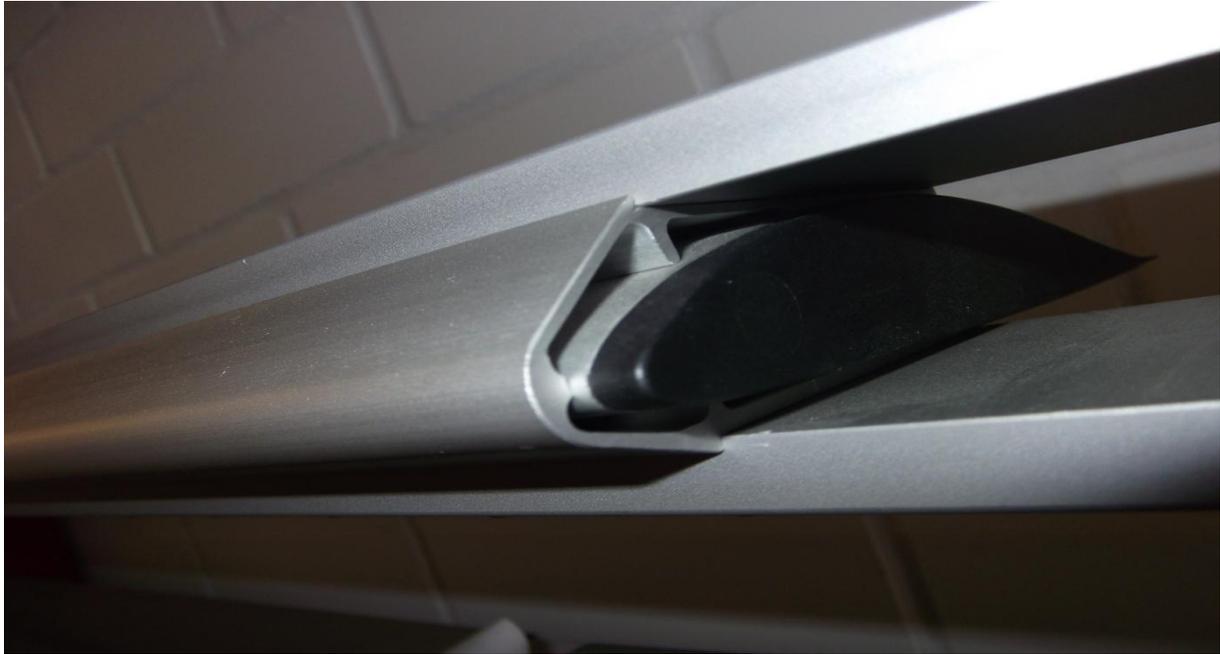
Inside of blade of the AutoGyro rotor system

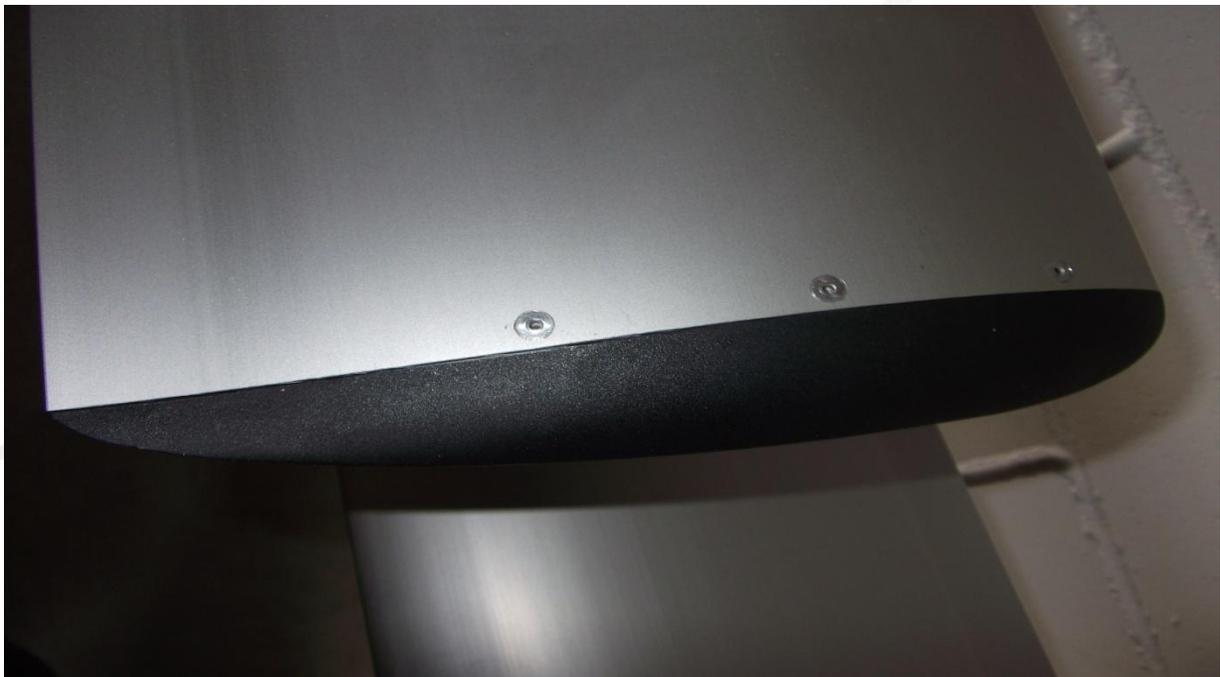
Outside of blade of the AutoGyro rotor system

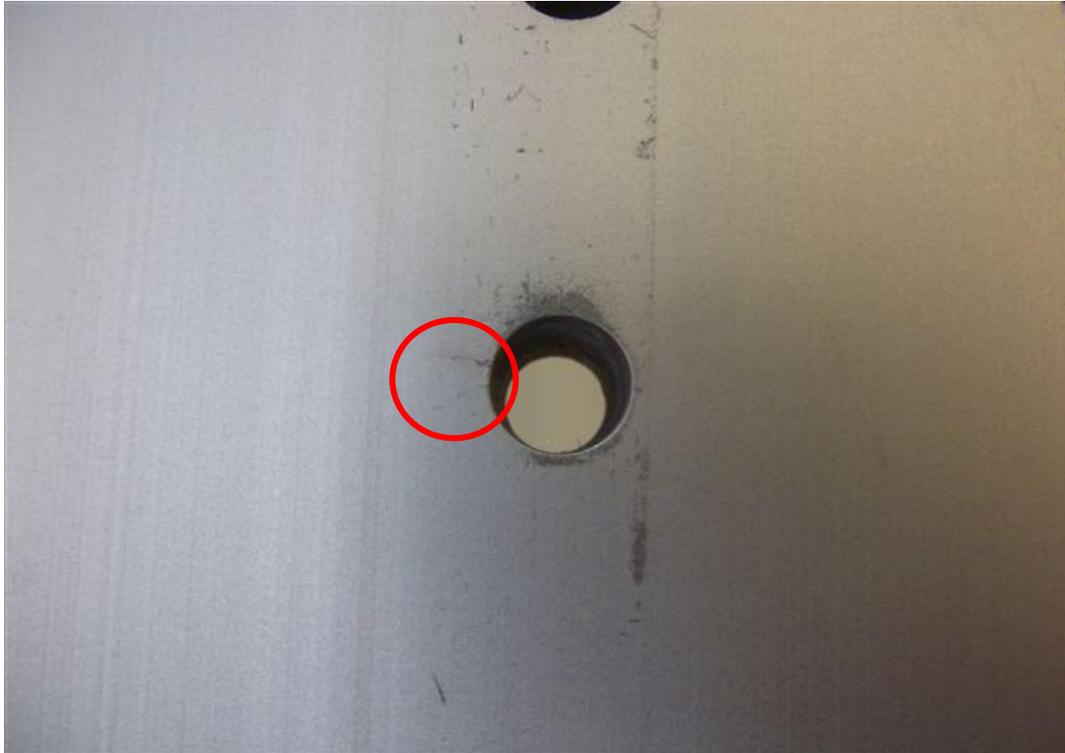
1.6	Manpower	1 hour
1.7	Mass data	No change
1.8	Electrical load data	No change
1.9	References	None
1.10	Other publications affected	None
1.11	Interchangeability of parts	All rotor systems with showing cracks or abnormal bending in the area of the fixation of the rotor blade are not usable anymore.

Example for occurring cracks from the bore hole on one side approx. 10mm

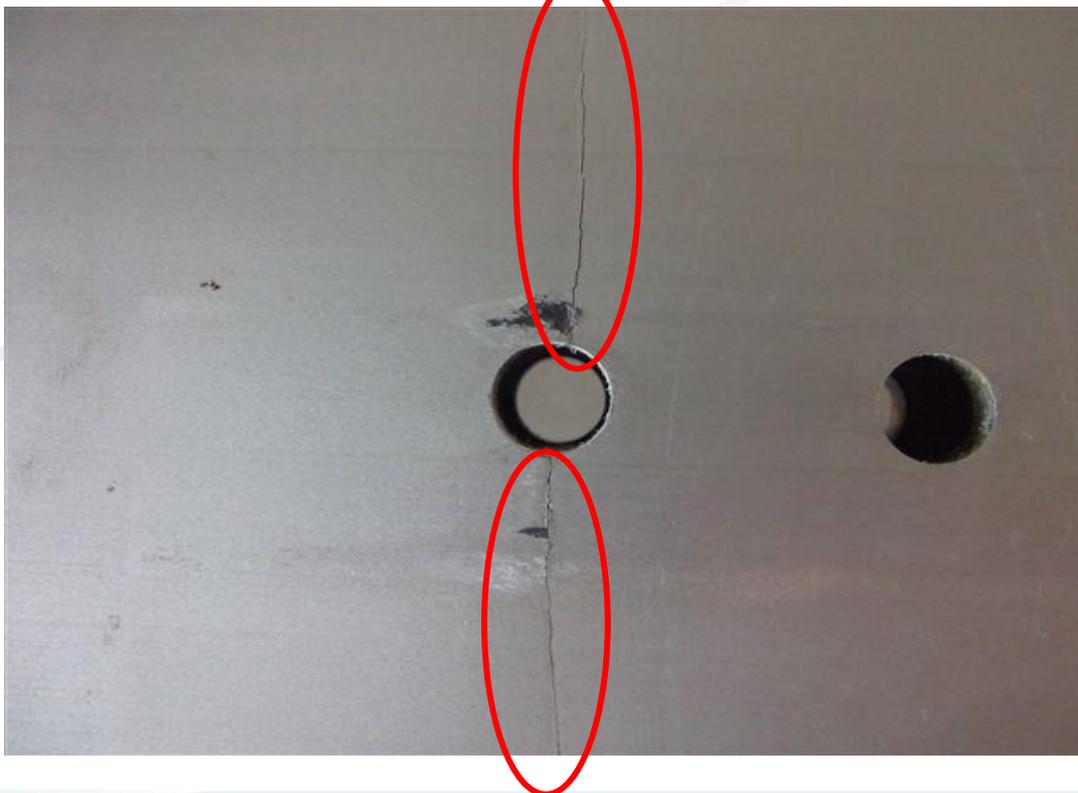
Example for occurring cracks from the bore hole on two sides approx. 30mm

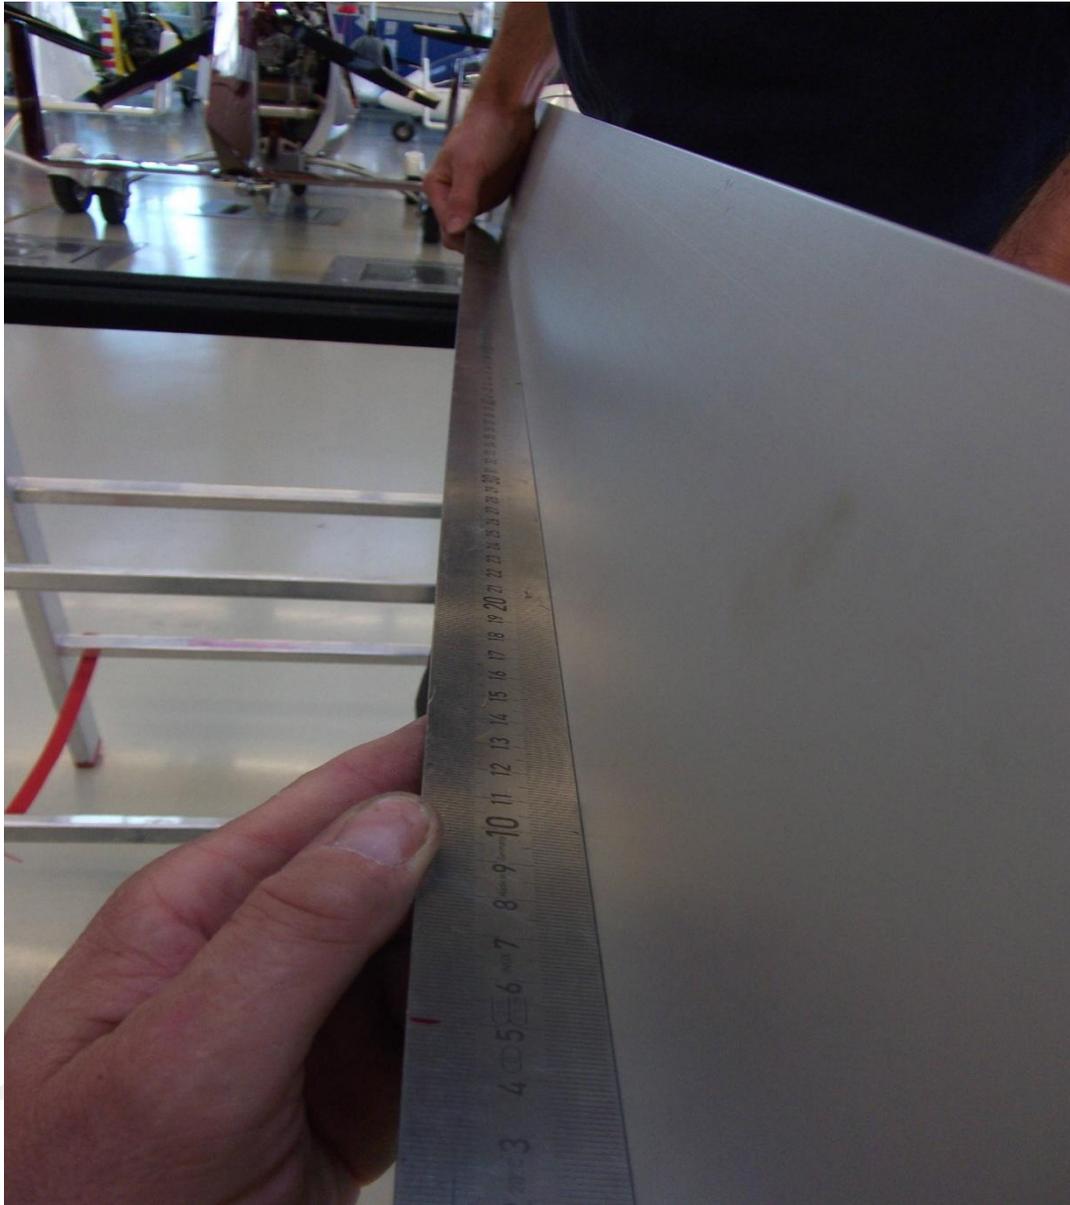
Measuring of the alignment with a steel ruler (1000mm)

The upright position of the blade prevents a sagging and therefore the measuring is not affected. A light slit should not be showing (as the picture is showing)

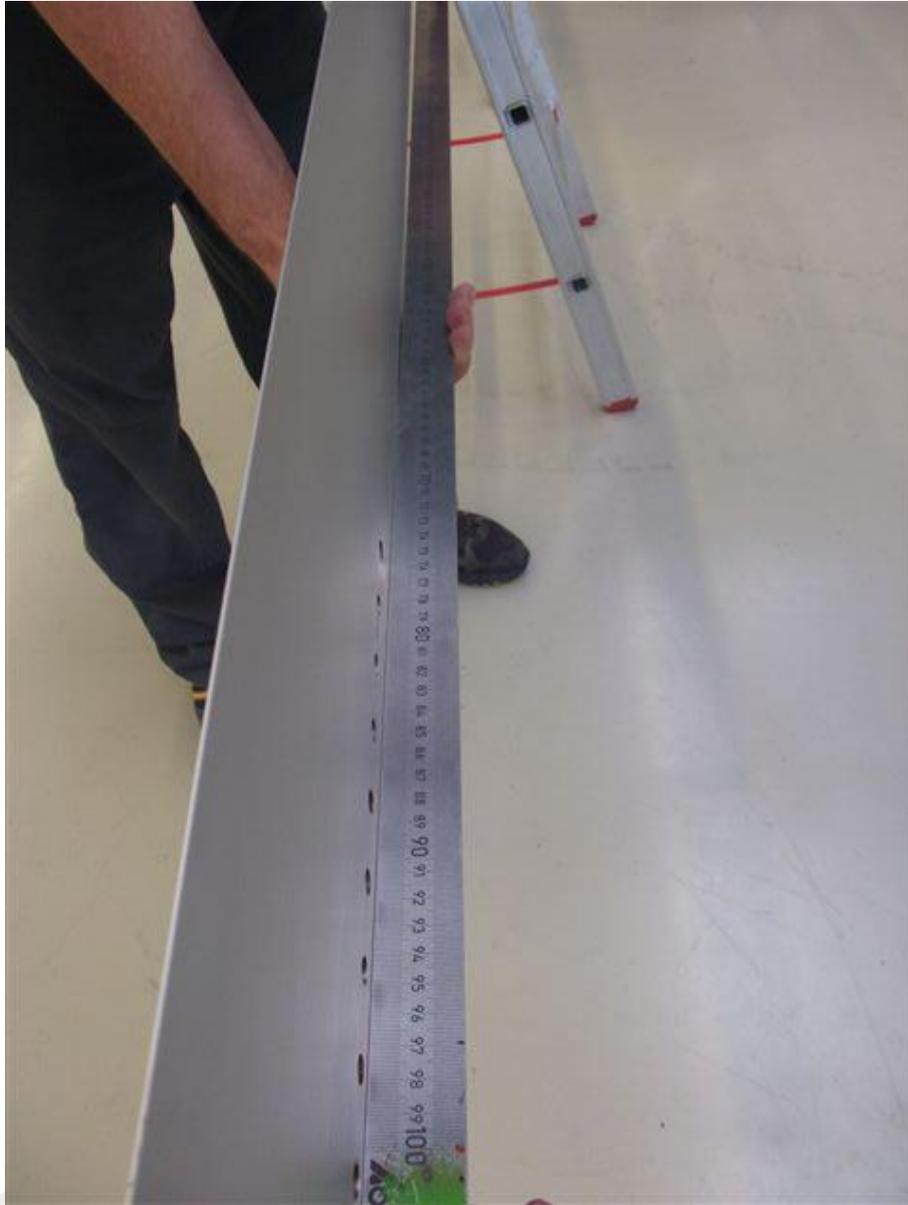
Example for a bended blade behind the fixation (result:rotor system is not airworthy)
