RotorSport UK Ltd

Service Bulletin

SB No.: 006 issue 2	CCAR No.: None	Classification:
Aircraft type & model (applicability) RotorSport UK MT-03	Aircraft serial Nos. effected RSUK/MT-03/all	OPTIONAL or RECOMMENDED or MANDATORY

A number of Cyclon 0859-0020 12v 8.0Ah/1005 batteries have been replaced in service for failed links between the 2 rows of battery cells. Whilst the cause is sometimes use beyond the battery design (eg turning the engine over to bleed the oil system), RSUK and AutoGyro have identified and engineered a service improvement to the battery that significantly extends the battery ability to withstand field use, and eliminate the risk of blown links.

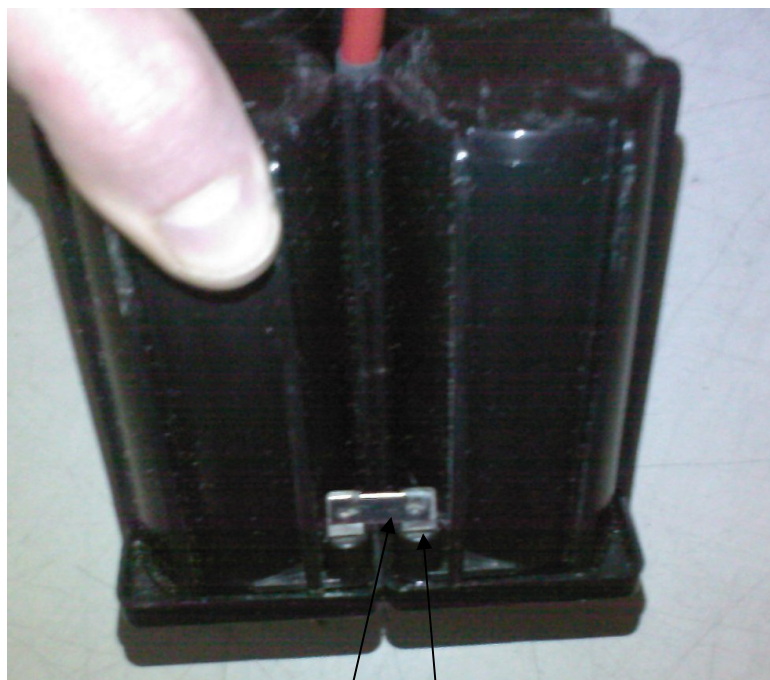
Link at the base of the battery

Upstands

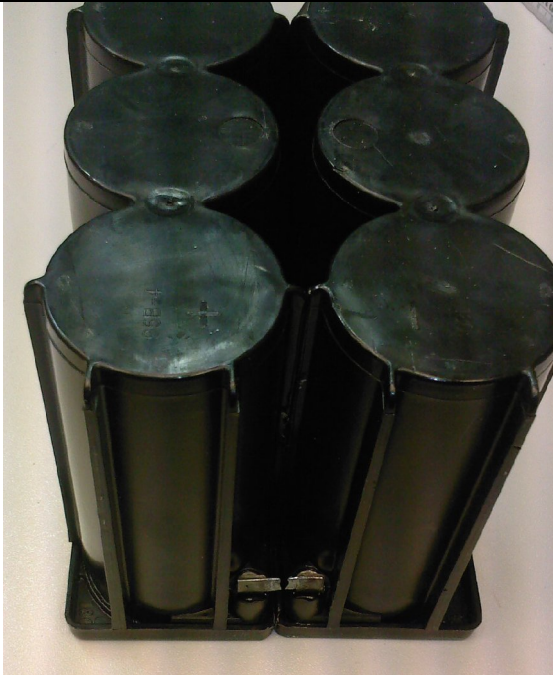
Example of blown link

Bridge the link between the two rows of battery cells with a 15mm length of 10mm² copper cable, soldered in place. This may be done whether or not the link is already blown. Due to the soldering required this process is to be done by RotorSport UK Ltd. Modification no. MC-087.

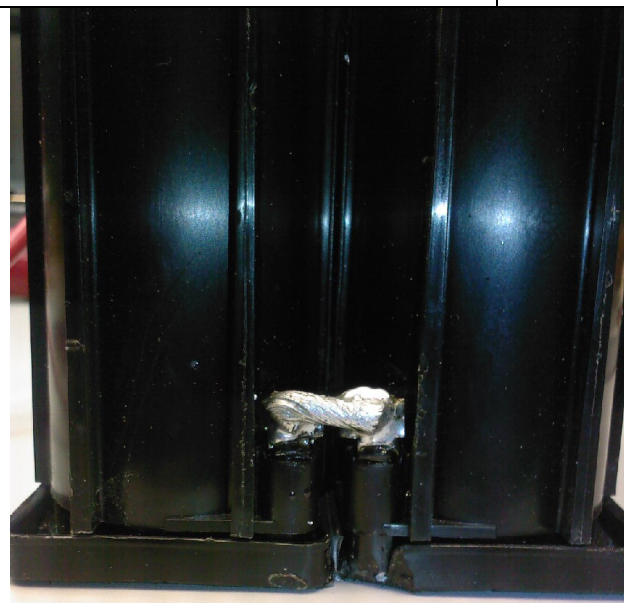
View of link with length of cable soldered over.
