RotorSport UK Ltd

Service Bulletin

SB No.: 010 issue 1

Aircraft type & model (applicability)
RotorSport UK MT series

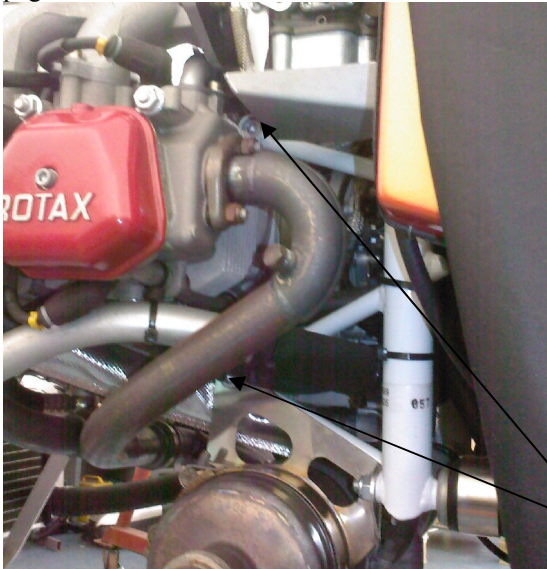
A high service hours MT-03 reported an increase in-service engine vibration. This was traced to one of the four M10 bolts which hold the engine to the white engine bearer frame being loose. The bolt was retightened and normal vibration levels returned.

These bolts are retained by Loctite 243 and a 35Nm torque. The looseness cause is unknown, and the bolt tightness is not specifically called for to be checked.

Engine bearer bolts (2). Same on engine right side.

Check tightness of engine mounting bolts by tightening to a max of 35Nm. Observe if rotational movement occurs..

If bolts move, they must be removed individually, loctited, and refitted/torqued to 35Nm. Paint on torque stripe.

Paint 'torque stripe' across bolt head to adjacent frame to allow visual tightness inspection
