RotorSport UK Ltd

Service Bulletin

SB No.: 023 issue 1	CCAR No.: None	Classification:
Aircraft type & model (applicability) RotorSport UK MTOsport, MT-03 if retrofitted with MTOS enclosure	Aircraft serial Nos. effected RSUK/MTOsport all, MT-03 if retrofitted with MTOS enclosure	OPTIONAL or RECOMMENDED or MANDATORY

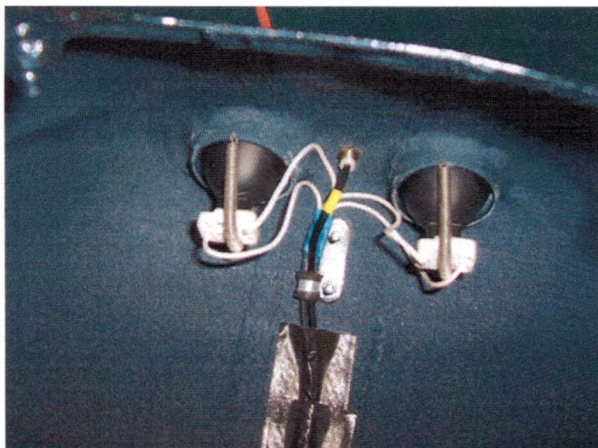
The halogen landing lights fitted to the nose of MTOsport aircraft (or MT-03 retrofitted with MTOS enclosure) are accessible inside the nose luggage locker. After a long period of use these lights become hot and could cause damage to luggage. The connectors could also be dislodged when loading the luggage.

Landing light location inside nose (tension spring retention is shown)

1. Remove the luggage hatch. Examine the landing lights to confirm that the lamp units are secure and the cable connectors properly fitted. NB: lamp retention may be by circlips (accessible outside the nose) or by tension springs (accessible through the hatch).

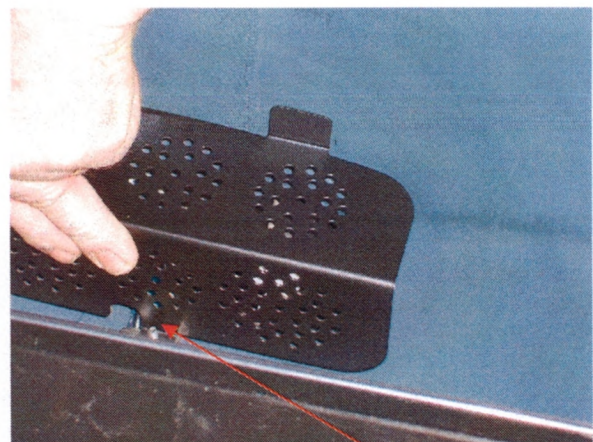
Shield offered-up over aft-most stud

2. Offer-up the shield over the aft-most stud that retains the tie-down loop and mark-out the position of the two tabs on the enclosure. Verify that the electrical cables are clear of contact with the shield edge.

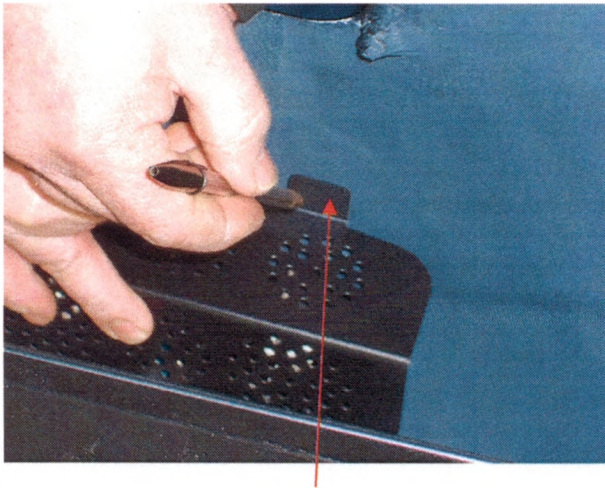
Marking-out for Velcro location

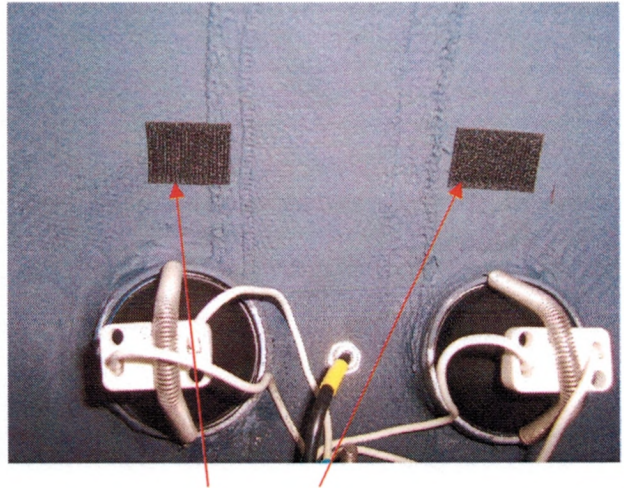
Velcro pads in place

3. Remove the shield, clean the enclosure contact surface with Amberklene LO30 (or equivalent) and attach the two Velcro pads (hook side) to the marked areas on the enclosure.

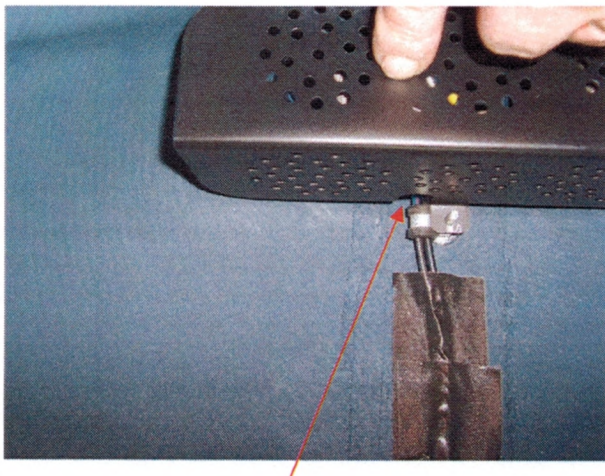
Ensure clearance over cable

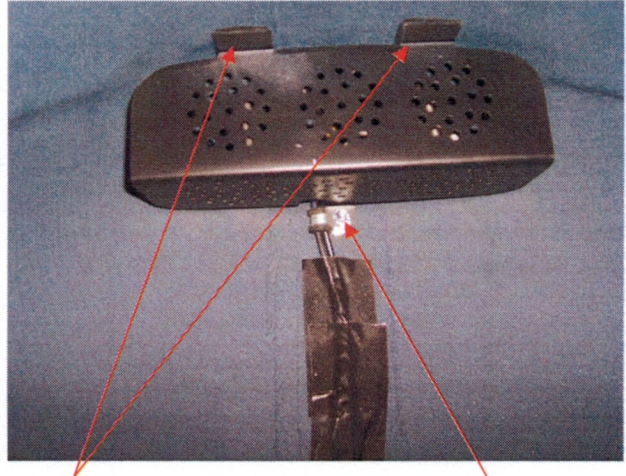
Push onto Velcro then fit washer and nut to stud

4. Replace the shield, press the Velcro into place and fit an M5 plain washer and M5 nyloc nut to the protruding stud. Tighten the nut using a socket/extension (hand-tight 2Nm). Refit the hatch cover ensuring all four fasteners engaged.
