# RotorSport UK Ltd

## Service Bulletin

| <b>SB No.: 027 issue 1</b> | CCAR No.: None | Classification:<br><del>OPTIONAL</del> or<br><b>RECOMMENDED</b> or<br><del>MANDATORY</del> |
| Aircraft type & model<br>(applicability)<br>RotorSport UK MT-03and<br>MTOsport series | Aircraft serial Nos. effected<br>RSUK/MT-03/all<br>RSUK/MTOsport all | |

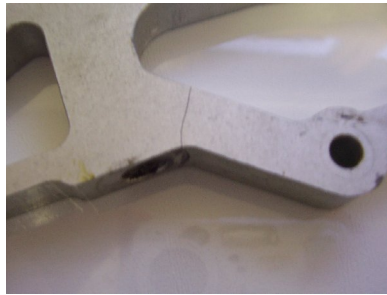
1) A small number of Pre-rotator Brackets RSD5023 have failed in service by way of a fine crack, originating at a mounting-screw hole and passing across a web – see photo below:

This crack would not result in a flight safety issue but may cause vibration and incorrect function of the pre-rotator. Can be resolved by replacement of Pre-rotator Bracket part number RSD5023 by M.PR01.06.01. (Modification Classification MC-128 refers).

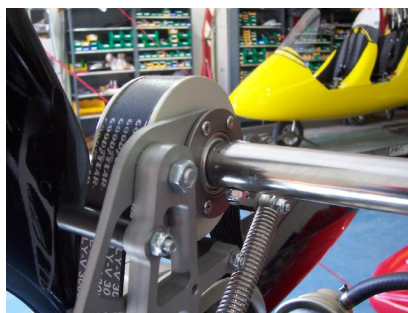
2) Failure of an adhesive bond in Pre-rotator Drive Shaft RSD7082 could result in looseness and damage to the cross-bolt area at the aft end of the shaft. An improved design is now available in which the shaft is a fully-welded construction, available as part number M.PR01.01 (aka BG166). (Modification classification MC-132 refers)
