# RotorSport UK Ltd

## Service Bulletin

<b>SB No.: 040 issue 2</b>	CCAR No.: None	Classification: <b>OPTIONAL</b> or <b>RECOMMENDED</b> or <b>MANDATORY</b>
Aircraft type & model (applicability) RotorSport UK MT-03, MTOsport	Aircraft serial Nos. effected RSUK/MT-03/any RSUK/MTOsport/any

This service bulletin SB-040 describes how an MT-series aircraft may be upgraded to Rotorsystem II (with either the standard or TOPP variant rotors). Once the upgrade has been done then subsequently either the standard variant or the TOPP variant rotors may be fitted under the conditions of service bulletin SB-116 "RSII rotor interchange". Note that as the weight of each rotor variant is different the aircraft's AWC and weight placard must be amended accordingly, together with an application to CAA for amendment of the Permit-to-Fly.

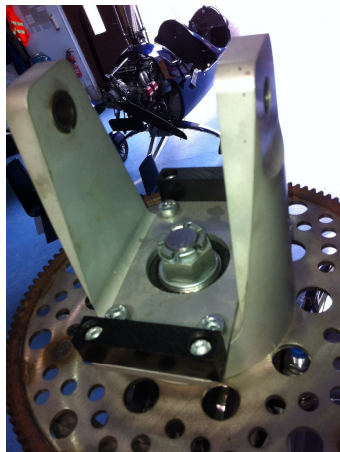
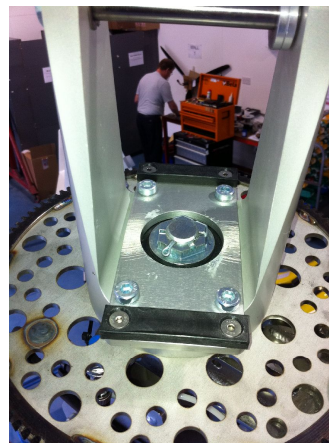
Important note: The new rotors by themselves (identified by red end-caps or blue end-caps) are not directly interchangeable with any other rotors having black, grey or orange end-caps. In embodying this SB-040 the whole rotor system (consisting of rotating parts and teetering parts) must be changed (see photos below).

The rotating parts of the original rotor system (RS1) on left and RotorSystemII on right  
Note the taller teeter tower, smaller teeter blocks and special castle nut of RotorSystemII

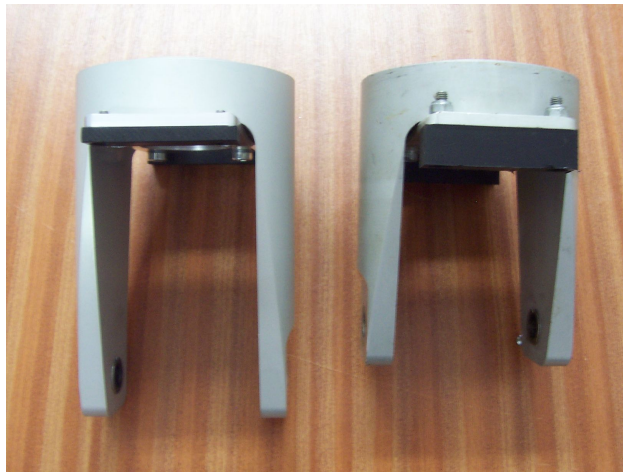
Close-up views of the different teeter-towers and teeter stops.  
Rotorsystem II (red or blue end-caps) is used with the taller tower shown on the left  
An original rotor (black or grey end-caps) must NEVER be fitted to the taller tower

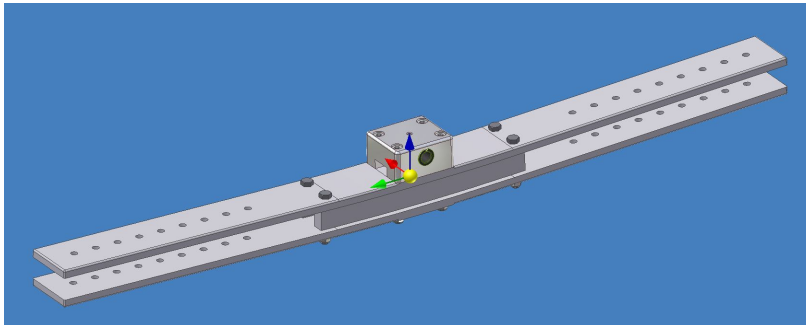
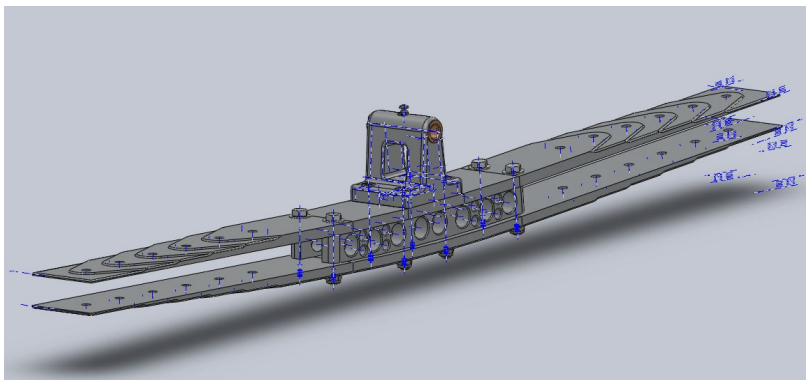
The hub-bar assemblies of the original rotor system (RS1) above and RotorSystemII (below)  
Note the scalloped hub-bars, perforated spacers, taller teeter block and 6-bolt blade attachment of RotorSystem II

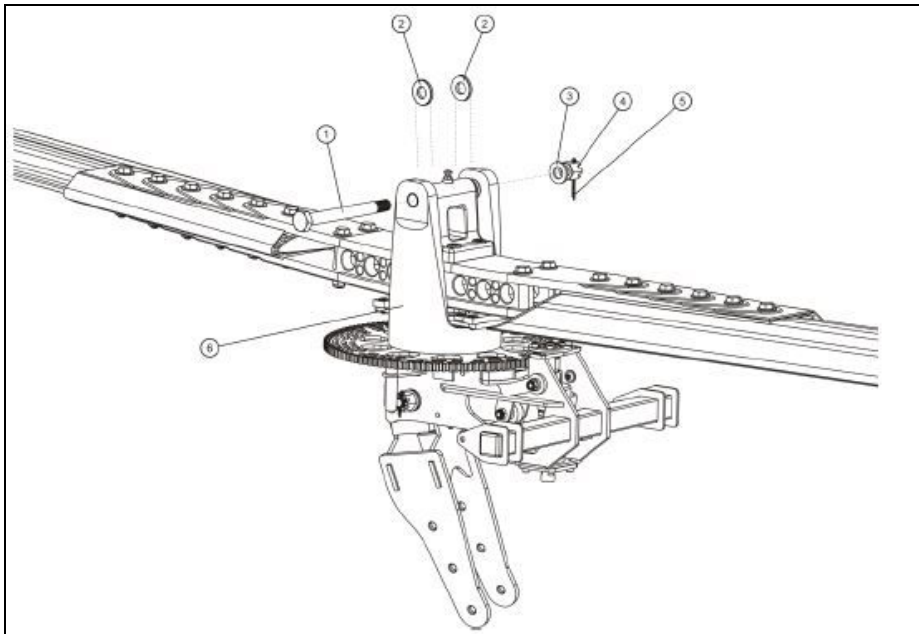
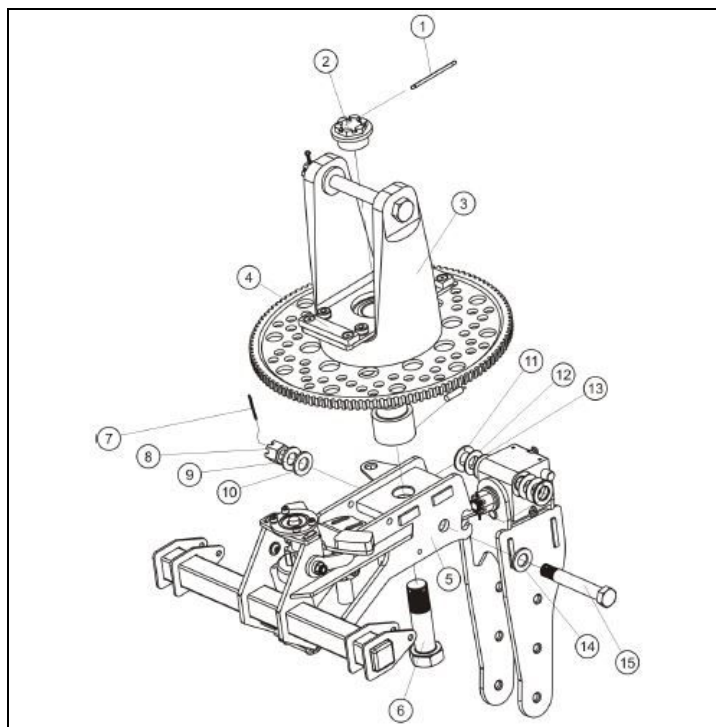
Schematics of RotorSystemII installation (MTOS shown)  
– see AMM’s RSUK0012 and RSUK0044 for further information

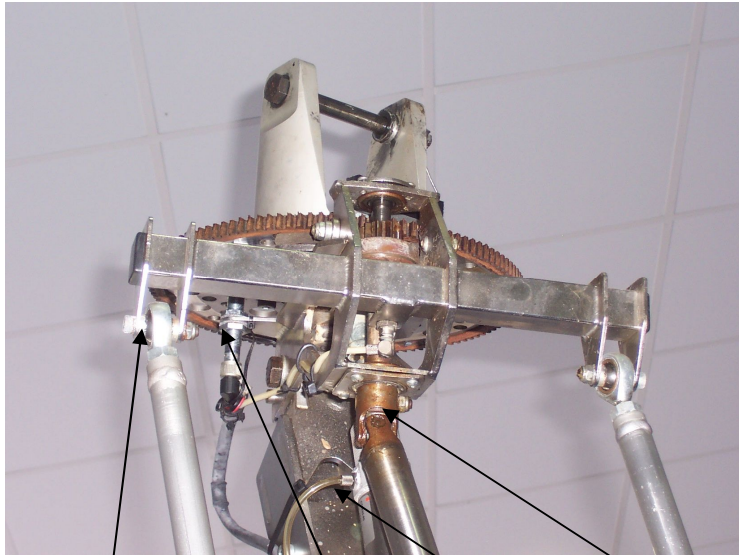
control rod mounting      speed sensor      4mm air pipe      UJ cross-bolt

MT-03 installation ready for removal

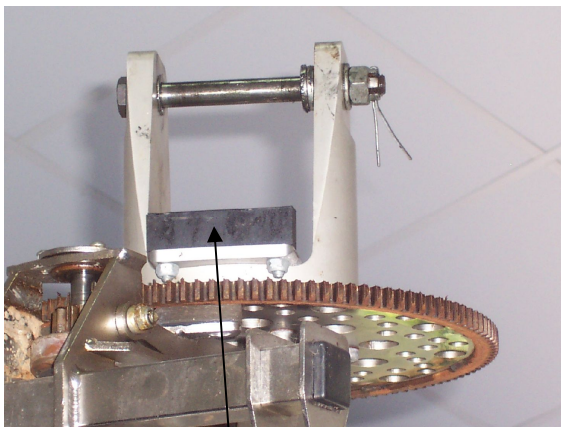
Original 18.8mm teeter-stop (MT-03 shown)

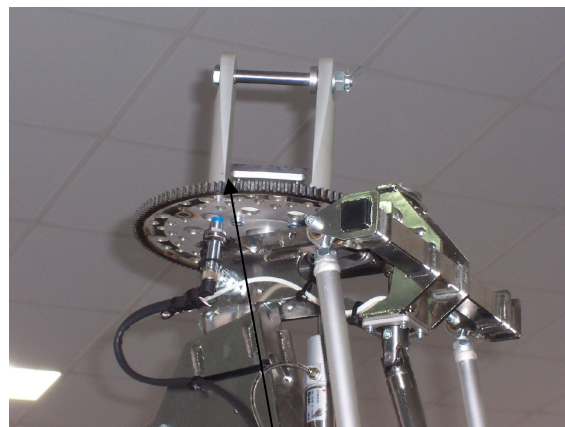
Rotorsystem II 7mm teeter-stop (MTOS shown)

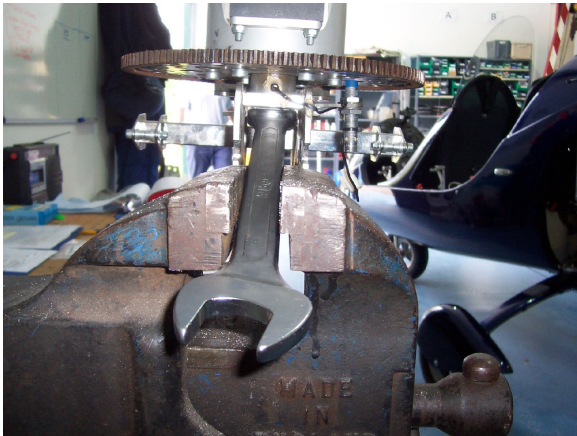
Head assembly held in bench-vice

1. Place a 30mmAF ring spanner on the hex-head bolt on the underside of the rotor-head. Clamp this ring spanner in a substantial vice.
2. Remove the split-pin from the castle-nut. With an assistant to steady the assembly in the vice, use a 30mmAF socket to unscrew the castle-nut from the bolt. It will be very tight.

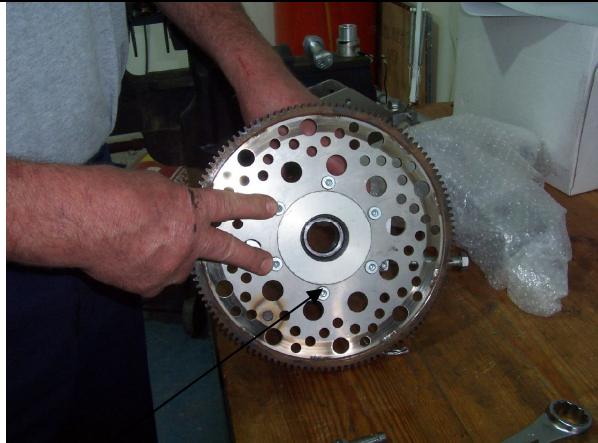
Low-profile capscrews (6-plcs)

3. Remove the M20bolt, M20 plain washer and aluminium spacer (with bonded-in sensor)
4. Note the orientation of the ring-gear on the teeter tower. Clamp the tower in the soft-jaws of a vice and remove the six low-profile capscrews retaining the gear to the tower. If necessary use a temperature-controlled heat-gun to heat the bolt-heads and degrade the Loctite bond (NB: 120degC max to avoid damage to the alloy teeter-tower).

8. Replace the M8 low-profile screws using new M8 friction washers and Loctite 243. Progressively tighten the screws to 20Nm.
9. Temporarily fit the bolt into the aluminium collar and bond the temperature sensor into the collar with a bead of hot-melt adhesive RSD4659. When the adhesive has solidified the bolt may be removed.

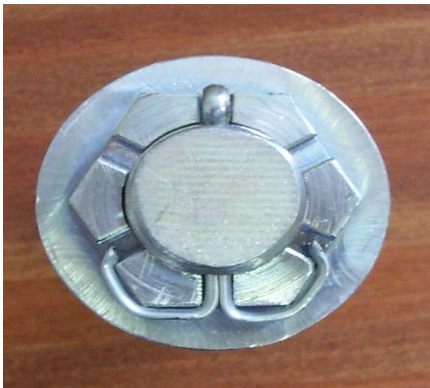
Top view of rotor bearing nut with split pin fitted.

11. Fit the new split-pin supplied in the kit. Back-off to nearest split-pin hole is acceptable but minimum torque 140Nm must be realised. Fit pin in nut as shown in later bulletin photo.

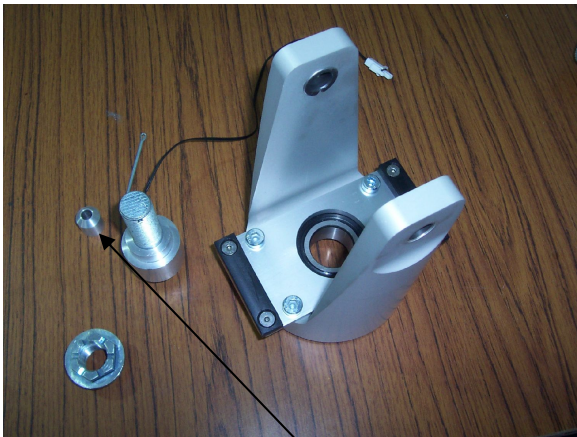
Installation kit C.RK38  
The conical spacer shown is for Calidus and is not required for an MT-series installation.

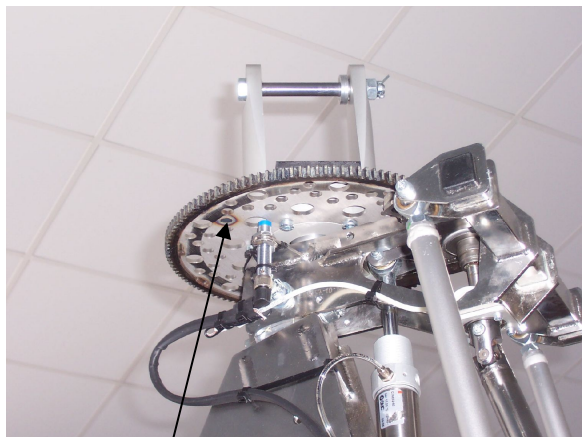
Welded plug at 11-o'clock position to rotor axis

7. Position the ring gear on the new tower's spigot so that the witness-mark from the rotor brake is on the underside and the welded-plug is at the 11-o'clock position relative to the rotor axis

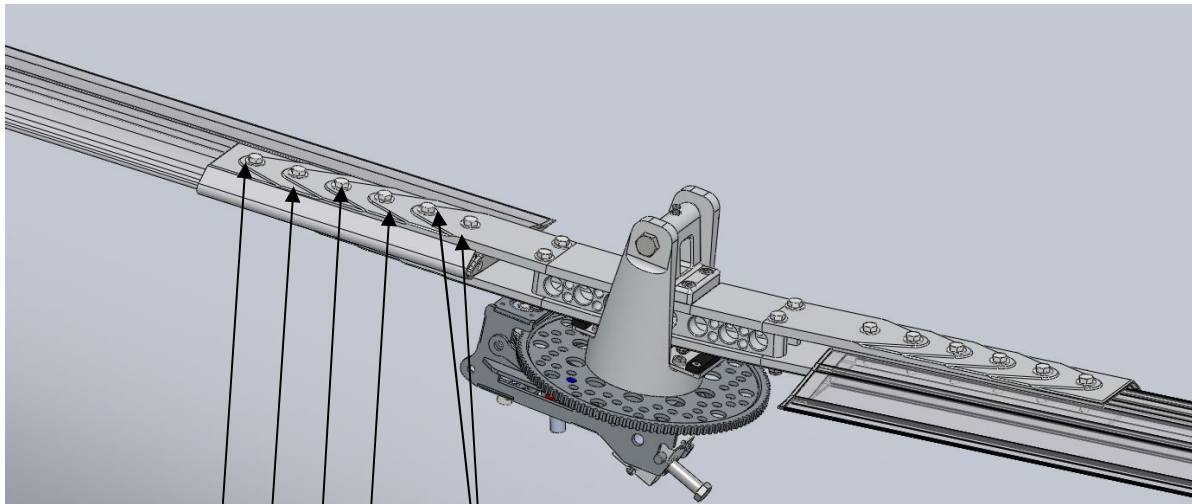
- Bolt BT3697, 49mm
- Bolt BT3698, 52mm
- Bolt BT3699, 55mm
- Bolt BT3670, 58mm
- Bolt BT661, 60mm long

Schematic view of Rotorsystem II. Note the different length bolts

**WARNING!** It is important to fit the correct length bolt in the associated hole! Fitting the wrong length bolt may result in insufficient safety protrusion through the nylock nut, or that the nut jams on the shank of the bolt before the joint is properly tightened.
