# RotorSport UK Ltd Service Bulletin (Permit)

<b>Title: IVO-prop motor housing nut torque</b>		
<b>SB-126 Iss1</b>	<b>Related documents</b> Modification: MC-276, -294, -318, -323 CCAR No.: CCAR-64, -66, -70	<b>Compliance Category:</b>  <b>OPTIONAL</b> <del>or</del> <b>RECOMMENDED or</b> <b>MANDATORY</b>
<b>Applicability</b>		
<b>Aircraft type &amp; model:</b> Any RSUK type fitted with IVO-prop DL3-68 VP-propeller	<b>Aircraft serial Nos. affected:</b> Any RSUK type fitted with IVO-prop DL3-68 VP-propeller	
The maintenance manual to be referenced is this stated or subsequent issue.		MT-03 RSUK0012 Iss 10 MTOsport RSUK0044 Iss 9 Calidus RSUK0061 Iss 7 Cavalon RSUK0288 Iss 5
<p>This form is the response from RotorSport UK Ltd either against a problem found in the product in service requiring a containment or rectification action, or as service information for aircraft modification incorporation. For help, contact RotorSport on 44(0)1588 505060, or email <a href="mailto:compliance@rotorsport.org">compliance@rotorsport.org</a>.</p> <p>The technical content of this document is approved under the authority of the UK CAA Design Organisation Approval Ref: <b>DAI/9917/06</b></p>

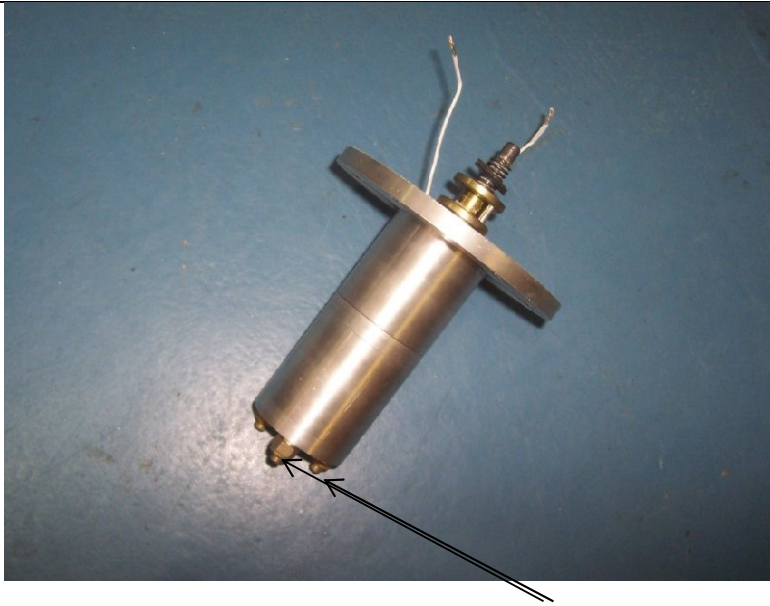
- The tightness of the three nuts at the end of the gearbox assembly can adversely influence the axial load incurred by the internal thrust bearings, leading to premature wear and excessive current draw by the motor.
- The grease used by the OEM is better replaced by a Molykote type grease

Motor/gearbox assembly removed. Adjust these three nuts.

5. Using a 1/2"AF spanner progressively release the three nuts.
6. Progressively tighten these 1/2"AF nuts to 10Nm (tolerance 10-15Nm) only.
7. Suitably mark the rear motor face of the motor housing to denote the nut torque has been adjusted.
8. Following safe practice a qualified gyroplane pilot or appropriate person must ground-test the propeller in accordance with the instructions in the Pilots Handbook, to demonstrate proper function to pitch limit stops.
9. If satisfactory, refit the spinner (if fitted) in accordance with the aircraft AMM. Otherwise repair in accordance with the propeller handbook.
10. Update aircraft and propeller documents accordingly.
