**FLANGE BUSHINGS INSPECTION of the KW-30 PROPELLER INSTALLED in  
ROTAX 915 ENGINE**

Type / Model: **Hydraulically variable pitch propeller  
KW-30-A-H-3-0-0-F**

Manufacturer: **Woodcomp Propellers s.r.o.**

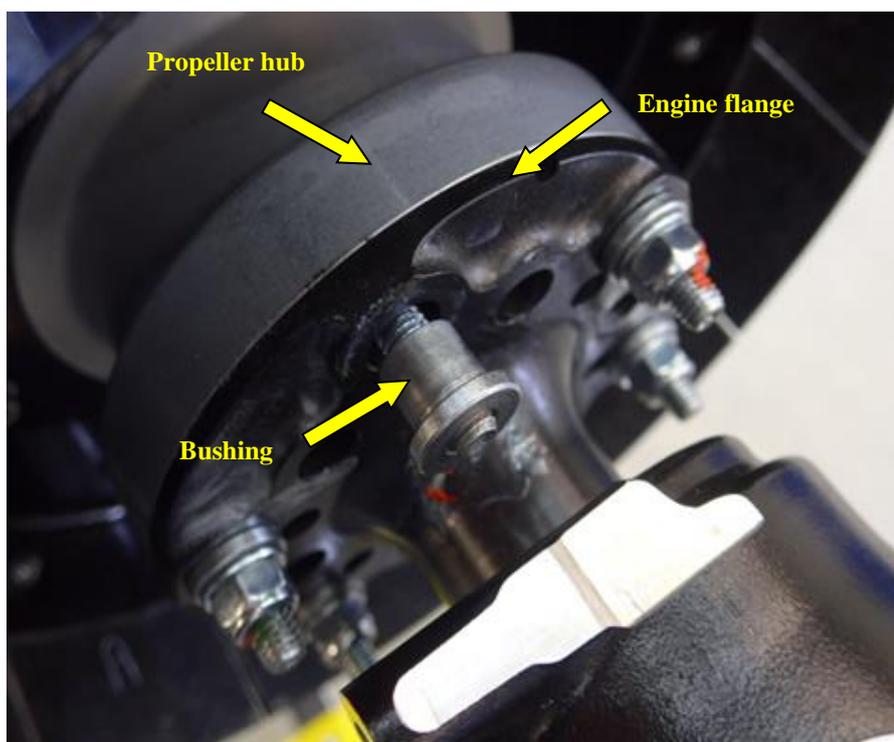
Reason  
It has been found that due to tolerances in the production of the Woodcomp assembly bushings and the engine flange, there is a possibility that the propeller may not correctly seat on the engine flange when the bushings are produced on the upper tolerance and the engine flange on the lower tolerance. This can lead to movement of the propeller on the engine propeller flange. See Fig. 1 and Fig. 2 for the situation.

Fig. 1: Bushing installation.

This service bulletin provides instructions on how to inspect and rectify the problem of negative coincidence of tolerances.

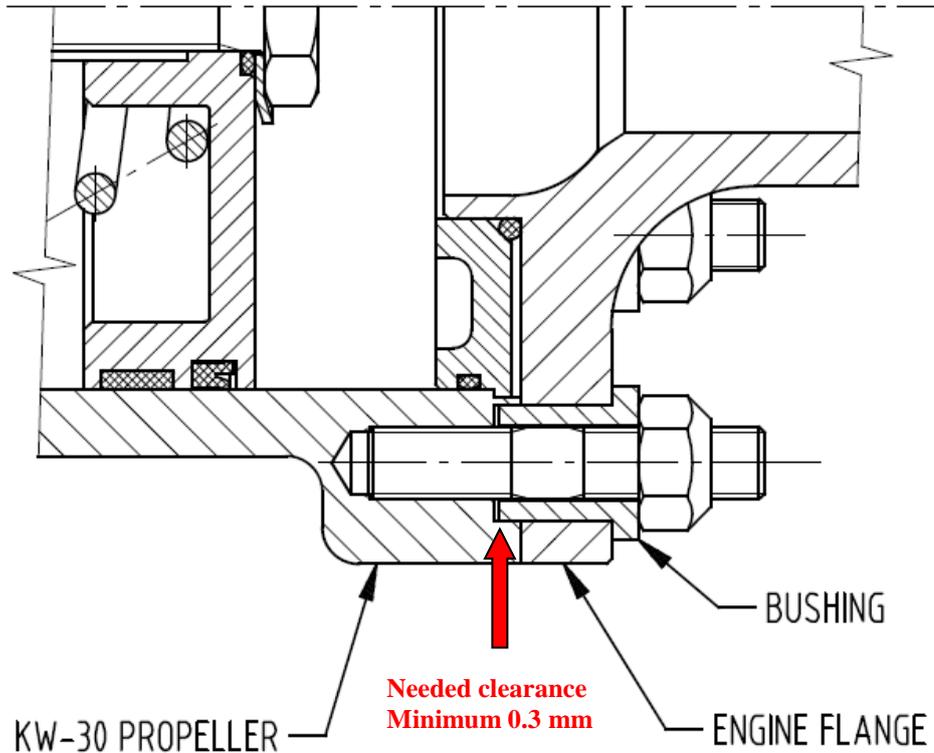
Fig. 2: Requested minimum clearance 0.3 mm

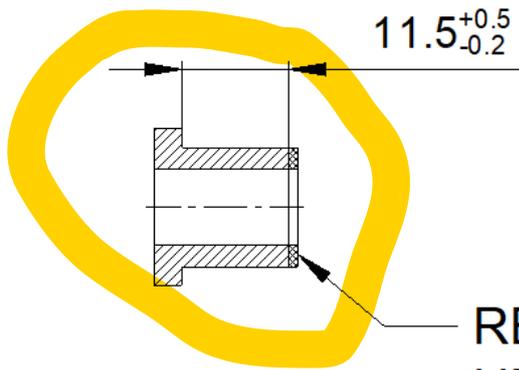
**REMOVE MATERIAL  
HERE**

Fig. 3: Bushings rework

<p>Manpower estimates</p>	<p>The task may only be performed by an organization or individual entitled and trained to carry out maintenance on the aircraft. Estimated man-hours to complete the task as a stand-alone item is: 1.0 – 2.0 hrs</p>
<p>Compliance</p>	<p>This bulletin should be complied with <b>before next flight!</b></p>
<p>Work procedure</p>	<ol style="list-style-type: none"> <li>1. Ensure the wheel brakes are applied and the mag switches/ignition are switched in the "off" position.</li> <li>2. Remove the propeller spinner.</li> <li>3. Remove the 6 nuts and washers securing the propeller to the propeller gearbox flange.</li> <li>4. Place a container under the propeller gearbox flange (a small amount of oil will escape from the flange shaft when the propeller is removed). Carefully remove the propeller.</li> <li>5. Remove the bushings from the engine flange.</li> <li>6. Shorten the bushings according to the Fig. 3.</li> <li>7. Re-assemble the propeller in accordance with the Woodcomp UM-06 User Manual, tightening the nuts to 22Nm.</li> <li>8. Once assembled, ensure there is no movement of the threads or bushes evident in the propeller flange discernible when applying force to the propeller assembly laterally and vertically.</li> <li>9. Carry out a ground run of the aircraft for correct function and security of the propeller.</li> <li>10. Carry out a check-torque of the 6 propeller assembly nuts post ground run. Mark the threads and nuts with torque seal if required (country of registration dependent).</li> <li>11. Check the engine oil level post ground run and top up if required.</li> </ol>
