Title: Inspection of Rotor head		
AG-SB-2022-09-B-EN	Effective Date: 07.10.2022	Compliance Category: A - MANDATORY B - RECOMMENDED C - OPTIONAL
Applicability		
Aircraft type & model: All Cavalon and Calidus with Rotor head III	Affected Serial number(s): All Cavalon and Calidus with Rotor head III	
The maintenance manual to be referenced is this stated or subsequent issue.		As per AutoGyro website
This form is the response from AutoGyro GmbH either against a problem found in the product in service requiring a containment or rectification action, or as service information for aircraft modification incorporation. For help, contact airworthiness@auto-gyro.com .

The purpose of this SB is to highlight the need for effective pre-flight and service inspection of the weld that joins the rotor head side plate to the roll link bracket.

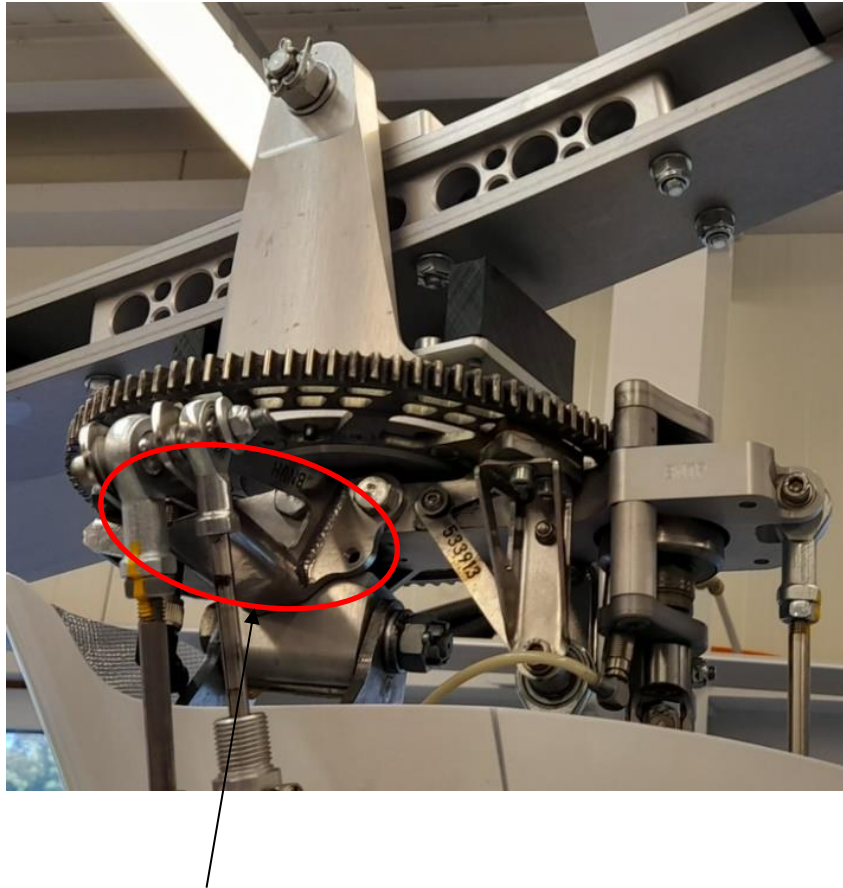
Rotorhead III

Pre-flight inspection requires a thorough review of the rotorhead. Pilot/operators are reminded that this includes the welded connection between the side plates and roll link bracket shown below. This area is open for easy inspection.

If a crack is found, the part is to be replaced in accordance with normal maintenance procedures.

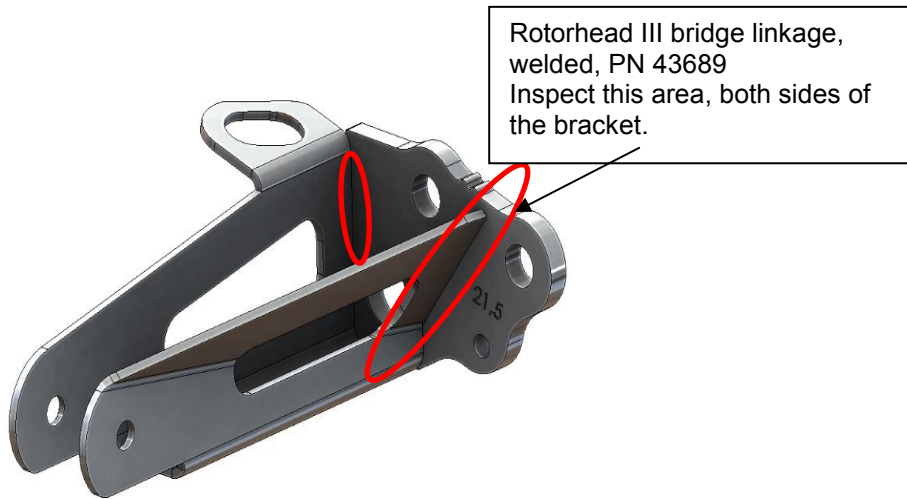
The ringed area indicates the installed bridge linkage

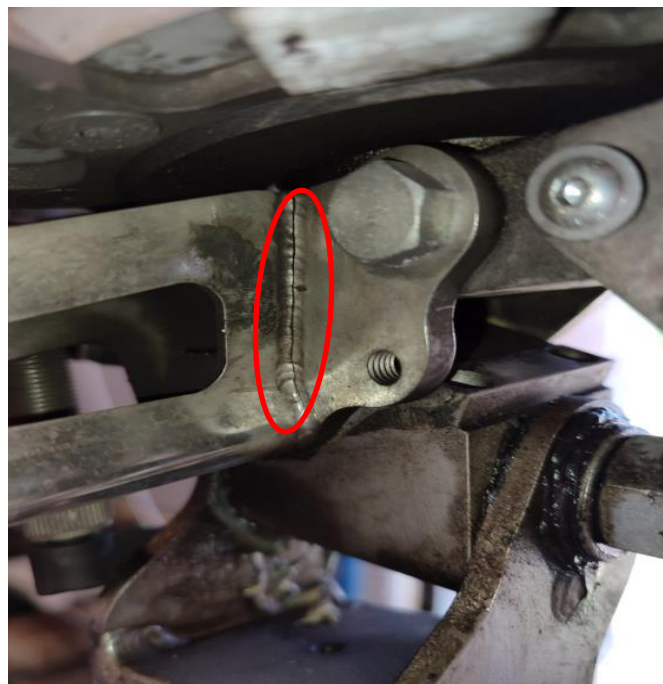
Reason; a small number of 1st generation Rotorhead III Rotor head bridge roll linkage assemblies were found during service inspection to have a weld crack. The inspection in this area is considered to be part of the pre-flight inspection, and the area is easily visually inspectable.

External weld with crack:

This area is readily inspected during pre-flight inspection

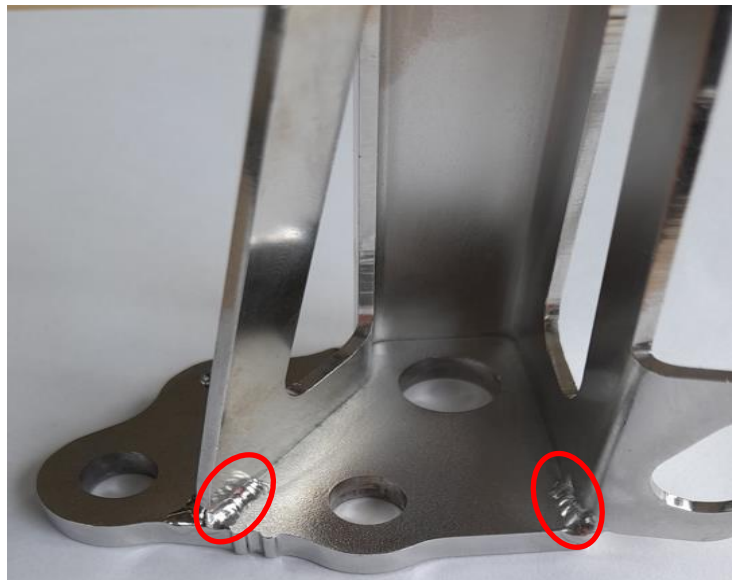
There are two generations of the Rotorhead III Rotor head bridge roll linkage assemblies. The second generation is welded on the inside upper end of the bracket, see photo, and was released in 2019. Only this later generation is available, and is fully interchangeable with the earlier version.

Note: these assemblies are stamped with the size (21.5 and 22.5). If replacing, ensure that the correct size is fitted!

Replacement parts if required
 45966, Rotor head bridge roll linkage 22,5 welded (Cavalon)
 43689, Rotor head bridge roll linkage 21,5 welded (Calidus)
