# RotorSport UK Ltd

## Service Bulletin

**SB No.: 039 issue 1**

Aircraft type & model  
(applicability)  
RotorSport UK Calidus

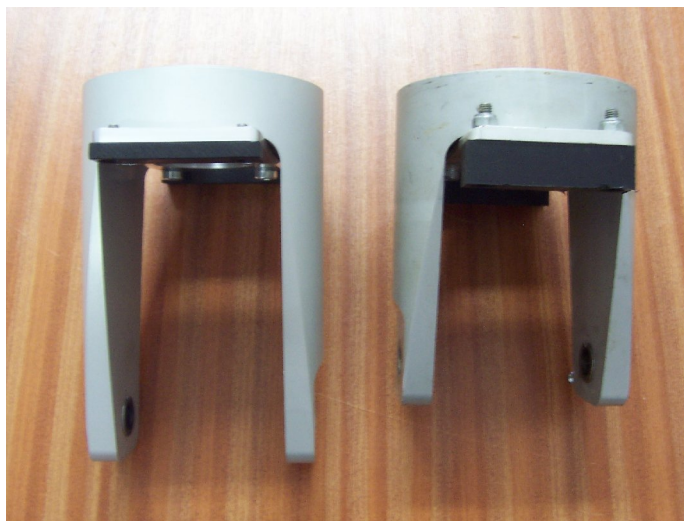
The different teeter-towers and teeter stops.  
Rotorsystem II (red end-caps) is used with the taller tower shown on the left  
An original rotor (orange end-caps) must NEVER be fitted to the taller tower

Important note: The new rotors by themselves (identified by red end-caps) are not interchangeable with any other rotors (black, grey or orange end-caps). The whole rotor system must be changed.

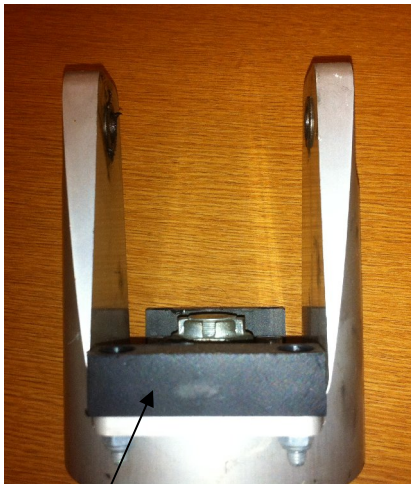
Original 18.8mm teeter-stop

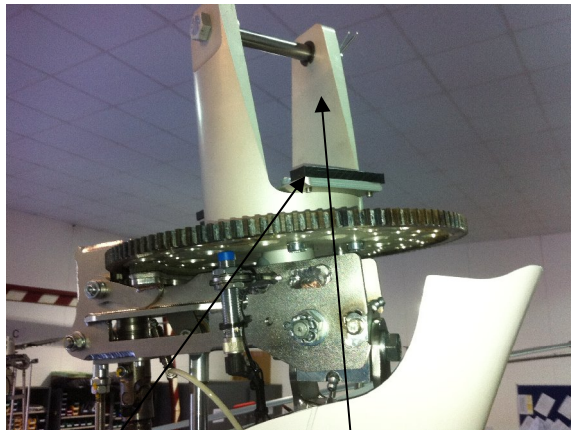
Rotorsystem II 7mm teeter-stop. Note the 30mm taller tower.

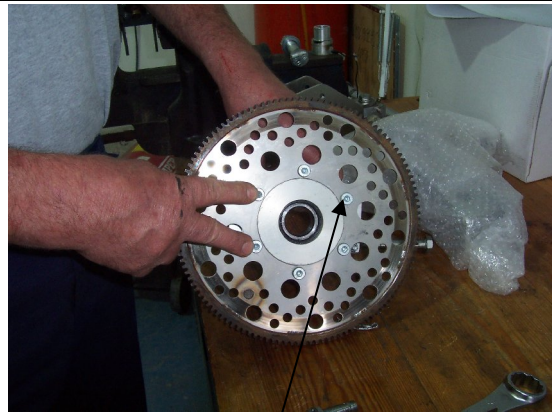
Low-profile capscrews (6-plcs)

3. Remove the M20bolt, M20 plain washer and aluminium spacer (with bonded-in sensor)
4. Note the orientation of the ring-gear on the teeter tower. Clamp the tower in the soft-jaws of a vice and remove the six low-profile capscrews retaining the gear to the tower. If necessary use a temperature-controlled heat-gun to heat the bolt-heads and degrade the Loctite bond (NB: 120degC max to avoid damage to the alloy teeter-tower).

8. Replace the M8 low-profile screws using new M8 friction washers and Loctite 243. Progressively tighten the screws to 20Nm.
9. Temporarily fit the bolt into the aluminium collar and bond the temperature sensor into the collar with a bead of hot-melt adhesive RSD4659. When the adhesive has solidified the bolt may be removed.

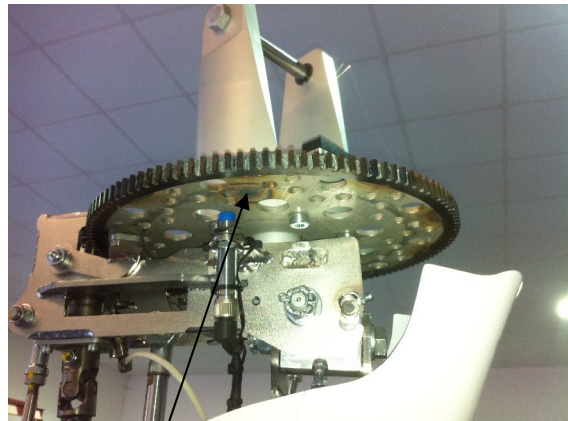
Welded plug at 11-o'clock position to rotor axis

7. Position the ring gear on the new tower's spigot so that the witness-mark from the rotor brake is on the underside and the welded-plug is at the 11-o'clock position relative to the rotor axis

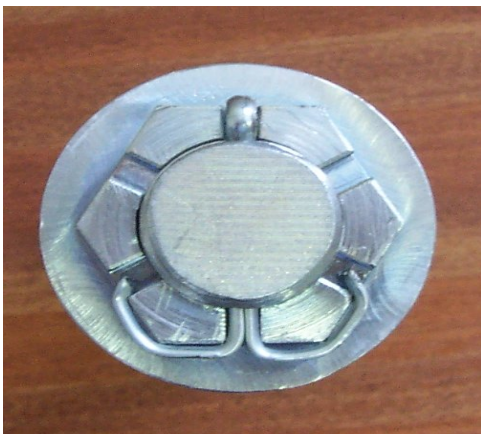
Top view of rotor bearing nut with split pin fitted.

11. Fit the new split-pin supplied in the kit. Back-off to nearest split-pin hole is acceptable but minimum torque 140Nm must be realised. Fit pin in nut as shown in later bulletin photo.

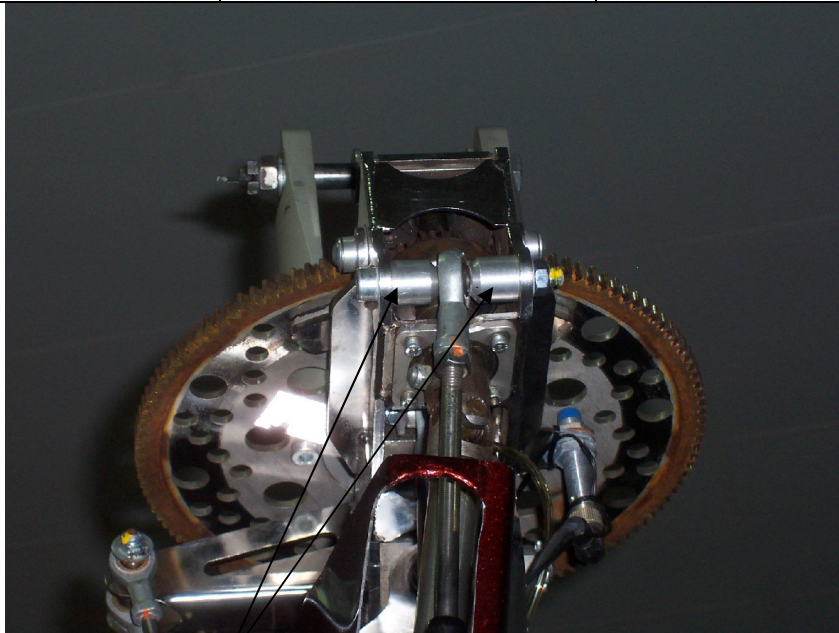
19mm conical spacers either side of pitch control cable

6. Refit the pitch control cable. In place of the damper rod-end a new 19mm conical spacer is used and this is provided in the conversion kit. It should be installed along with the original 19mm conical spacer as shown in the photograph below. Use Loctite 243 and a new nyloc nut (M8). Paint-mark the nut after tightening

Note: Each coned end may be dressed with a fine file (by no more than 0.1mm/.004”) in order to fit the assembly between the side-plates of the rotor bridge. Ensure that the filed surface is square to the bore.

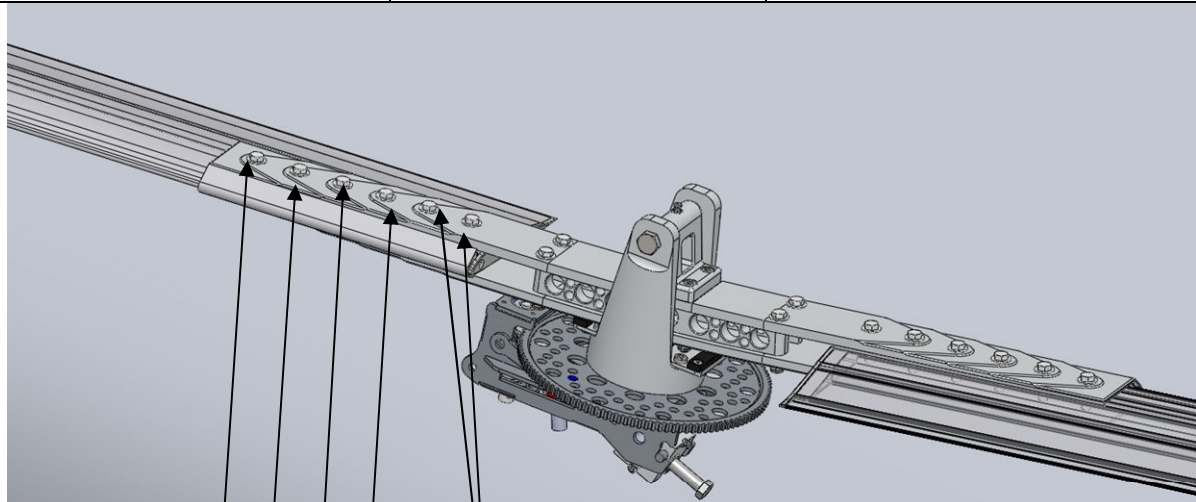
Bolt BT3697, 49mm  
Bolt BT3698, 52mm  
Bolt BT3699, 55mm  
Bolt BT3670, 58mm  
Bolt BT661, 60mm long

Schematic view of Rotorsystem II. Note the different length bolts.

**WARNING!** It is important to fit the correct length bolt in the associated hole! Fitting the wrong length bolt may result in insufficient safety protrusion through the nylock nut, or that the nut jams on the shank of the bolt before the joint is properly tightened.
