RotorSport UK Ltd

Service Bulletin

| SB No.: 042 Iss1 | CCAR No.: None | Classification: |
| Aircraft type & model (applicability) RotorSport UK Calidus | Aircraft serial Nos. effected RSUK/CALS/all | OPTIONAL or RECOMMENDED or MANDATORY |

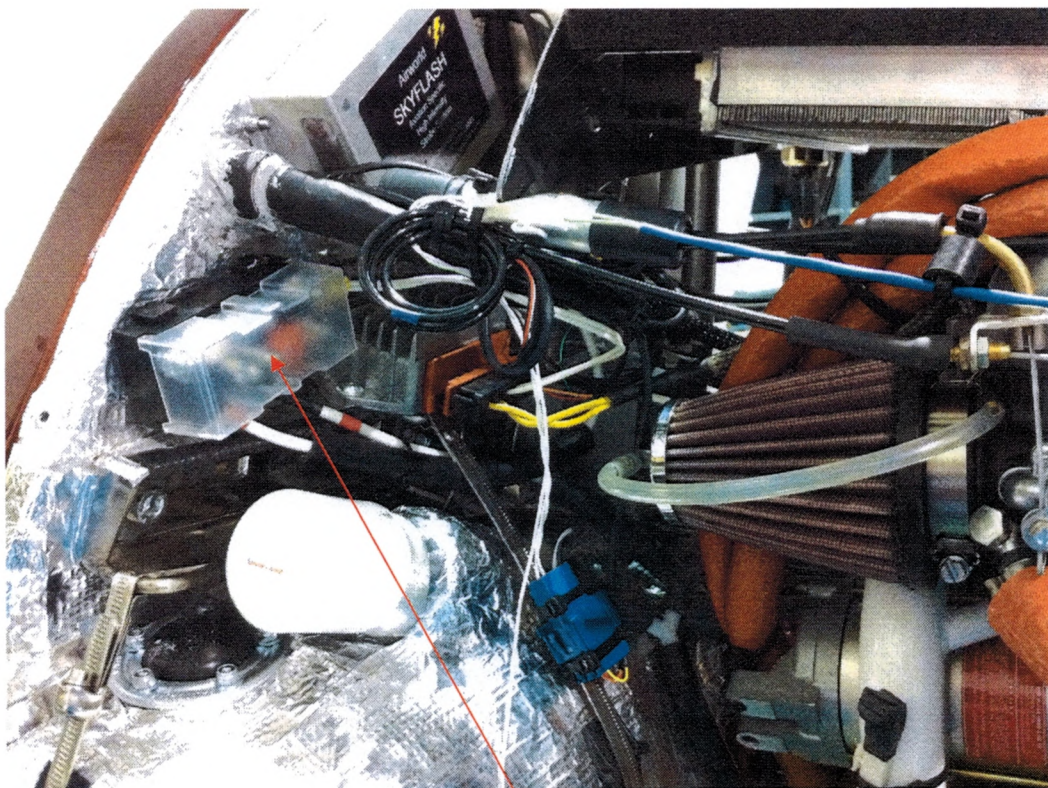
Fuse-holder location on the bulkhead

- 1) To gain access to the fuse-holder it is necessary to remove the upper engine cowling and possibly the mast cowlings, which will require disconnection of the fuel-inlet pipe and its earthing cable. To avoid risk of debris entering the fuel tank cover the exposed fuel inlet with a rag or plastic cap.
- 2) Remove the starboard lower cowling for access to the battery connections. Visibility and access will be made easier if the port lower cowling is also removed.
- 3) Disconnect the battery earth terminal. **THIS IS ESSENTIAL AS INADVERTENT CONTACT BETWEEN THE FUSE TERMINALS, A METAL SPANNER AND THE AIRFRAME WOULD RESULT IN A SHORT-CIRCUIT.**
- 4) Identify the fuse-holder location, either on the bulkhead above the stainless-steel mounting frame at the port side of the aircraft or within the mounting frame on the port side of the engine.

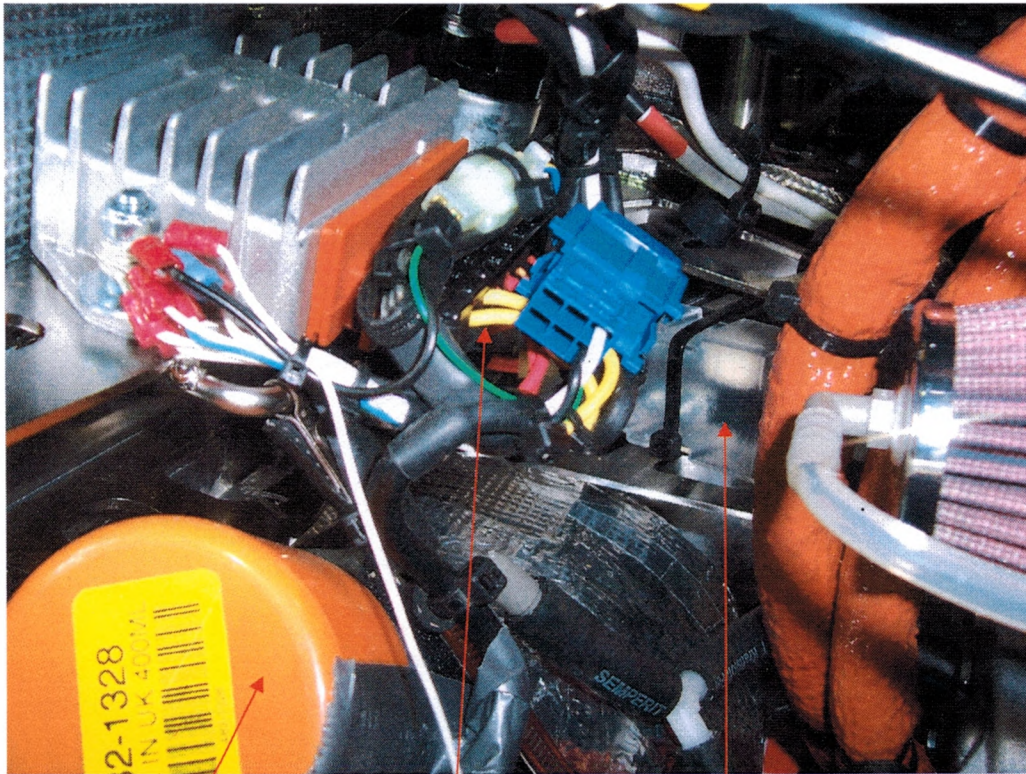
Temporary protective cap Regulator cables Fuse holder with "Safety" cable-tie visible

Fuse-holder location within the mounting frame

- 5) Carefully cut as many cable-ties as needed to enable the regulator cables to be pulled to one side and allow access to the fuse holder.
- 6) Cut any "safety" cable-tie around the fuse-holder and unclip the fuse-holder lid.

- 7) Identify the 80A fuse (by its marking) and remove the two nuts/washers retaining it. Discard the 80A fuse.
- 8) Fit the 100A fuse (identified by its marking), replace the two nuts/washers and tighten the nuts to 1.0 – 1.6Nm.

- 9) Replace the fuse-holder lid and "Safety" cable-tie
- 10) Reinstall the cable-ties on the regulator cables ensuring that there is no risk of vibration or chafing against sharp edges.

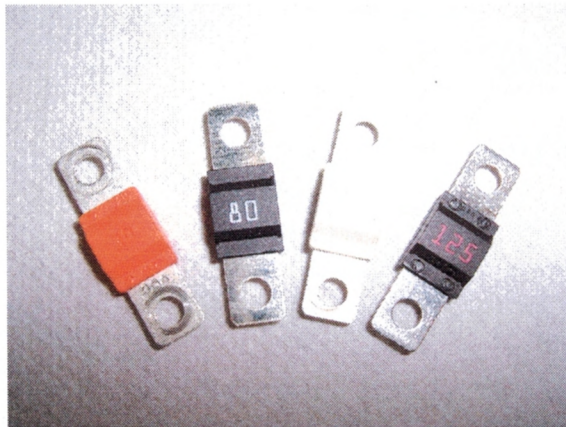
Important: Fuse value identified by marked number not by colour

100A fuse RSD4652
 Cable-ties (as required)
