RotorSport UK Ltd

Service Bulletin

SB No.: 043 Iss1	CCAR No.: None	Classification:
Aircraft type & model (applicability) RotorSport UK Calidus	Aircraft serial Nos. effected RSUK/CALS/004 onwards!	OPTIONAL or RECOMMENDED or MANDATORY

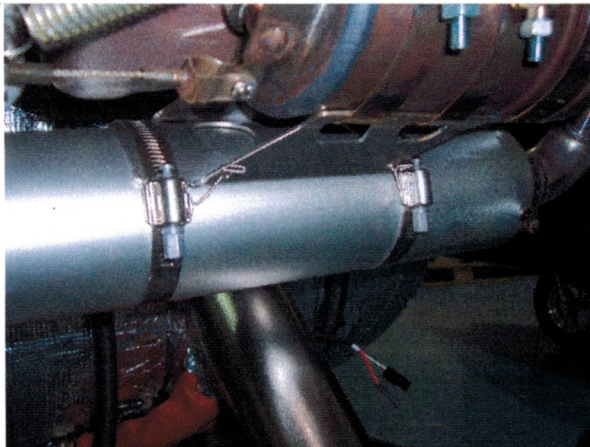
914UL

Calidus aircraft after S/no 004 (both 912ULS and 914UL-engined variants) have a transverse after-muffler clamped under the main silencer by means of a stainless-steel saddle/tension-band arrangement. The tension bands may fail due to the thermal stresses in the mounting system (but the aftermuffler will be retained by its pipe-clamp and wire-locking). A silicone strip may be fitted under each tension-band to reduce these stresses and prevent band failure.

Original installation without silicone rubber strips.
Note the wire-locking fitted through the bracket and the holes in the clip

- 1) Gaining access through the rear aperture of the engine cowlings note the arrangement of, then cut-away the wire-locking retaining the two tension bands
- 2) Unscrew, separate and remove each band.
- 3) Loosely fit new bands then position a rubber strip centrally under each band either side of the saddle lugs. Tighten each band firmly but not such that the rubber is extruded from underneath the band.
- 4) Reinststate the wire-locking

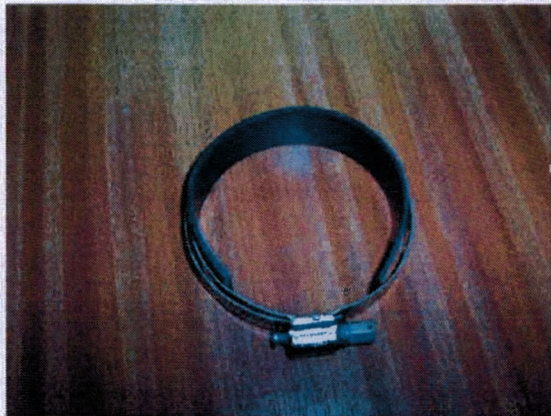
Silicone strip inside band

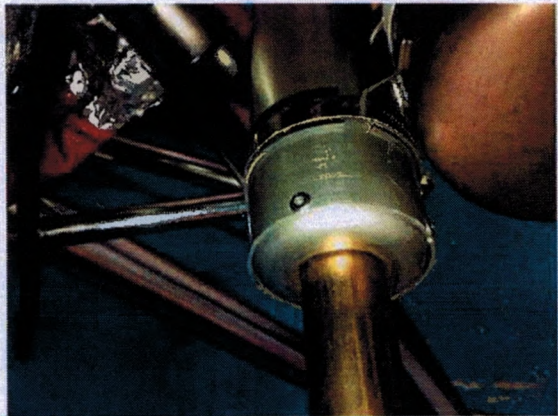
Fitted to aircraft
