RotorSport UK Ltd

Service Bulletin

Title: Stick vibration reduction.		
SB No.: 061 Iss 1	Related documents MC No: MC-209 CCAR No.: None	Compliance Category: OPTIONAL or RECOMMENDED or MANDATORY
Applicability		
Aircraft type & model MT-03 MTOsport Calidus	Aircraft serial Nos. effected Any Any prior to RSUK/MTOS/048 Any prior to RSUK/CALS/022	
This form is the response from RotorSport UK Ltd either against a problem found in the product in service requiring a containment or rectification action, or as service information for aircraft modification incorporation. For help, contact RotorSport on 44(0)1588 650769, or email info@rotorsport.org.		
<u>Reason and overview of the Service Bulletin (cause of problem if known)</u>		
This service bulletin describes the installation of Pitch/Roll Improvement Kit RSD7218 which reduces the transmission of rotor vibration to the control stick. It is particularly effective with Calidus aircraft (which utilise push/pull control cables) but also provides some benefit for MTOsport and MT-03 aircraft (which use control rods).

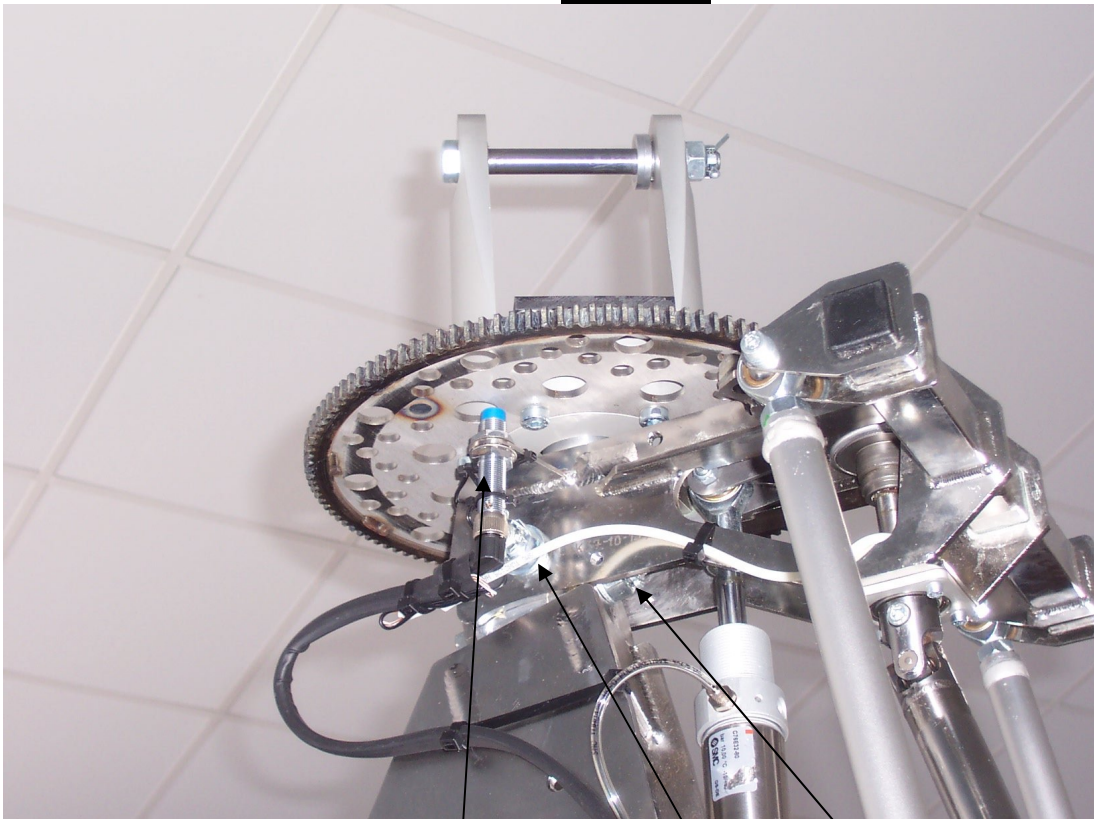
MT-series

View of MT series rotor head. Speed sensor Pitch bolt Roll bolt

- (i) To remove gimbal block from aircraft
1. Position the aircraft on level ground and apply brakes/chock wheels. Remove the rotor as described in the Maintenance Manual.
 2. Disconnect the rotor rpm sensor and tie the cable safe to one side
 3. Remove the split pin, and unscrew the nut from the pitch-pivot bolt. Remove the washers and the bolt and move the rotor-head clear of the mast
 4. NB: on early aircraft the pivot bolt head may be adjacent to the rotor-speed sensor requiring that the sensor is temporarily removed. Before doing this use a feeler-gauge to establish the clearance between the sensor face and the disk and note the orientation of the sensor. Its face should be clear of the disk by ~2mm.
 5. Remove the split-pin, and unscrew the nut from the roll-pivot bolt.
 6. Remove the washers and the bolt and lift the gimbal block clear.

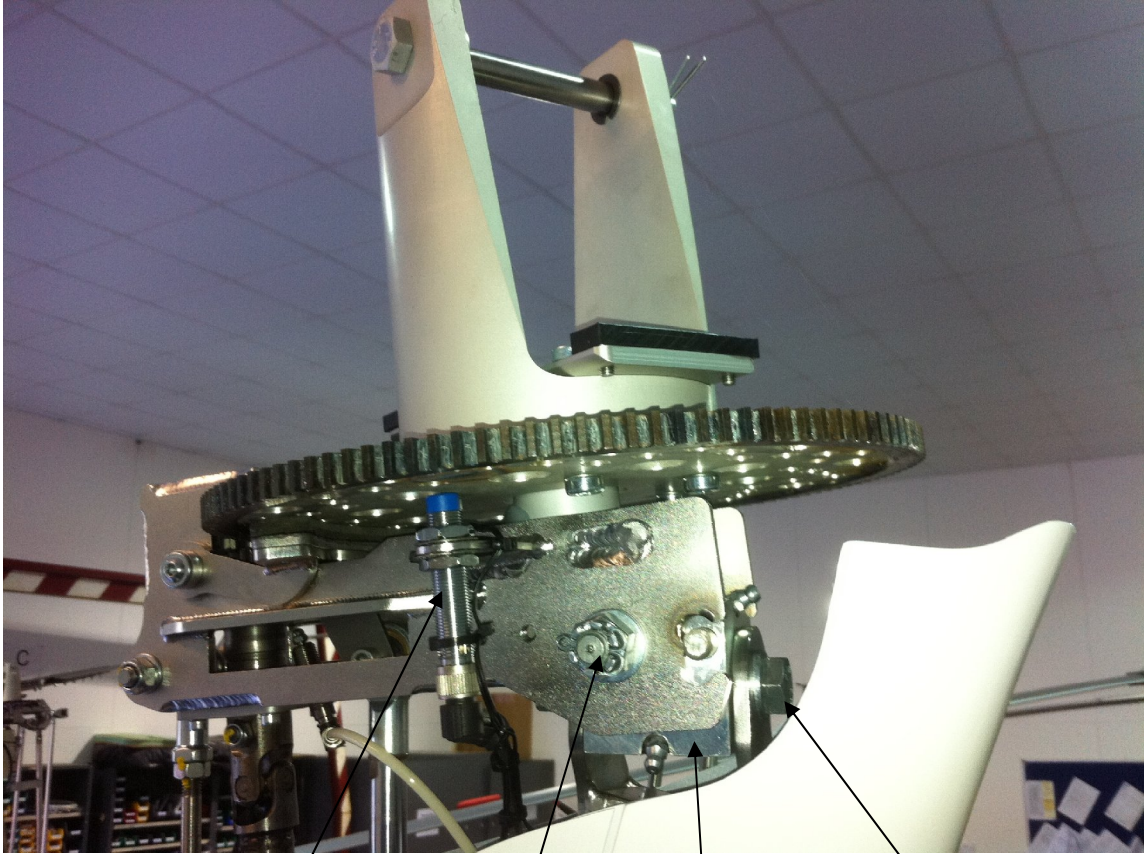
<p><u>Calidus rotor head</u> Speed sensor Pitch bolt Gimbal block Roll bolt</p>		
<p>(i) To remove gimbal block from aircraft</p> <ol style="list-style-type: none"> 1. Position the aircraft on level ground and apply brakes/chock wheels. Remove the rotor as described in the Maintenance Manual. 2. Cover the canopy with thick fabric to protect against any dropped tools 3. If required (recommended), remove the upper engine cowling and the two mast cowlings 4. Set the pitch damper (if fitted) to minimum by turning fully anti-clockwise. 5. Disconnect the rotor rpm sensor and tie the cable safe to one side 6. Disconnect the roll control cable and roll trim cylinder from the rotor head. Note

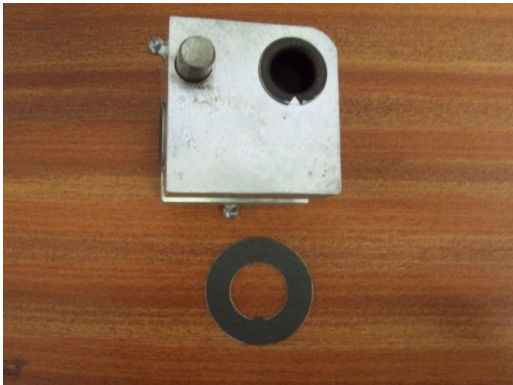
<p>Pitch/roll block and full-washer</p> </div> <div style="text-align: center;">

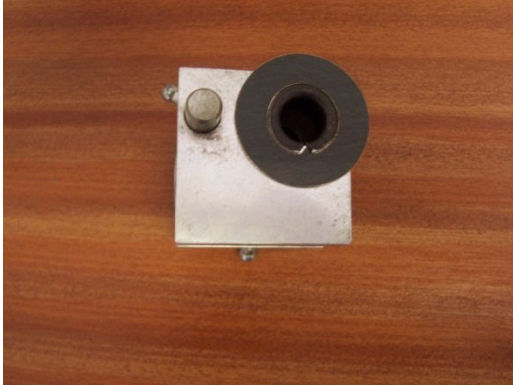
<p>Full-washer in place</p> </div> </div> <p>The bore of the washer should fit closely around the flange of the headed bush with the</p>
