RotorSport UK Ltd Service Bulletin

| Title: Fire-warning cable terminal improvement | | |
| SB No.: 081 Iss1 | Related documents MC No:271 CCAR No.: 017, 052 | Compliance Category: OPTIONAL or RECOMMENDED or MANDATORY |
| Aircraft type & model: Calidus Cavalon | Aircraft serial Nos. affected: RSUK/CALS/001 onwards RSUK/CVLN/001 onwards | |

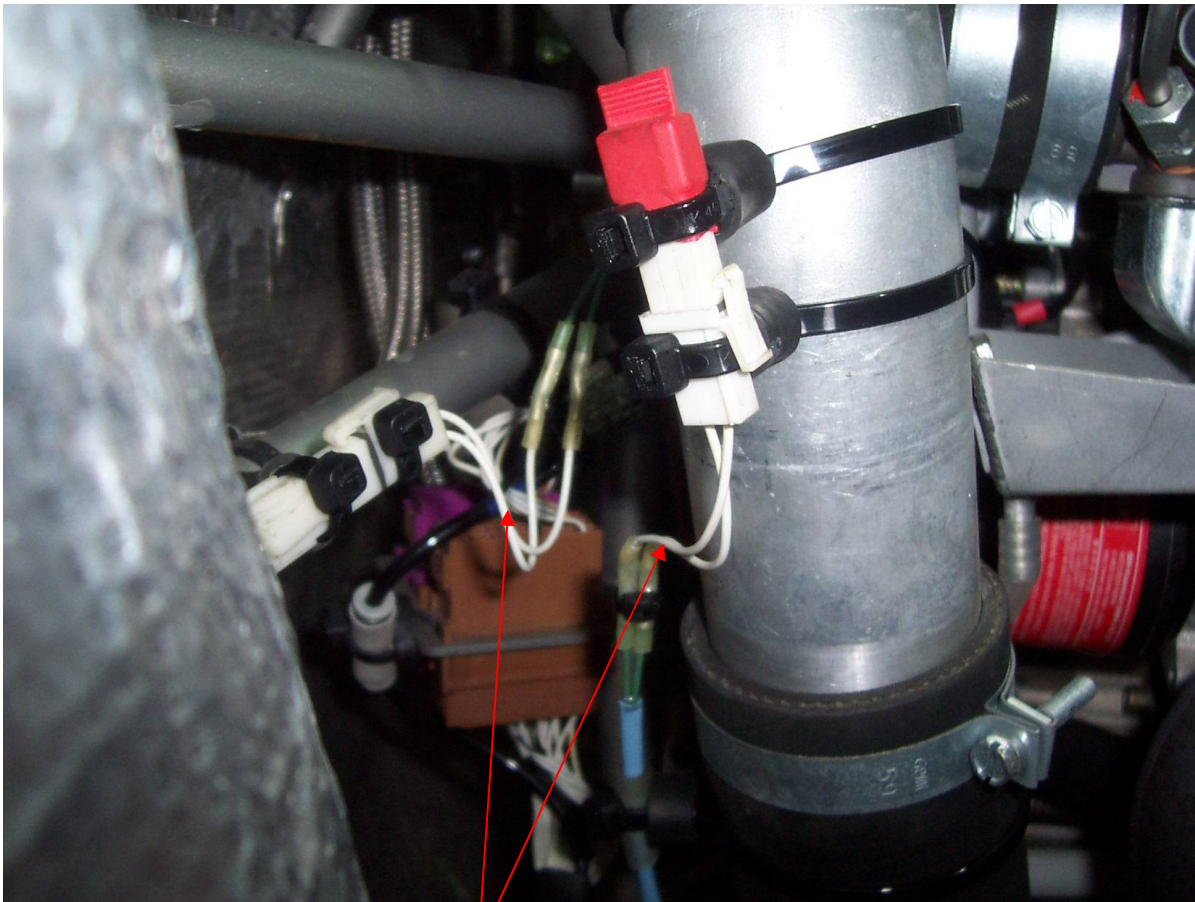
Installation on Cavalon

The fire-warning system fitted to Calidus and Cavalon aircraft makes use of a special sensing cable (Protectowire) that has rigid steel conductors with a meltable coating. Terminating and joining this special cable has been difficult to achieve and unreliable in service, as the rigid conductors are difficult to crimp into the small connector terminals and are prone to open-circuit failure from vibration. By introducing short lengths of flexible cable the connector crimps can be made more reliable and larger insulated butt-crimps used to join to the rigid cable.

| <p><u>Accomplishment instructions (Action required to implement this bulletin):</u> Effective date of this SB-081 is 03.03.14 There is no relevant MPD or other outside body documentation to be referenced. This task may be carried-out by any A3-7 approved person.</p> <ol style="list-style-type: none"> 1) Making reference to the aircraft AMM remove the aircraft cowlings to gain access to the white connectors that are: <ul style="list-style-type: none"> ② joining the blue Protectowire to the aircraft wiring loom ② joining the blue Protectowire to the terminating resistor Remove cable-ties as required for access 2) Remove the Protectowire cable ends from the connector shell and remove the crimp terminals by cutting free 3) Fit a 50-60mm length of #22AWG Raychem cable with a new crimp terminal and locate into the connector. Dress the other end to length and connect to the Protectowire with a butt-crimp. Repeat for the other cables. Heat-shrink the sleeving and cable-tie the installation as required. 4) Remove the terminating resistor to test the system with deliberate open-circuit – the red warning light should illuminate to a “solid” condition when the master switch turned on. 5) Connect together the two terminals, so simulating a fire-warning. The red warning light should flash continuously until reset by the master switch | | |
