RotorSport UK Ltd Service Bulletin

Title: Pre-rotator clutch torque check		
SB No.: 087 Iss2	Related documents MC No: None CCAR No.: None	Compliance Category: OPTIONAL or RECOMMENDED or MANDATORY
Applicability		
Aircraft type & model:	Aircraft serial Nos. affected:	
Cavalon	Any a/c manufactured before 7/14	
Calidus	Any a/c manufactured after RSUK/CALS/021 and before 7/14. Any aircraft retrofitted with Pneumatic Coupling III under MC-212	
This form is the response from RotorSport UK Ltd either against a problem found in the product in service requiring a containment or rectification action, or as service information for aircraft modification incorporation. For help, contact RotorSport on 44(0)1588 650769, or email info@rotorsport.org.		
<u>Reason and overview of the Service Bulletin (cause of problem if known)</u>		
<p>All Cavalon aircraft and later Calidus aircraft have a miniature pressure regulator in the pneumatic supply to the pre-rotator clutch (also evidenced by a black pre-rotator interlock push-button on the instrument panel). The clutch is combined with a right-angle gearbox under part number BG3792 (Pneumatic coupling III).</p> <p>During aircraft assembly the pressure re

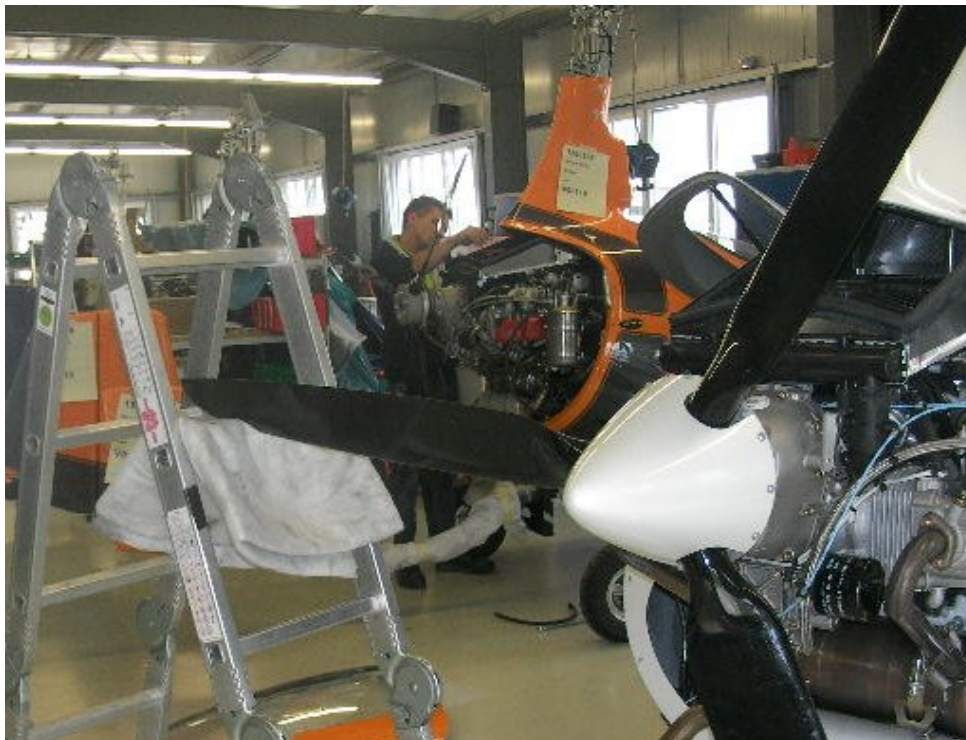
Typical propeller chocking arrangement

- 1) Position the aircraft on level ground and apply the wheel brakes to prevent unexpected movement. Use the rotor tie-down bag to stabilise the rotor and disengage the rotor brake by selecting “Flight”. Chock the propeller to prevent rotation (in normal direction), using soft packing material to ensure that the blades cannot be damaged
