RotorSport UK Ltd Service Bulletin (Permit)

Title: Improved IVO-prop motor		
SB No.: 098 Iss1	Related documents MC No: 276, 294, MC-323 CCAR No.: 064, 066	Compliance Category:
Applicability		OPTIONAL or RECOMMENDED or MANDATORY
Aircraft type & model: Calidus, Cavalon	Aircraft serial nos. affected: Any fitted with IVO-prop prior to 12.07.15	
This form is the response from RotorSport UK Ltd either against a problem found in the product in service requiring a containment or rectification action, or as service information for aircraft modification incorporation. For help, contact RotorSport on 44(0)1588 650769, or email info@rotorsport.org.		
<u>Reason and overview of the Service Bulletin (cause of problem if known)</u>		
IVO-prop DL3-68 in-flight variable pitch propellers are available as an option for Cavalon and Calidus recreational gyroplanes. The blade pitch of these propellers is changed by means of an electric motor/planetary gearbox/leadscrew driving a simple linkage in the root of each propeller blade. There are no electrical switches limiting blade movement because when the linkage reaches hard-stops in the propeller hub the motor current increases rapidly and is disconnecte

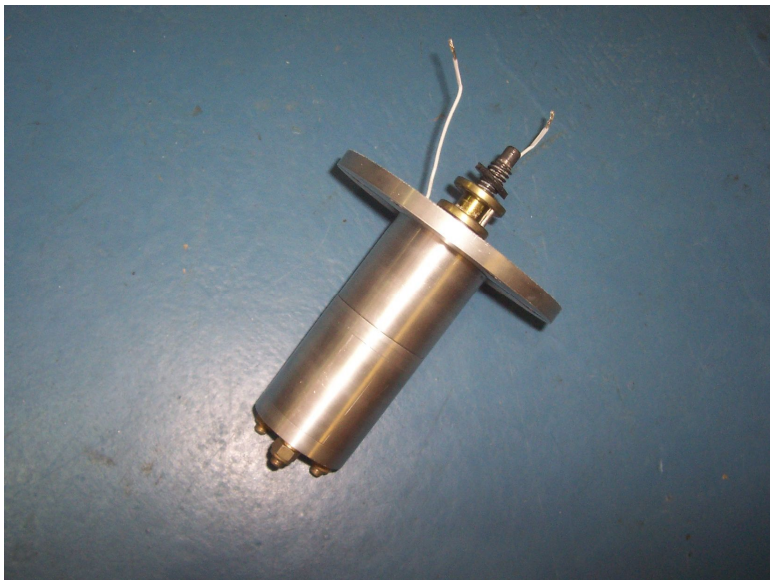
Motor/gearbox assembly removed

4. Transfer the propeller to a suitable work-bench and making reference to the propeller manual RSUK0325 remove the three blades then the motor/gearbox assembly.
(NB: Service Bulletins SB-083 Fit IVO-prop to Calidus and SB-088 Fit IVO-prop to Cavalon provide further information)
