RotorSport UK Ltd Service Bulletin (Permit)

Title: Stainless steel after-muffler tube		
SB-114 Iss1	Related documents Modification: MC-336 CCAR No.: None	Compliance Category:
Applicability		OPTIONAL or RECOMMENDED or MANDATORY
Aircraft type & model: Calidus with 914UL only Cavalon with 914UL only	Aircraft serial Nos. affected: RSUK/CALS/028 RSUK/CALS/029 RSUK/CVLN/018 Also see note below	
The maintenance manual to be referenced is this stated or subsequent issue.		Calidus RSUK0060 Iss6 Cavalon RSUK0288 Iss5
This form is the response from RotorSport UK Ltd either against a problem found in the product in service requiring a containment or rectification action, or as service information for aircraft modification incorporation. For help, contact RotorSport on 44(0)1588 505060, or email compliance@rotorsport.org . The technical content of this document is approved under the authority of the UK CAA Design Organisation Approval Ref: DAI/9917/06

AG-SB-2016-04-C-EN – Replacement Muffler Tube Cavalon and Calidus

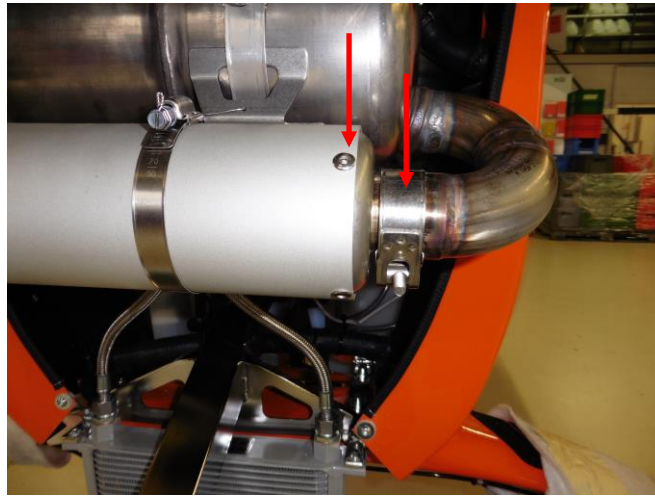
Fig.1 Rivets and hinge pin clamp

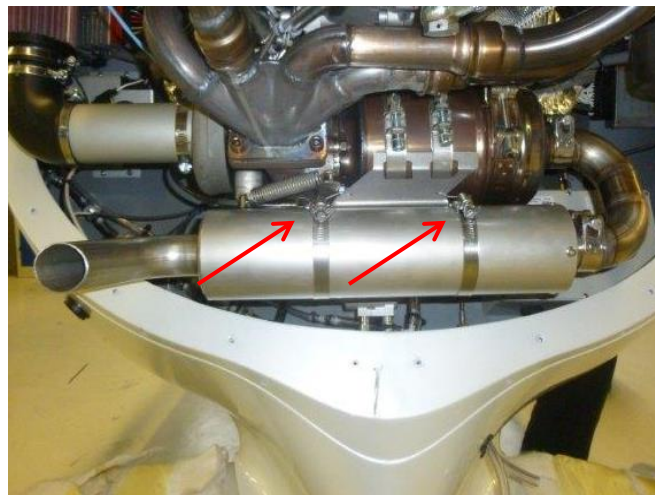
Fig.2: Hose clamps

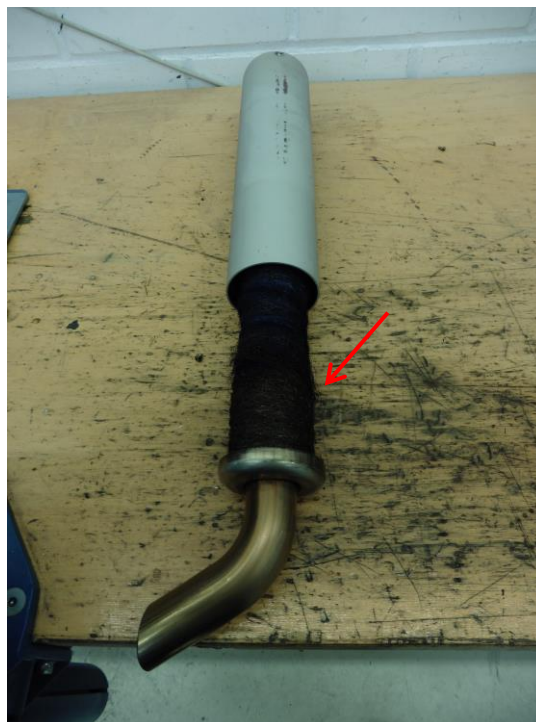
Fig.4: Wool

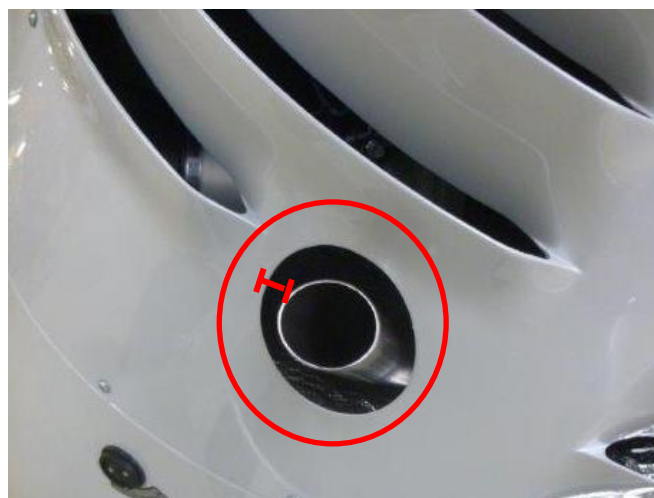
Fig.7: Position of the muffler tube

- 15 Fix the bottom cowling according to chapter 52-00-00 4-1. Make sure that the pipe of muffler tube is placed in the middle opening (surrounding 15 mm). If necessary, adjust the position of the muffler tube (Fig.7).
- 16 Remove the bottom cowling and tighten the two hose clamps and hinge pin clamp.
- 17 Secure the screws of hose clamps with locking wire (Fig.8).
- 18 Install the cowling according to chapter 52-00-00 4-1.
