# RotorSport UK Ltd Service Bulletin (Permit)

<b>Title: Pneumatic clutch III Pressure Plate inspection</b>		
<b>SB-128 Iss1</b>	<b>Related documents</b> Modification: MC- none CCAR No.: None	<b>Compliance Category:</b>
<b>Applicability</b>		<b>OPTIONAL or RECOMMENDED or MANDATORY</b>
<b>Aircraft type &amp; model:</b> MTOS2017 Cavalon	<b>Aircraft serial Nos. affected:</b> RSUK/MT02/004,06,07 and 08 RSUK/CVLN/027	
The maintenance manual to be referenced is this stated or subsequent issue.		MTOS2017 RSUK0395 Iss1 Calidus RSUK0061 Iss7 Cavalon RSUK0288 Iss5
This form is the response from RotorSport UK Ltd either against a problem found in the product in service requiring a containment or rectification action, or as service information for aircraft modification incorporation. For help, contact RotorSport on 44(0)1588 505060, or email <a href="mailto:compliance@rotorsport.org">compliance@rotorsport.org</a> .  The technical content of this document is approved under the authority of the UK CAA Design Organisation Approval Ref: <b>DAI/9917/06</b>

<b>Title: Pneumatic Clutch III (2017) – Pressure Disc Inspection</b>		
<b>AG-SB-2018-05-B-EN</b>		<b>Compliance Category:</b>
<b>Applicability<

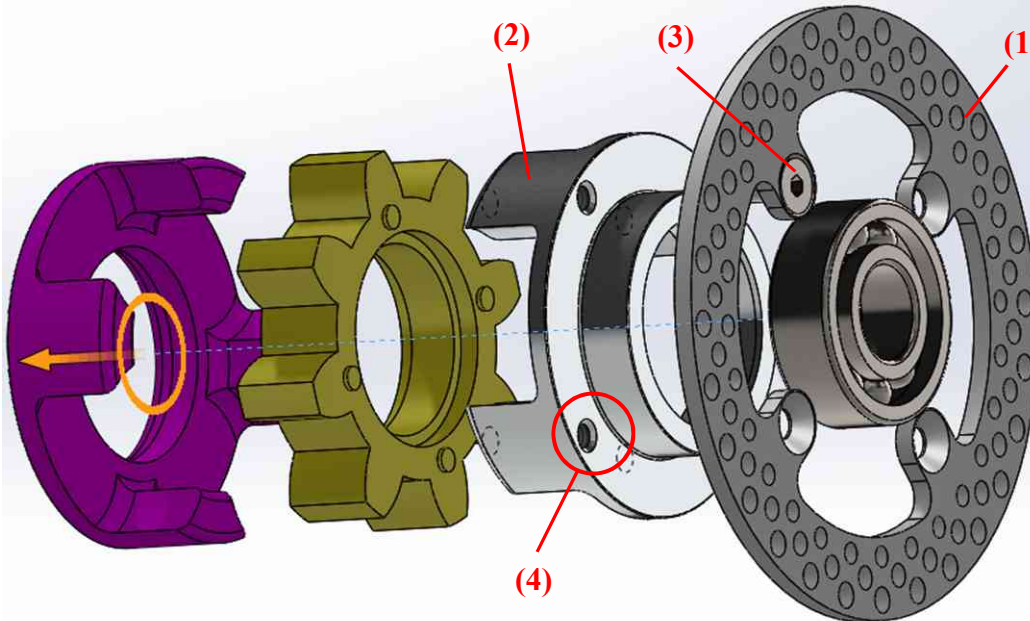
Fig. 1 - Pressure Plate Assembly (31713)

It has been found that the threaded holes in the first batch of pneumatic clutch III (2017) Pressure Plate front (2) are not sufficiently countersunk to accept the countersunk screws securing the Pressure Disc PKII (1). The effect is that the screws are unable to properly clamp the disc and plate together, possibly leading to looseness, rattle noise, and wear of this connection.

1. Remove any cowlings required to gain access to the clutch assembly.
2. Remove the pneumatic clutch from the engine in accordance with AMM job card 63-11-10 4-1.
3. Remove the center screw retaining the pressure plate assembly (31713) to the clutch in accordance with AMM job card 63-11-10 8-1 part 4.
4. Remove the pressure plate assembly (31713) from the clutch and remove the 4 countersunk screws (3) securing the pressure disc (1) to the pressure plate front (2).
5. Inspect for signs of rotational movement of the pressure disc (1) on the pressure plate front (2), and/or elongated holes in the disc (1). If damaged, replace (article 23604).
6. Inspect the complete clutch assembly for any further damage and replace any affected parts (eg. 31713 Pressure Plate Mounted).
7. Inspect the pressure plate front (2) and ensure that the threaded holes (4) are countersunk to a

- depth of 1mm with a 45° countersink. If not, re-work with a suitable countersink tool.
8. Re-assemble the clutch in reverse order of disassembly.
  9. Assemble the clutch to the engine in accordance with AMM job card 63-11-10 4-1.
  10. Re-fit any cowlings previously removed.
  11. Ground run the aircraft in a suitably secured area, including a pre-rotation clutch functional check.
  12. Note the SB action within the aircraft documentation.
