# AutoGyro Certification Ltd    Service Bulletin (Permit)

<b>Title: Inspection of Rotor head</b>		<b>Release date 07.10.2022</b>
<b>SB-147 Iss1</b>	<b>Related documents</b> Modification: CCAR No.: None	<b>Compliance Category:</b>  <b>OPTIONAL</b> <del>or</del> <b>RECOMMENDED</b> <del>or</del> <b>MANDATORY</b>
<b>Applicability</b>		
<b>Aircraft type &amp; model:</b> All Cavalon and Calidus with Rotor head III	<b>Aircraft serial Nos. affected:</b> All Cavalon and Calidus with Rotor head III	
The maintenance manual to be referenced is this stated or subsequent issue.		None
<p>This form is the response from AutoGyro Certification Ltd either against a problem found in the product in service requiring a containment or rectification action, or as service information for aircraft modification incorporation. For help, contact RotorSport on 44(0)1588 505060, or email <a href="mailto:compliance@rotorsport.org">compliance@rotorsport.org</a>.</p> <p>The technical content of this document is approved under the authority of the UK CAA Design Organisation Approval Ref: <b>DAI/9917/06</b></p>

The purpose of this SB is to highlight the need for effective pre-flight and service inspection of the we

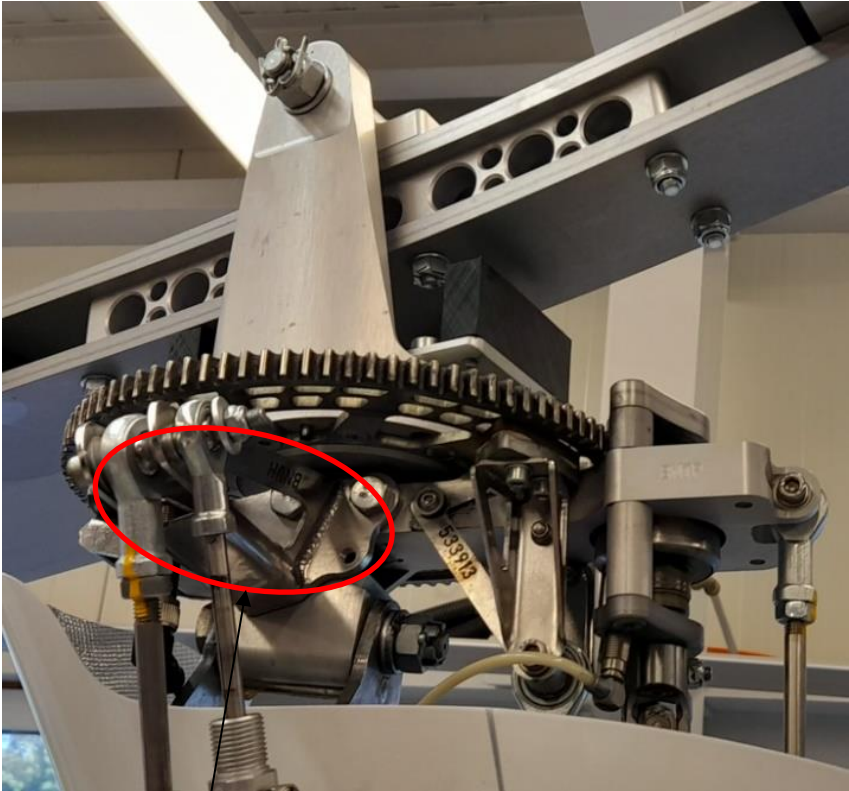
**Rotorhead III**

The ringed area indicates the installed bridge linkage

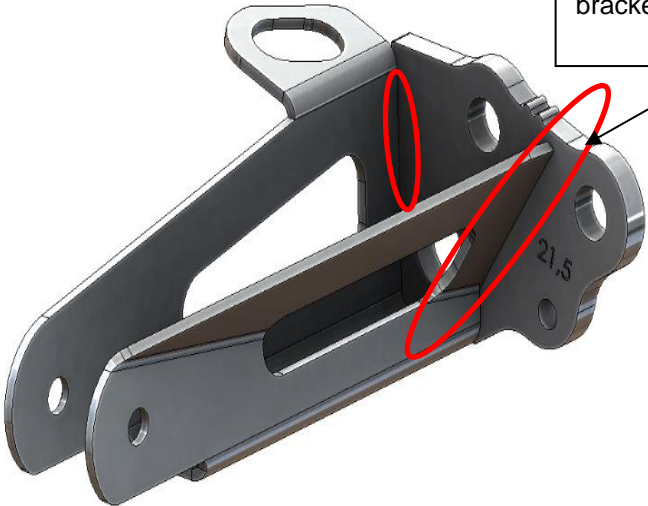
Rotorhead III bridge linkage, welded,  
PN 43689  
Inspect this area, both sides of the  
bracket.

Pre-flight inspection requires a thorough review of the rotorhead. Pilot/operators are reminded that this includes the welded connection between the side plates and roll link bracket shown below. This area is open for easy inspection. If a crack is found, the part is to be replaced in accordance with normal maintenance procedures.

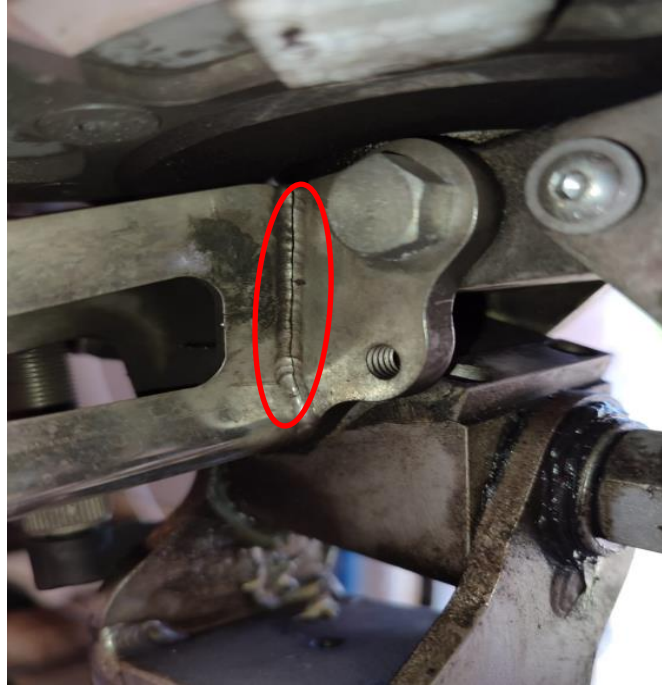
Reason; a small number of 1st generation Rotor head III Rotor head bridge roll linkage assemblies were found during service inspection to have a weld crack. The inspection in this area is considered to be part of the pre-flight inspection, and the area is easily visually inspectable.

External weld with crack:

This area is readily inspected during pre-flight inspection

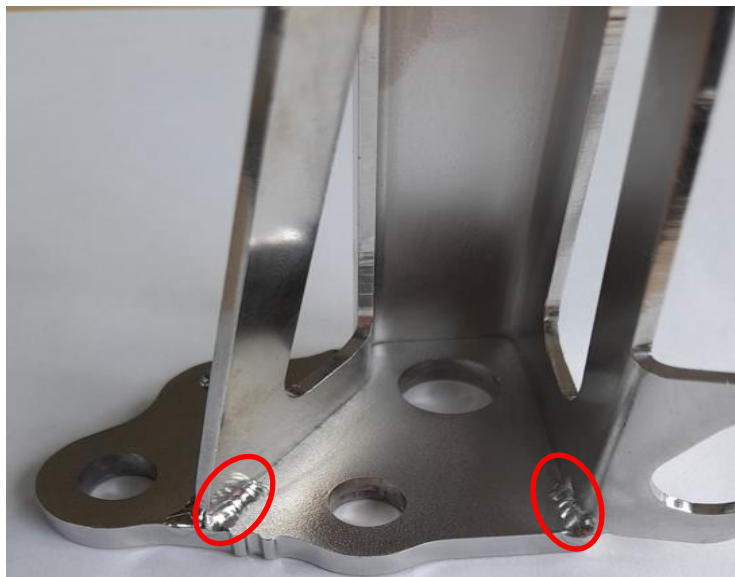
There are two generations of the Rotor head III Rotor head bridge roll linkage assemblies. The second generation is welded on the inside upper end of the bracket, see photo, and was released in 2019. Only this later generation is available, and is fully interchangeable with the earlier version.

Note: these assemblies are stamped with the size (21.5 and 22.5). If replacing, ensure that the correct size is fitted!
