| Title: Improved Version For The Heat Protection On Lower Ignition Cables | | |
| AG-SB-2025-01-B-EN | Effective Date:<br>22.10.2025 | Compliance Category: |
| <b>Applicability</b><br><b>Aircraft type &amp; model:</b><br>AutoGyro Cavalon and Calidus with<br>ROTAX® 915/916iS engines | | <b>A - MANDATORY</b><br><b>B – RECOMMENDED</b><br><b>C - OPTIONAL</b> |

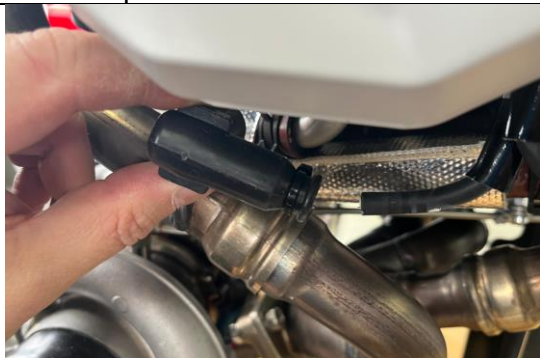
▲ Unscrewed spark plug cap

- 1) Remove the engine cowlings according to Chapter 52-00-00 4-1 of the respective AMM.
- 2) Remove one lower spark plug cap from the spark plug.
- 3) Cut the tie that wraps around the cap to hold it to the cable. Remove the tie
- 4) Unscrew the spark plug cap from the ignition cable.
- 5) Check if the cable is heat damaged; if so, replace. If only the end is damaged, ~5mm may be cut off.
- 6) *If present: Remove the old heat protection.*
- 7) Install the new heat shield.
- 8) Reinstall the spark plug cap onto the ignition cable.
- 9) Fit a new 2mm tie around the groove in the end of the cap and tighten. Cut off the waste.
- 10) Install the spark plug cap onto the spark plug.
- 11) Repeat steps 3) to 7) for the remaining three ignition cables.
- 12) Perform an engine test run.
- 13) Reinstall the engine cowlings according to Chapter 52-00-00 4-1 of the respective AMM.

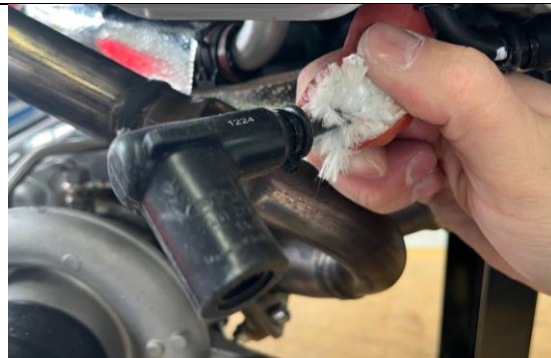
▲ Heat protection and spark plug cap

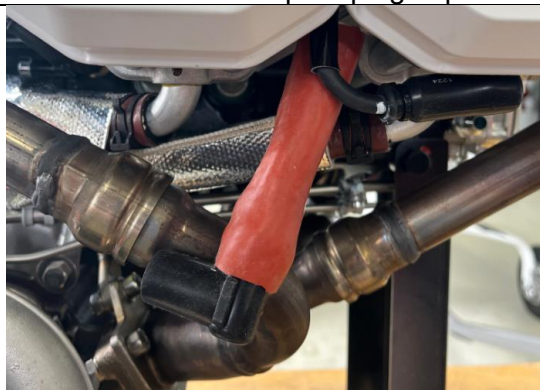
▲ Heat protection slid onto the spark plug cap

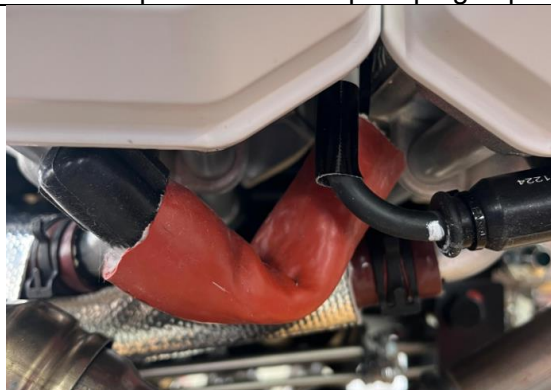
▲ Re-Installed spark plug cap

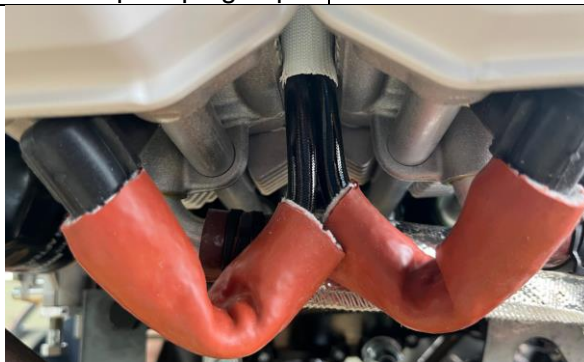
▲ task performed on one side of the engine
