### **Propeller inspections on gyroplanes with Rotax 915 and Rotax 916 engines**

Type / Model: PROPELLER TYPE KW-3(X), MODEL **KW-30, KW-31**

Manufacturer: **Woodcomp Propellers s.r.o.**

Applies to:	<b>KW-30 and KW-31 propellers installed in a pusher configuration on gyroplanes with Rotax 915 and Rotax 916 engines.</b>
-------------	---

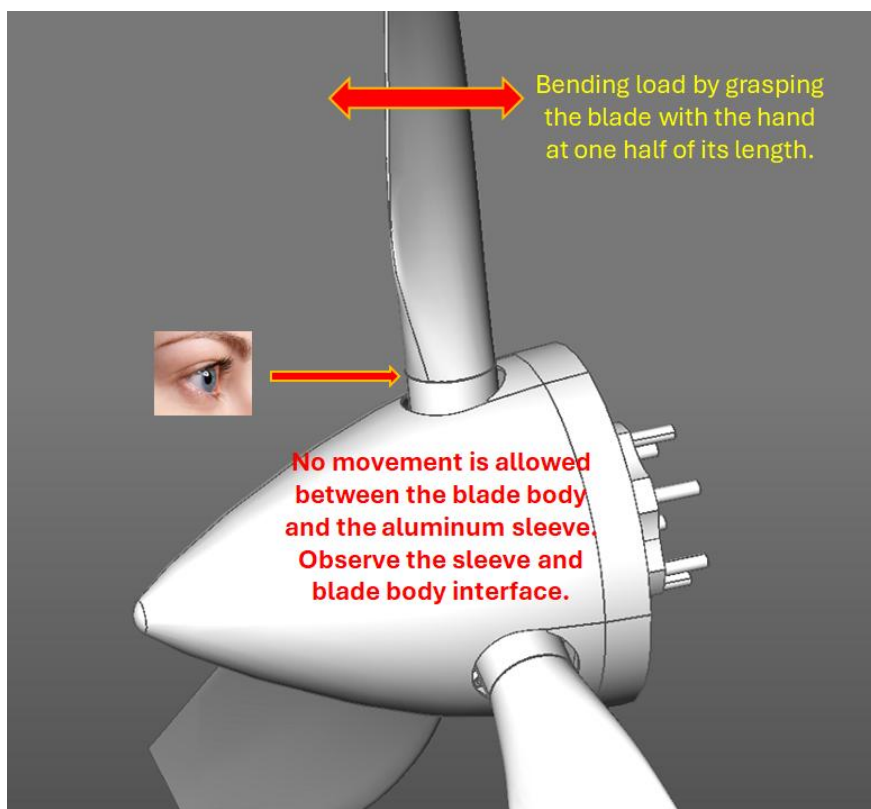
Reason	A propeller blade loss in flight from a pusher-propeller operated on a gyroplane with a Rotax 916 engine has been reported. The propeller installed in this power unit configuration is systematically affected by the air flow off the axis of rotation. This fact can cause increased dynamic stress and, together with other influences of operating conditions, cause clearances in the blade mounting.
--------	---

4. Check the condition of each propeller blade body fastening in the aluminum sleeve according to the following:

5. Keep records about performed maintenance in the propeller log-book.
6. If you find damage that exceeds the scope of permitted repairs described in the User Manual, remove the propeller from service and send it to an authorized service center for repair.
7. If you notice any signs of loosening of the blade body attachment in the aluminum sleeve, remove the propeller from service and immediately inform the propeller manufacturer at [service@woodcomp.cz](mailto:service@woodcomp.cz) and also the aircraft manufacturer according to his contact details. Send the propeller to an authorized service center for repair.
