RotorSport UK Ltd

Service Bulletin

SB No.: 046 Iss1	CCAR No.: None	Classification:
Aircraft type & model (applicability) RotorSport UK Calidus	Aircraft serial Nos. effected RSUK/CALS/001-017	OPTIONAL or RECOMMENDED or MANDATORY

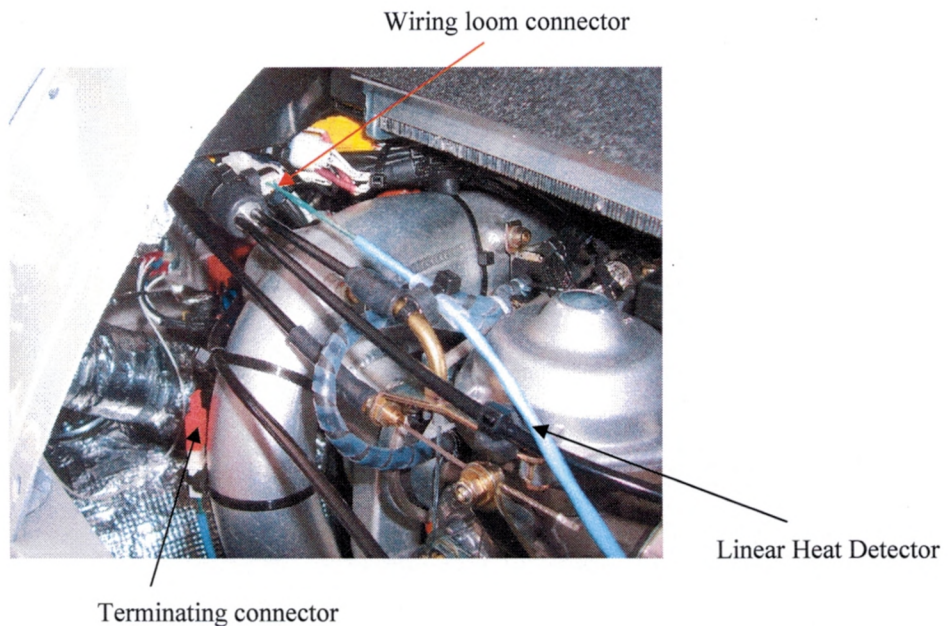
Photo below shows a 914UL installation. The 912ULS installation is similar.

2. Identify the LHD terminations, one has the wiring loom connector, the other has the terminating connector
Cut the cable tie, remove the terminating connector and using special tool AMP 189727-1 extract the inserts from the opposite mating housing. This will enable lengths of silicone sleeving to be fitted over the LHD.

3. Count the number of retaining ties fitted to the LHD. Slide this number of sleeves RSD4653 over the LHD

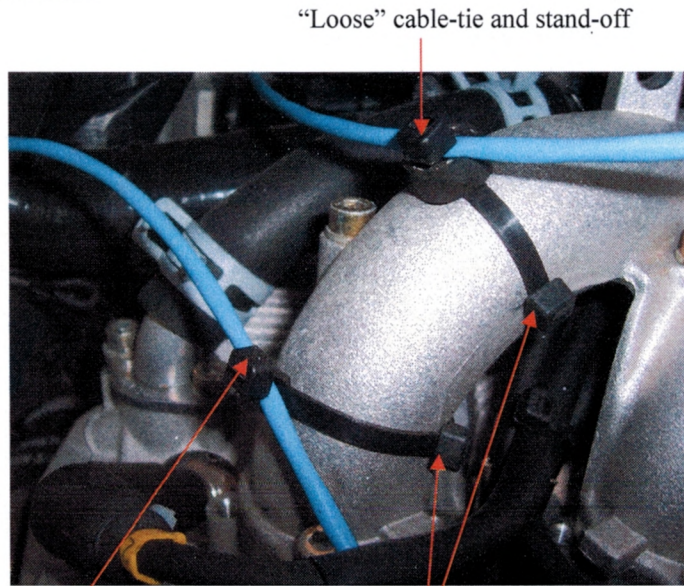
Photo before modification

This cable is attached to a number of mounting points by means of nylon cable ties and/or stand-offs manufactured from short lengths of rubber hose. Although two ties are used at each mounting (one “loose” around the LHD and one “tight” around the fixing point) it is possible that a nuisance-trip could occur due to the LHD collapsing under the cable tie and making the electrical contact.

“Loose” cable-tie and stand-off

“Loose” cable-tie

“Tight” cable-ties

An improvement may be made to each mounting by fitting a short length of silicone sleeving under the “loose” cable-tie.

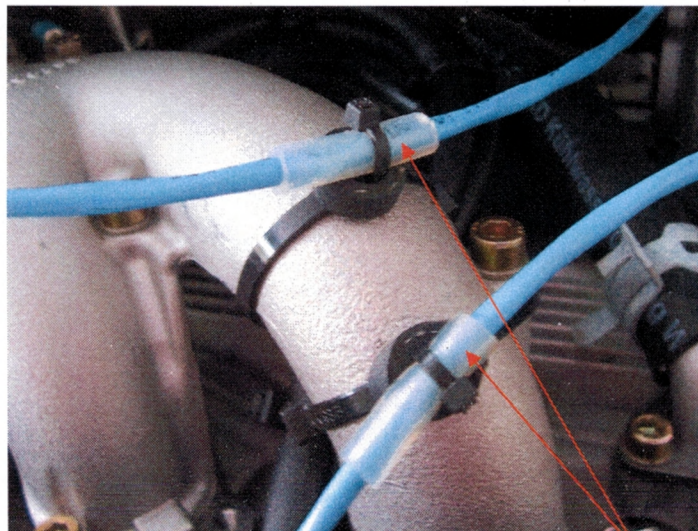
Photo after modification

Sleeves held firmly but not crushed

5. Progressively cut the “loose” cable-tie at each mounting position, move the sleeves past then fit the last sleeve at the mounting position using a new cable-tie. Tighten just enough to retain the sleeve without crushing.
(NB: This progressive sequence enables the routing of the LHD to be retained)
