RotorSport UK Ltd Service Bulletin (Permit)

Title: Engine mount support sleeve		
SB-095 Iss1	Related documents Modification: MC-317 CCAR No.: CCAR-67	Compliance Category:
Applicability		OPTIONAL <small>or</small> RECOMMENDED or MANDATORY
Aircraft type & model: Any RSUK type	Aircraft serial Nos. affected: Any RSUK type	
The maintenance manual to be referenced is this stated or subsequent issue.		MT-03 RSUK0012 Iss 10 MTOsport RSUK0044 Iss 9 Calidus RSUK0061 Iss 7 Cavalon RSUK0288 Iss 5
<p>This form is the response from RotorSport UK Ltd either against a problem found in the product in service requiring a containment or rectification action, or as service information for aircraft modification incorporation. For help, contact RotorSport on 44(0)1588 505060, or email compliance@rotorsport.org.</p> <p>The technical content of this document is approved under the authority of the UK CAA Design Organisation Approval Ref: DAI/9917/06</p>

Reason and overview of the Service Bulletin (cause of problem if known)

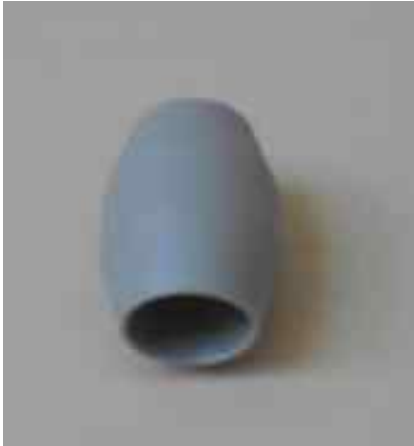
Actual Sleeve.

Replacement of the engine mount rubbers is carried out as a normal maintenance process. The only change is the fitment a single support sleeve inside each mounting as shown in the photo below.

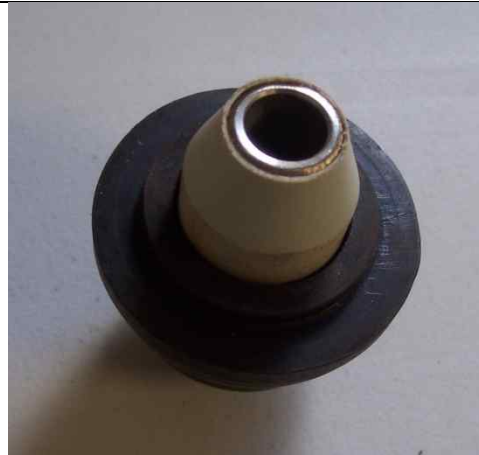
Engine mounting rubbers sag over time due to a number of causes, including natural ageing, weight of the engine and prop assy, in-service temperatures, exposure to fuels and oils, and loads incurred resisting the engine thrust and torque.

Additionally, for a Cavalon 914UL installation, this can lead to the engine airbox contacting the engine mount frame, leading to wear and eventually perforation.

Sleeve fitted inside engine rubber with inner steel sleeve fitted

Ensure that an adequate gap exists between the 914UL airbox and the engine mount frame after fitment.

Sleeves should be fitted with new engine mount rubbers, especially where there is already deformation of the rubber part.
