RotorSport UK Ltd Service Bulletin (Permit)

Title: Cavalon mast-cowl infill		
SB-108 Iss1	Related documents Modification: None- rationalisation only CCAR No.: None	Compliance Category: OPTIONAL or RECOMMENDED or MANDATORY
Applicability		
Aircraft type & model: Cavalon	Aircraft serial Nos. affected: RSUK/any	
The maintenance manual to be referenced is this stated or subsequent issue.		RSUK0288 Iss: 4
<p>This form is the response from RotorSport UK Ltd either against a problem found in the product in service requiring a containment or rectification action, or as service information for aircraft modification incorporation. For help, contact RotorSport on 44(0)1588 505060, or email compliance@rotorsport.org.</p> <p>The technical content of this document is approved under the authority of the UK CAA Design Organisation Approval Ref: DAI/9917/06</p>

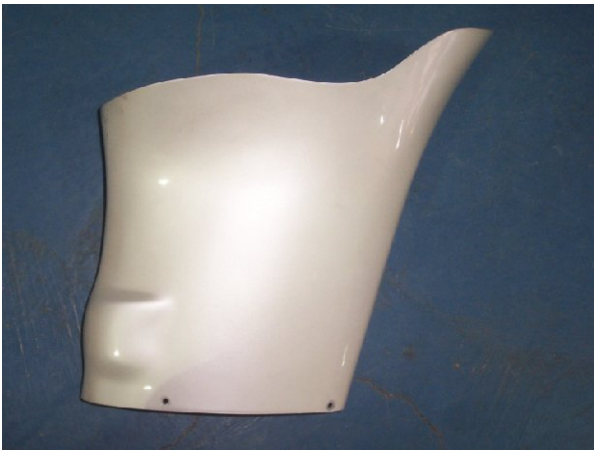
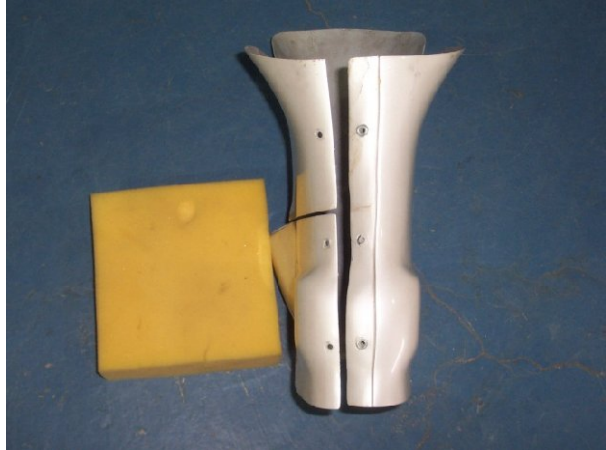
Single piece mast-cowling with split at rear

1. Remove the mast cowlings – early aircraft have a single moulding split at the rear, later aircraft (RSUK/CVLN/009 onwards) have a two-piece assembly.

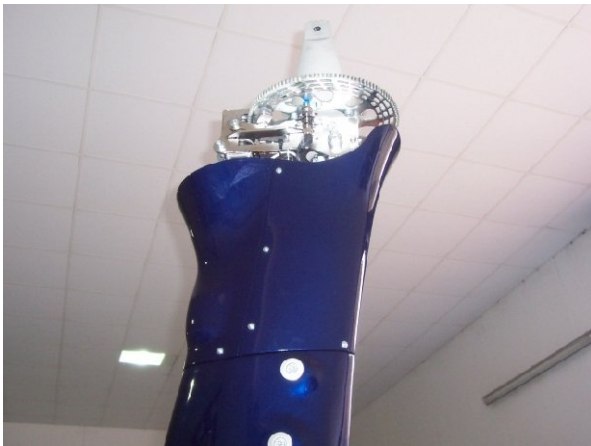
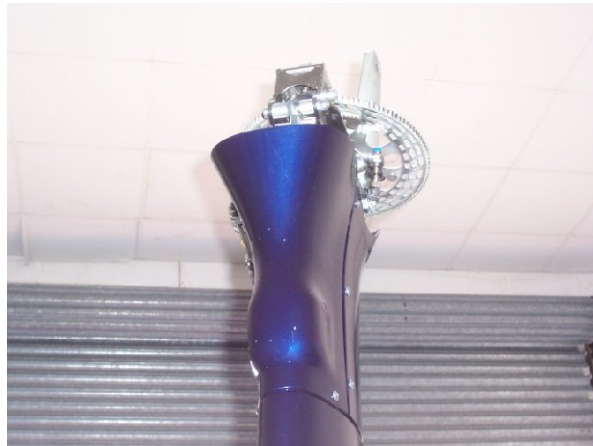
Two-piece mast cowling with vertical joint each side

The cowlings are held in place by M4 socket-head screws and plastic washers

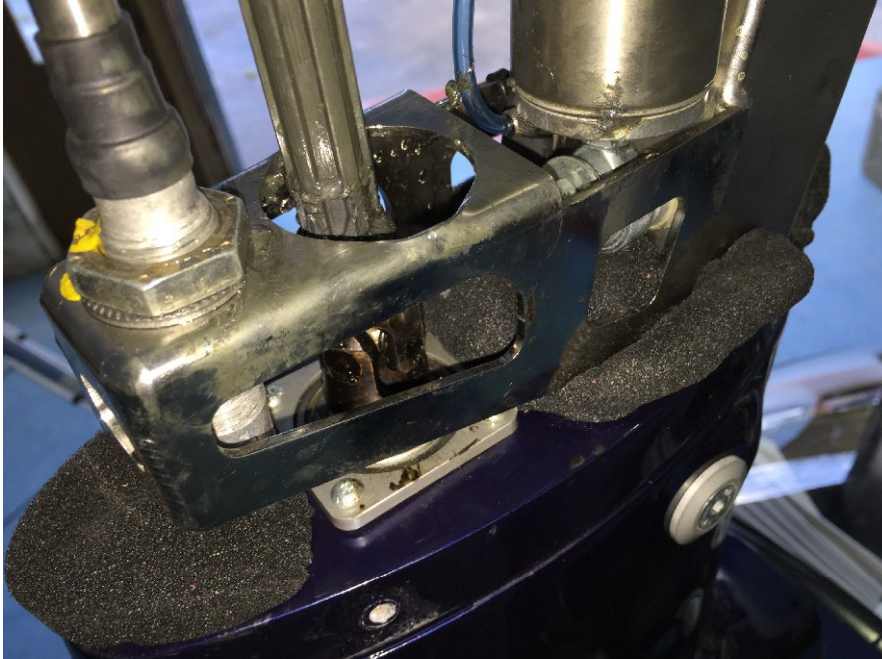
In order to prevent this passage of water, a special weathertight sealing foam (Kompriband) is installed in the lower mast area, but it has been found on some aircraft in service that this is not positioned to the standard required.

- Using the photograph below for reference, re-arrange, or if necessary fit new Kompriband foam into the lower mast, filling the apertures through which the push-pull cable and air cylinder pass. Ensure that the foam does not make contact with the pre-rotator shaft.

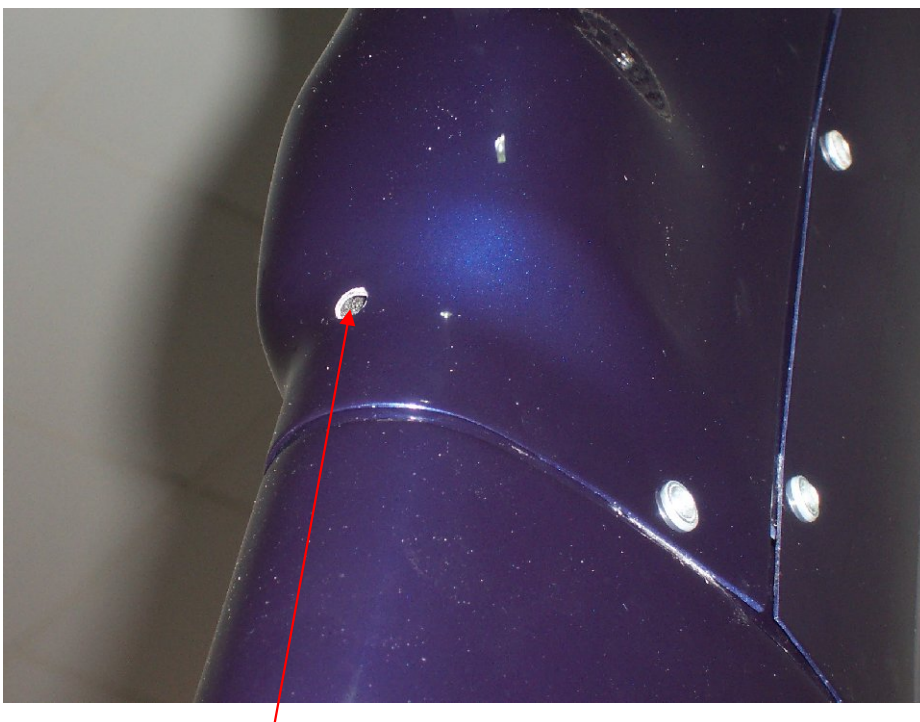
Drain hole in two-piece cowling

- Before re-fitting the mast cowl(s) drill a drain-hole 6.0-6.5mm diameter through the rear face of the cowling, just above the level of the Kompriband top surface. With the two-piece cowling the hole may be on centre-line, with the one piece cowling position the hole slightly to the right of centre to avoid disturbing the split junction. Touch-up the paint edge if required.
