RotorSport UK Ltd Service Bulletin (CofA)

Title: Cavalon pro fuel tank/body seal		
SB-C-004 Iss1	Related documents Modification: MC-357 CCAR No.: CCAR-063	Compliance Category: OPTIONAL or RECOMMENDED or MANDATORY
Applicability		
Aircraft type & model: Cavalon Pro	Aircraft serial Nos. affected: RSUK/CVLN/011 RSUK/CAVP/001 RSUK/CAVP/002	
The maintenance manual to be referenced is this stated or subsequent issue.		RSUK0335 Iss2
This form is the response from RotorSport UK Ltd either against a problem found in the product in service requiring a containment or rectification action, or as service information for aircraft modification incorporation. For help, contact RotorSport on 44(0)1588 505060, or email compliance@rotorsport.org . The technical content of this document is approved under the authority of the UK CAA Design Organisation Approval Ref: DAI/9917/06

AG-SB-2016-06-B-EN – Cavalon fuel-tank inlay ring

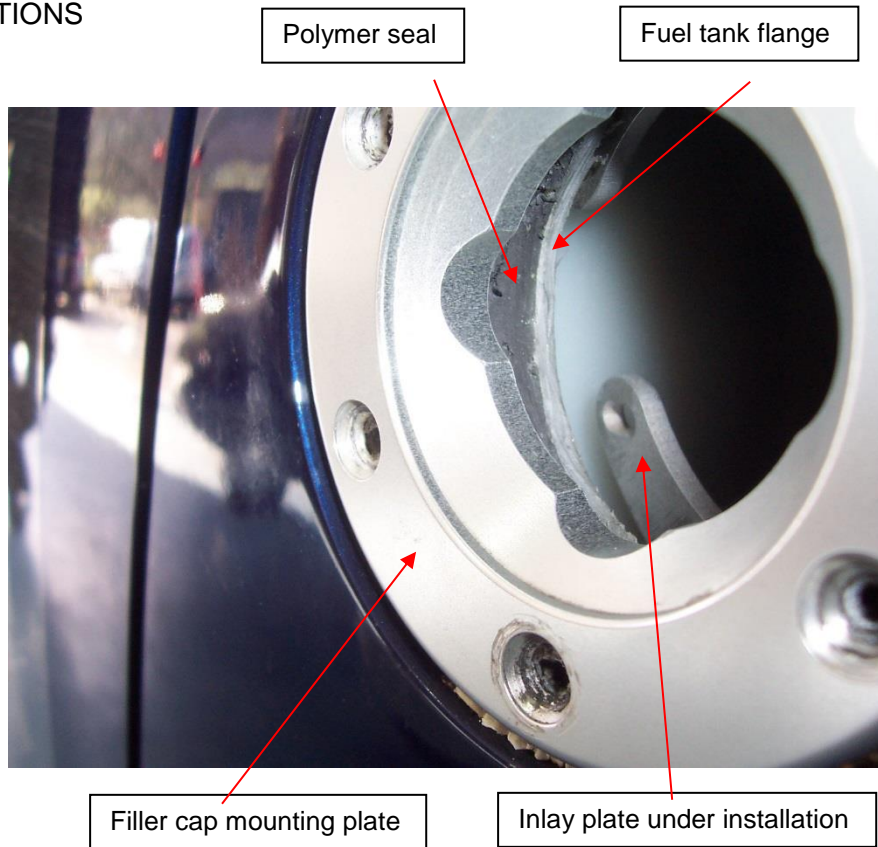
Fig. 1: Fuel filler

Some Cavalon owners have complained of a fuel smell in the cockpit, noticeable mainly after standing a longer period of time with the doors closed. This has been traced sometimes to small gaps in the sealing between the fuel tank flange and the composite body.

At the affected Cavalon an aluminium “inlay ring” is placed inside the filler neck and by means of a new rubber seal combined with longer fuel filler mounting screws allows the fuel tank flange to be pulled uniformly against the body – squeezing the new rubber seal between to ensure a perfect sealing (see fig. 1).

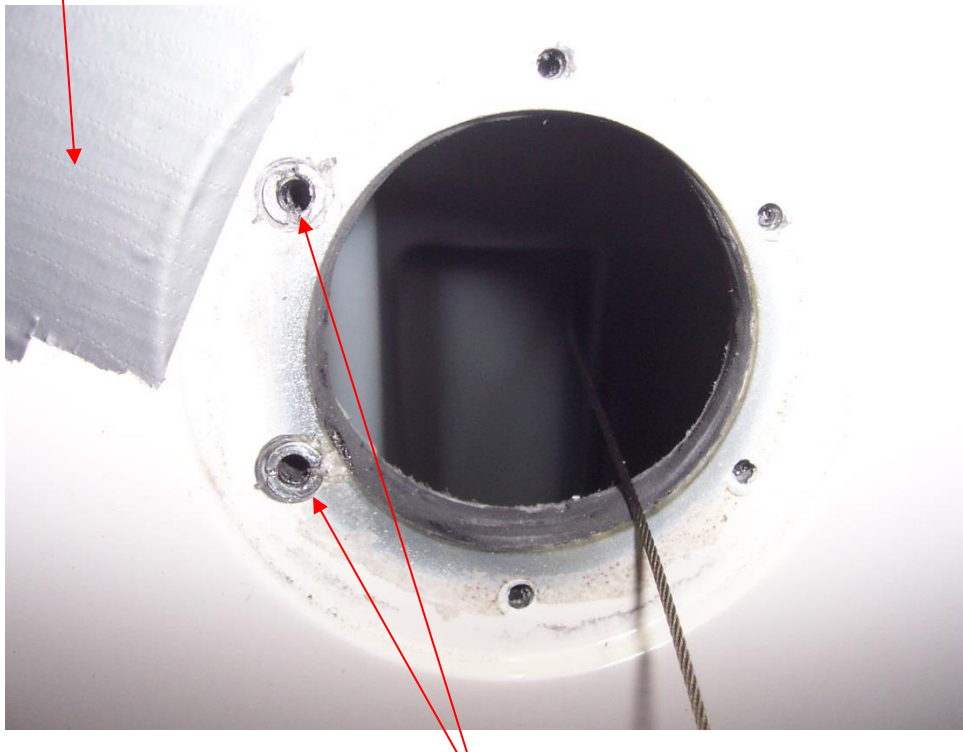
Fig. 6: Two rivnut heads slotted for drilling

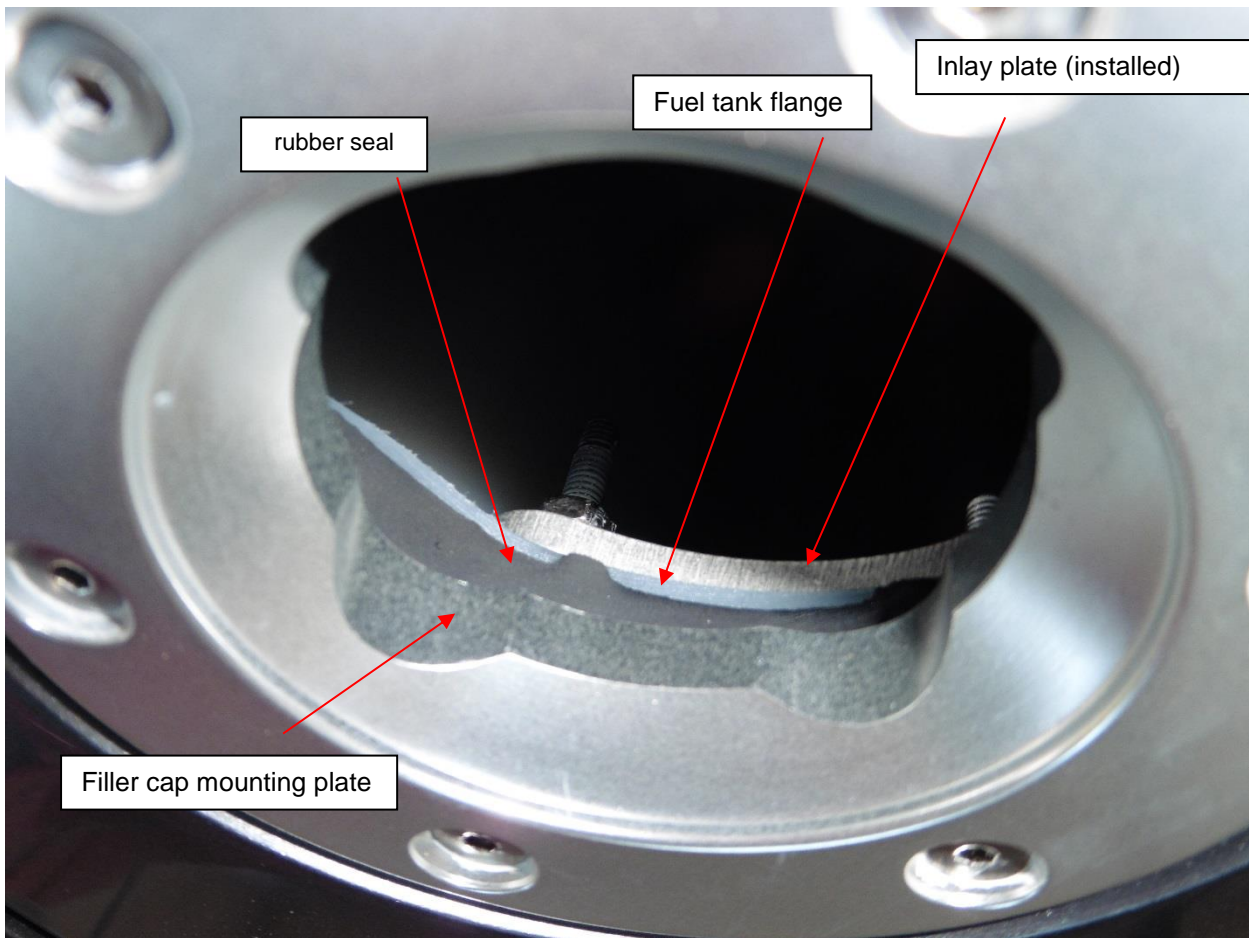
Fig. 9: fuell filler with attached inlay ring and rubber seal
