# RotorSport UK Ltd

## Service Bulletin

**SB No.: 004**

Aircraft type & model (applicability)  
RotorSport UK MT-03

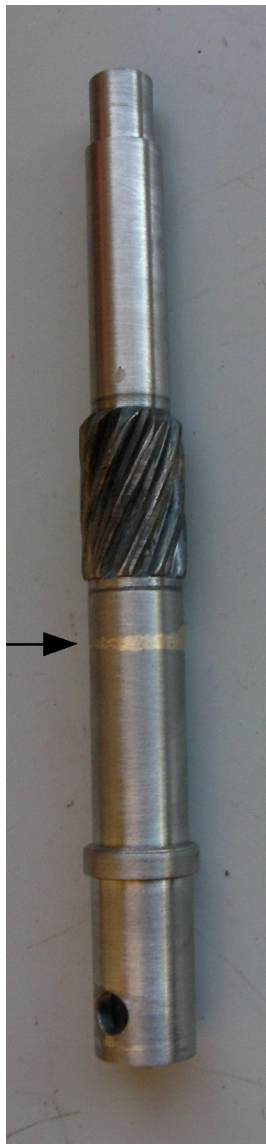
New Bendix shaft

The Bendix drive shaft is manufactured from two parts: in isolated cases the weld joining these has failed. The welding process is now changed to eliminate the potential failure.

Action required. – Replace Bendix gear pinion.
