RotorSport UK Ltd

Service Bulletin

SB No.: 007 issue 1

Aircraft type & model (applicability)
RotorSport UK MT-03

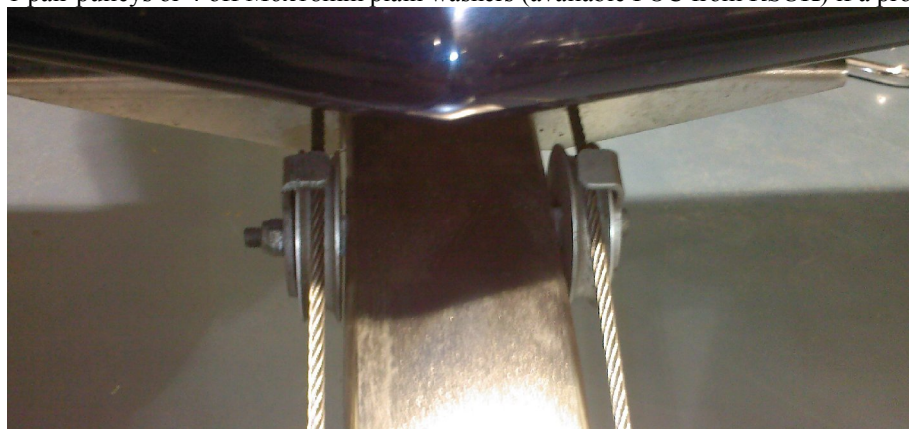
A factory manufacturing dimensional variance has been found on one of the UK fleet on the through bolt hole in the keel for the rudder pulleys. This hole may on one side of the keel be a slot instead of a 5mm hole, used by the factory to allow pulley alignment with the keel. A slot is an acceptable rework by the factory, provided the pulley assembly is lined up correctly with the keel. However, vertical positional variance of the bolt may lead either to the cable rubbing on the underside of the tail or on the top of the front rudder mounting bracket. This service bulletin is to address that variance.

Picture of rear rudder cable pulleys

1. Remove key and ensure mag switches are OFF.
2. Check that pulleys are running free, and not rubbing on the keel.
3. If rubbing on the keel, loosen nut, straighten, and tighten. If unsatisfactory, fit additional washer between keel and pulley on the side that is rubbing, and tighten square.. Ensure at least two threads show through the nut. If unsatisfactory contact RSUK for advice.
4. Check clearance between rudder cable and tail, and cable to front mounting bracket.

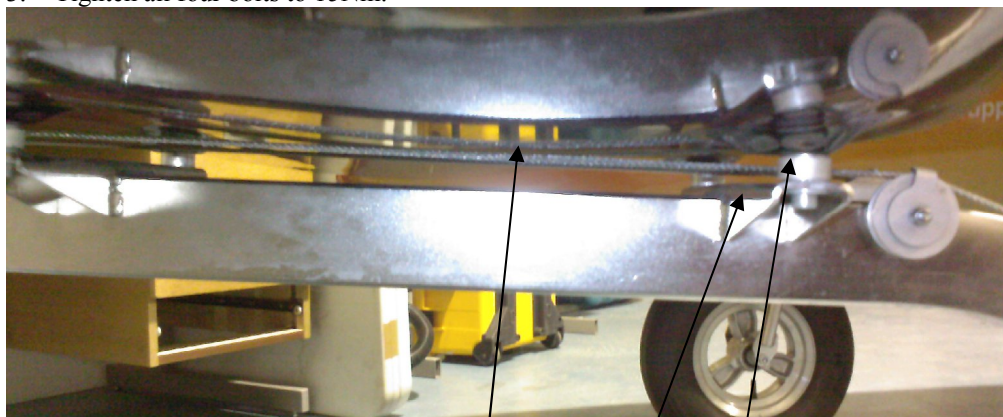
View under the tail.

1. Loosen all four tail mounting bolts by several turns. Remove two left side bolts, add a 1.5mm washer between the each spacer and mounting bracket, and replace bolt with loctite 243 liberally spread on the threads of the bolt. Do not tighten yet.
2. Repeat on right side.
3. Tighten all four bolts to 15Nm.

Check clearance of cable to tail and the bracket. Add washer between each spacer and tail/bracket if required
