RotorSport UK Ltd

Service Bulletin

SB No.: 016 issue 2	CCAR No.: None	Classification: OPTIONAL or RECOMMENDED or MANDATORY
Aircraft type & model (applicability) RotorSport UK MT-03	Aircraft serial Nos. effected RSUK/MT-03/all

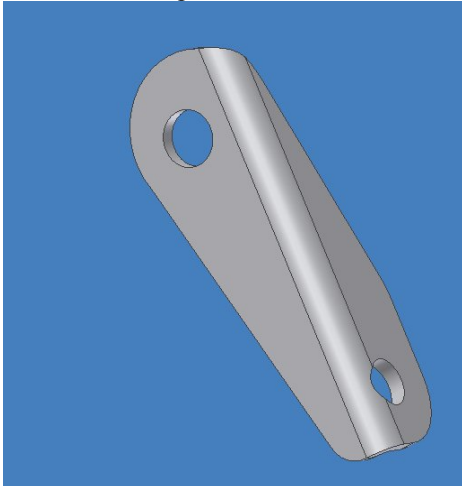
Picture of replacement bracket (RH shown)

1. Remove ignition key and isolate engine starter solenoid
2. Chock wheels.
3. Remove existing broken bracket, and carefully grind off any broken remains. Offer up new clamped bracket RSD3045 RH (or 3046 LH) to the Enclosure (see photo) so that the 6mm hole aligns with the hole indicated below, and the flat side is nearest the enclosure.
4. Clamp bracket to suspension bow cross tube with the M6 button head bolt, washers, and nylock nut (screw head uppermost, and bracket under the flange).
5. If required, adjust the bracket by bending so that the hole lines up with the enclosure.
6. Refit fastening between the enclosure and bracket.

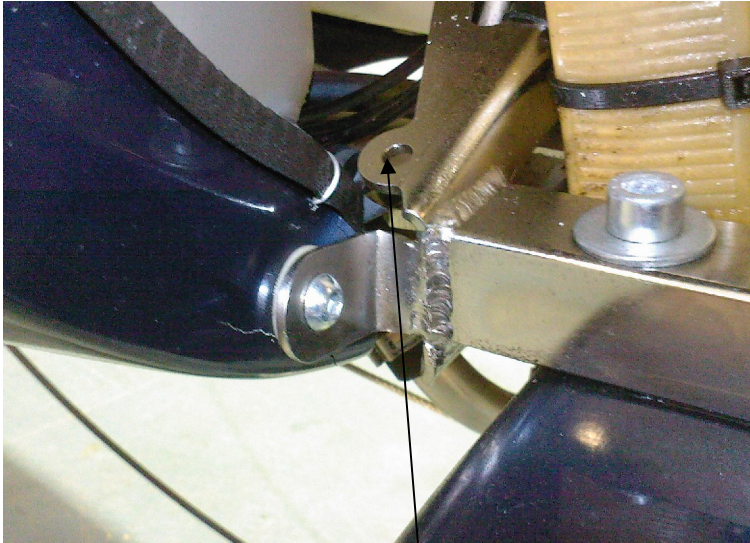
The MT-03 series gyroplane pilot enclosure is retained to the airframe via several fastening points, two of which are via short metal straps at the lower rear of the enclosure. The straps are welded to the airframe, and one has been found to have broken free in service due to vibration.

MT-03 mounting as current build 6mm hole to use for new bracket
Note that the bracket fits UNDER the flange.
