RotorSport UK Ltd

Service Bulletin

SB No.: 014 issue 3

Aircraft type & model (applicability)
RotorSport UK MTOsport series

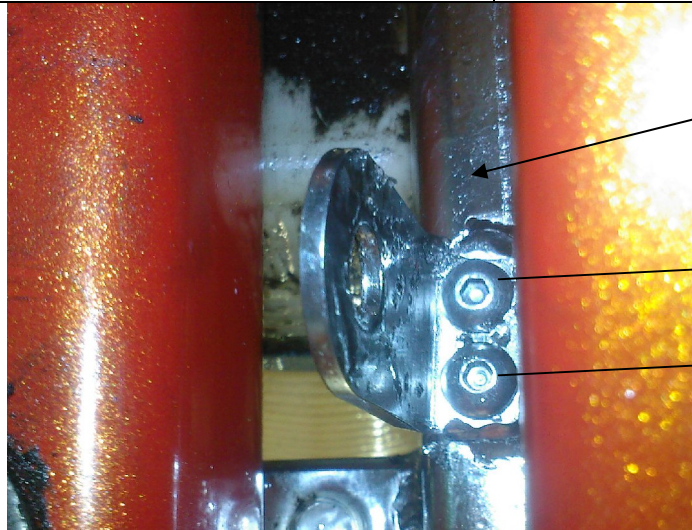
Photo of repair incorporated

The MTseries gyroplane pilot enclosure is retained to the airframe via several fastening points, two of which are via short metal straps at the lower rear of the enclosure. The straps are welded to the airframe, and one has been found to have broken free in service due to vibration.

Suspension carrier

Approx 9mm between screw holes.

Note that holes must be 8mm from the rear edge of the suspension carrier, otherwise the nut will ride up the bending radius of the flange.

1. Remove ignition key and isolate engine starter solenoid
2. Chock wheels.
3. If required, remove original bracket from aircraft.
4. The bracket is already bent under the suspension bow (see photo). Clamp in its original position, removing weld if required so that the bracket sits flush to the suspension bearer.
5. Drill two 4.1mm holes through the bracket and suspension bow, in the centre of the bent over flange as shown in the photo. Remove burrs.
6. Fit two RSD6220 M4x12 dome head screws with RSD6007 nylock nuts and RSD6023 plain washer to clamp the bracket to the mounting frame. Tighten all fastenings securely.
7. If undone, refit fastening to enclosure, with a new nylock nut.
8. Refit starter solenoid cable and remove chocks.
