## Measures after the accident of the KW-30 propeller on the AutoGyro Cavalon gyroplane

Type / Model: PROPELLER TYPE KW-3(X), MODEL KW-30

Manufacturer: **Woodcomp Propellers s.r.o.**

Applies to S/N: **22-08-1191, 22-08-1194, 24-01-1210, 24-03-1339, 24-03-1340, 24-03-1344, 24-03-1348**

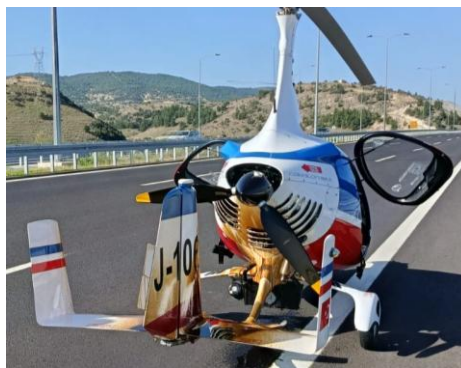
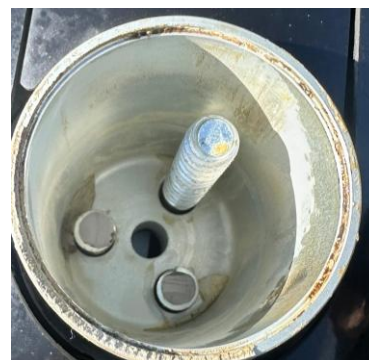
Reason: One blade loss was reported on 27 OCT 2025 from propeller S/N 24-03-1345. The propeller was installed on the Cavalon gyroplane powered by Rotax 916 engine.

Based on the information on the propeller failure mode as of the date of this bulletin, the following actions must be taken:

3. In light of the above incident, focus on the following during inspections: After each flight, compare the condition of the propeller with that found during the pre-flight inspection. Focus on newly discovered damage to the blade surface, which could indicate a bird or other foreign object strike at some stage in flight, or during propeller operation on the ground (engine test, taxiing, etc.).

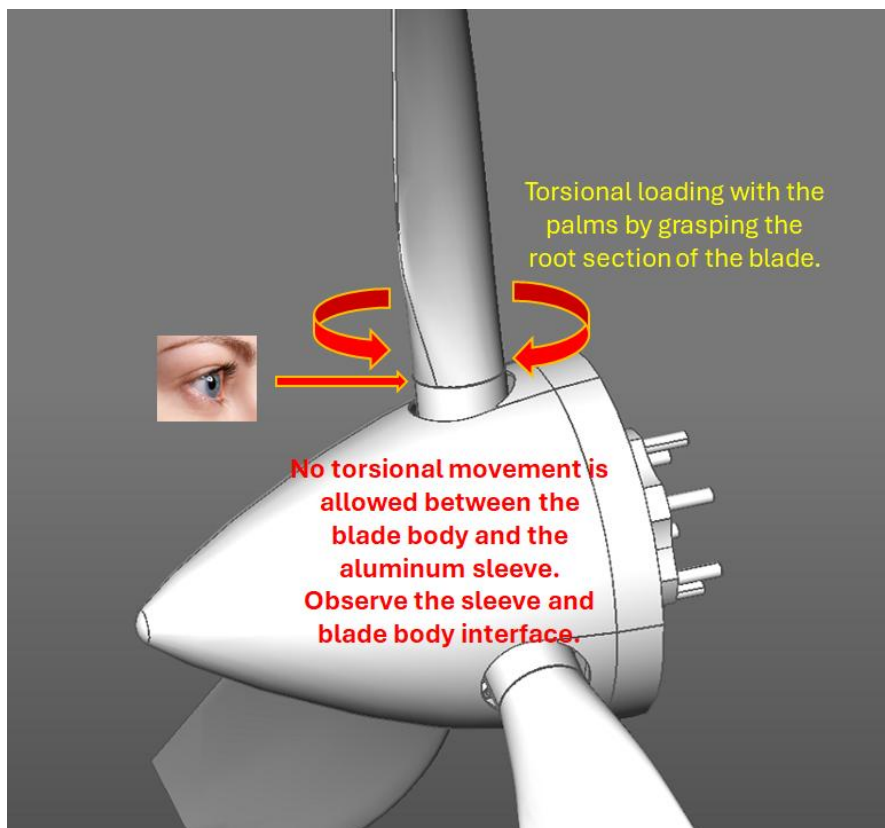
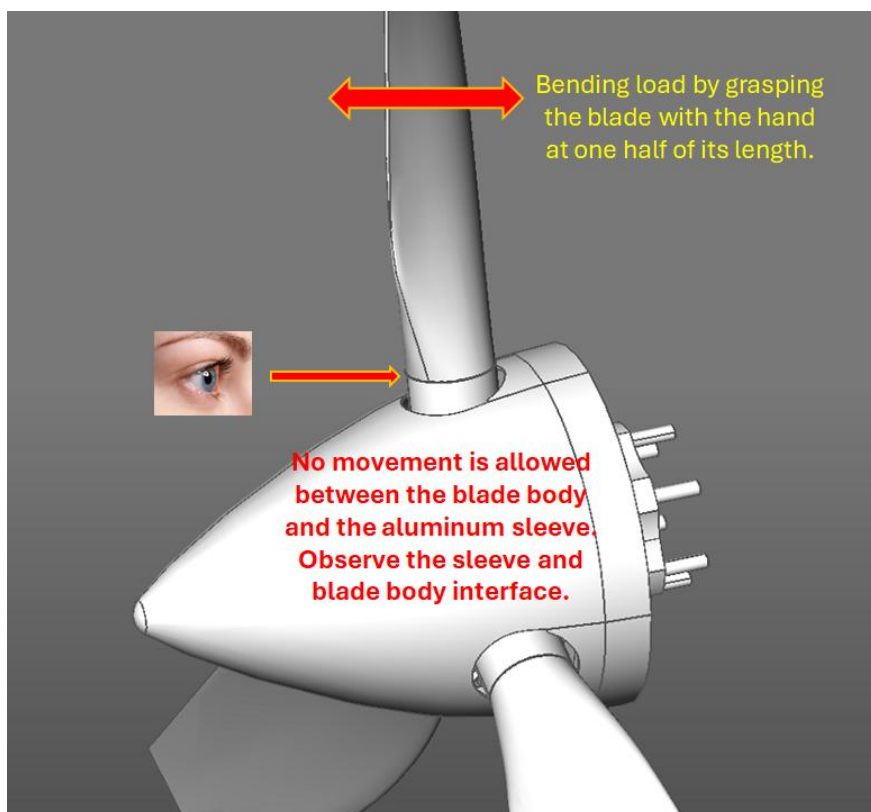
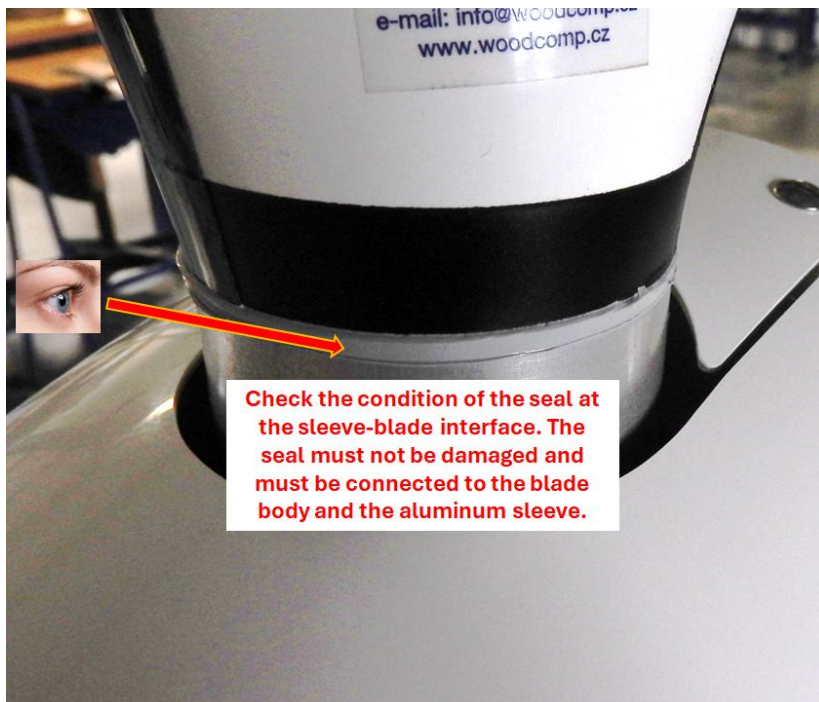
4. Check the condition of each propeller blade body fastening in the aluminum sleeve according to the following:

5. Keep records about performed maintenance in the propeller log-book.
6. If you find damage that exceeds the scope of permitted repairs described in the User Manual, remove the propeller from service and send it to an authorized service center for repair.
7. If you notice any signs of loosening of the blade body attachment in the aluminum sleeve, remove the propeller from service and immediately inform the propeller manufacturer at [service@woodcomp.cz](mailto:service@woodcomp.cz) and also the aircraft manufacturer according to his contact details. Send the propeller to an authorized service center for repair.
