# RotorSport UK Ltd

## Service Repair

Repair No.: <b>SR-001</b>	CCAR No.: None	Repair classification: <del>MAJOR</del> or <b>MINOR</b>
Aircraft type: <b>RotorSport UK MT-03</b>	Aircraft serial No affected: . RSUK/MT-03/002 onwards where a Garmin GPSmap is fitted

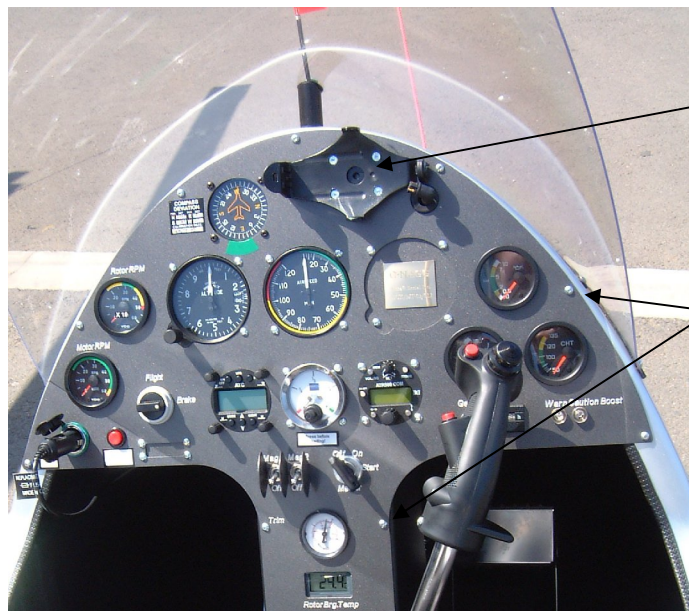
### View of existing panel mount

GPS mounting bracket  
Remove four securing screws and nuts/washers on the rear of the panel

Panel securing screws, 13 off
