RotorSport UK Ltd

Service Repair Request and Evaluation/Approval

Repair No.: 003	CCAR No.: None Mod approval No. MC-086	Repair classification: MAJOR MINOR
Aircraft type: MT-03	Aircraft serial No.: OPEN

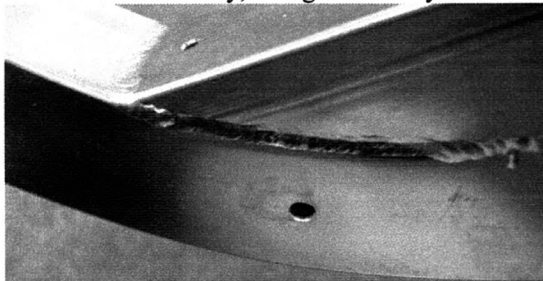
Foreword; Two holes are drilled through the lower keel tube of the MT-03 in order to pass the bolts through that holds the rudder cable pulleys to the keel. The hole needs to be square to the keel in order for the pulley to sit without rubbing on the side of the keel. The hole was drilled through from each side up to approximately Jan 2008, a process that could induce variance in the hole position if the drill wandered or the hole position was incorrectly marked.

Example of welded and re-drilled hole

1. Using filler metal suitable for 1.4301 stainless steel, carefully weld edge of hole. Maintain as far as practical, the wall section of 2mm or more. Weld distance to suit requirement for re-drilling.
2. Allow to cool, and using the jig, re-drill the hole. Check for correct alignment.
3. Document that the process has been carried out within the airframe documentation.
4. Alternatively, a single hole may be slotted to a maximum width of 10mm

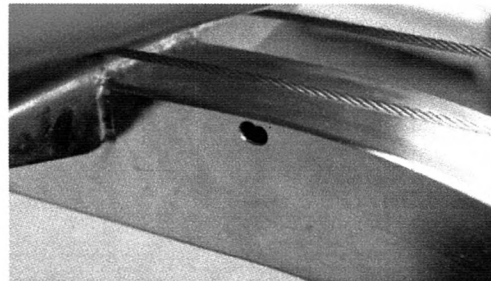
Example of slotted hole
