RotorSport UK Ltd

Service Repair Request and Evaluation/Approval

Repair No.: 004 issue 4, 04/Jan/10	CCAR No.: None Mod approval No. MC-115	Repair classification: MAJOR MINOR
Aircraft type: MT-03	Aircraft serial No.: OPEN (first application G-CFBJ)

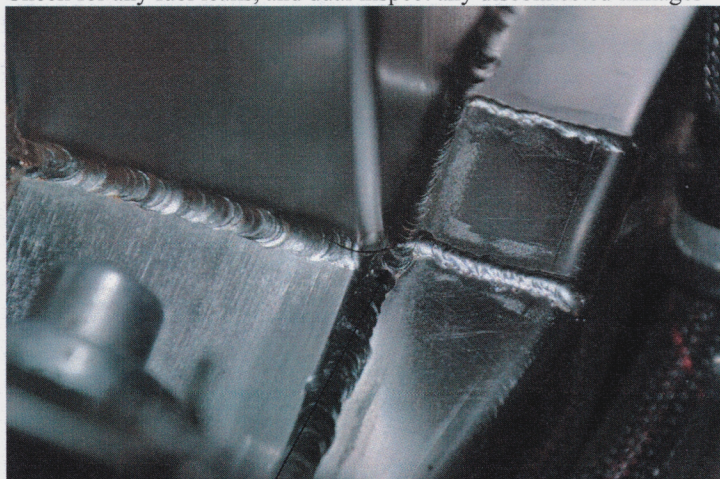
Aircraft has received some distortion of the airframe resulting in a small crack at the base of the mast, at the joint to the front keel. To rectify this it is proposed to straighten the airframe with a strap, cut back and repair the weld, and then weld a gusset between the mast and keel. In addition, the mast is to be braced with two straps as currently approved for the MT0sport, both in readiness for installation of the 500Kg suspension bow, and to further brace the area. Note that the mast is doubled in this area.

Crack at base of mast

4. Clean out the cracked weld, locate the ends of the split using suitable crack detection method, and reweld with 1.4301 graded filler material.
5. Weld gusset in place as per photo. Gusset is cut from 2mm thick, 50mm square 1.4301 tube, cut to give a gusset length of 20mm and welded at 30 deg to the vertical mast.

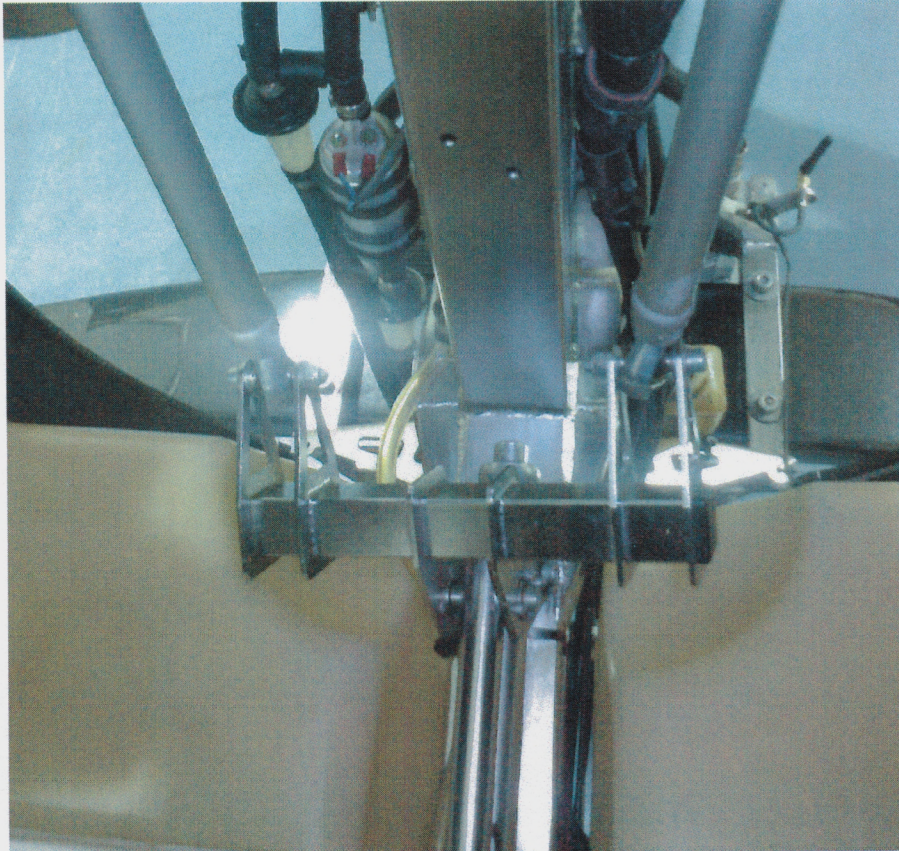
View of original mast to keel area.
