RotorSport UK Ltd

Service Repair Request and Evaluation/Approval

Repair No.: 005 issue 1, 11/05/10	CCAR No.: None	Repair classification:
Repair No.: 005 1550C 1, 11/05/10	Mod approval No. MC-140	MAJOR or
Aircraft type: MT-03	Aircraft serial No.: OPEN (first application G-YROX)	MINOR

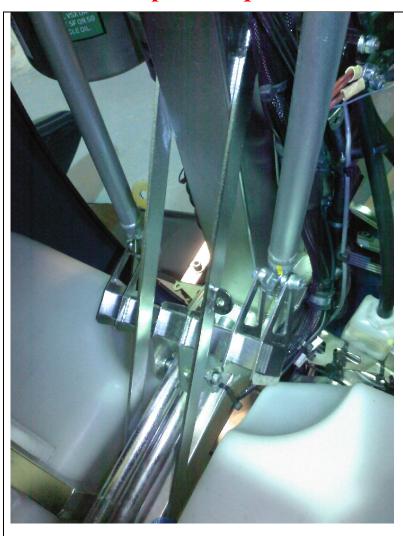
View of straps welded in place The straps are welded at 35 degrees to the mast, and must clear the control fork on full articulation! The ends of the strap may adjusted in shape to suit.

- 9. Weld in place two straps, from Fastener and strap kit RSD7175 (straps are 500 x 20 x 3mm 1.4301 stainless steel), carry over from MTOsport and for the MT-03 500Kg. See photos for position, and also fit lugs shown for the 914UL engine TCU. NOTE! Ensure these are in the highest possible position to clear the control forks!

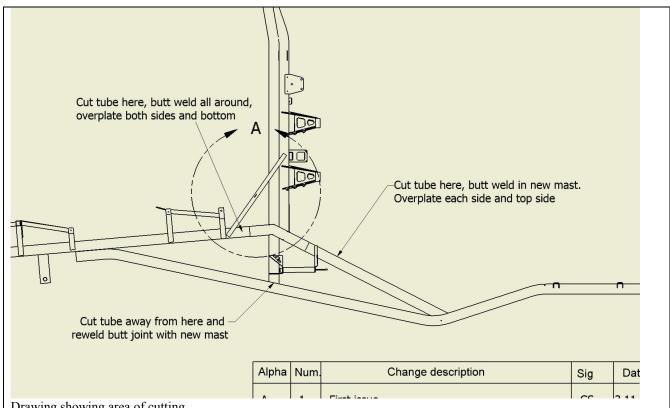
Drawing showing area of cutting

Aircraft has received significant airframe damage during impact into a lake in Thailand whilst circumnavigating the world. The owner wishes to continue the trip with the same frame and aircraft. The frame suffered bent suspension bow brackets and a bent mast. The safest and most robust solution is to cut the mast and suspension mounting area completely out of the airframe, and weld in a new section

- 3. The mast section is carefully marked out for an exact match to the new mast.
- 4. The old mast is cut out, and as far as practical, the cuts to be at 30deg. The connection to the lower keel tube is dressed back.

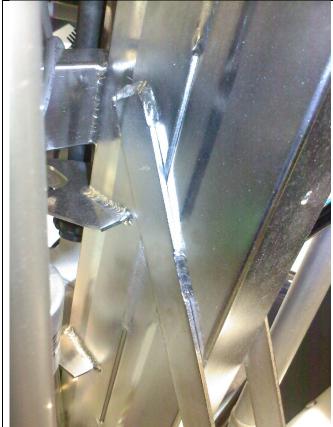
View of welded on strap. Weld as per RSD7178 and instructions above.
