# RotorSport UK Ltd

## Service Repair Request and Evaluation/Approval

Repair No.: <b>006</b> issue 1, 29/06/10	CCAR No.: None Mod approval No. MC-140	Repair classification: <del>MAJOR</del> <b>MINOR</b>
Aircraft type: MT-03	Aircraft serial No.: RSUK/MT-03/005

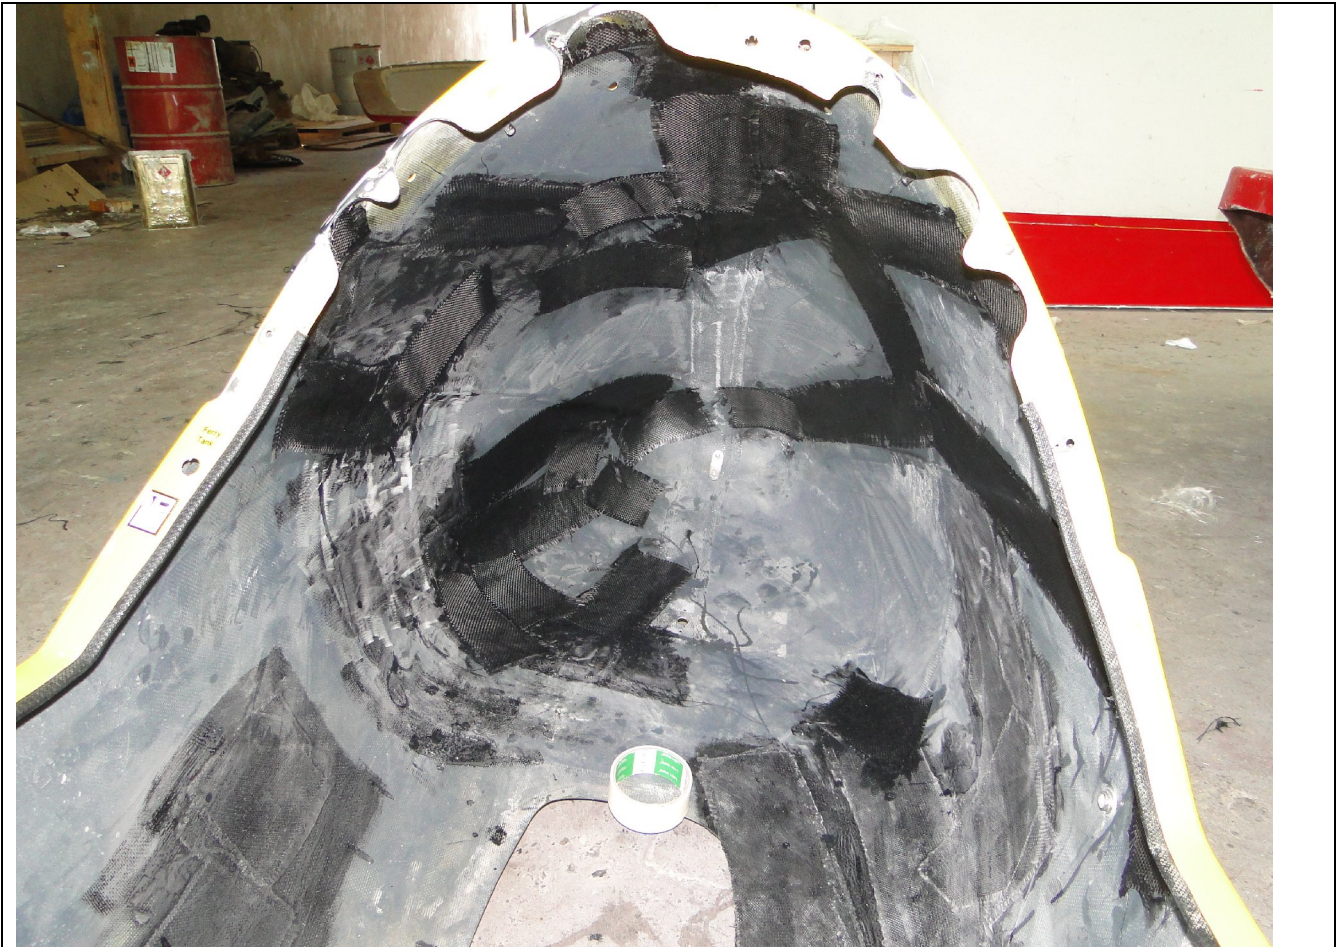
Inside of nose during repair

1. To enable the repair, the aircraft is disassembled, and the enclosure moved to a composite repair facility ('Helix')
2. Repair patches to be applied to the inside of the enclosure, whilst the outside is retained in the proper shape.
3. The original composite assembly sheets have been supplied to Helix used in the original manufacture of this enclosure.
4. Epoxy resin used, 100 parts resin YDL 586 to 38 parts Hardener TH8281.
5. Two layers laminated over each break – first layer 80mm wide, second layer 100mm wide.
6. Cloth used: Glass 200 mat where glass used in original enclosure, and carbon 290 ('12k carbon') where with carbon fibre.
7. After completion of the repair, the enclosure has been touched up with acrylic paint (spray can, no significant weight). Then to be refitted to the aircraft as per the maintenance manual RSUK0012
8. Enclosure weight gain noted as ~1Kg

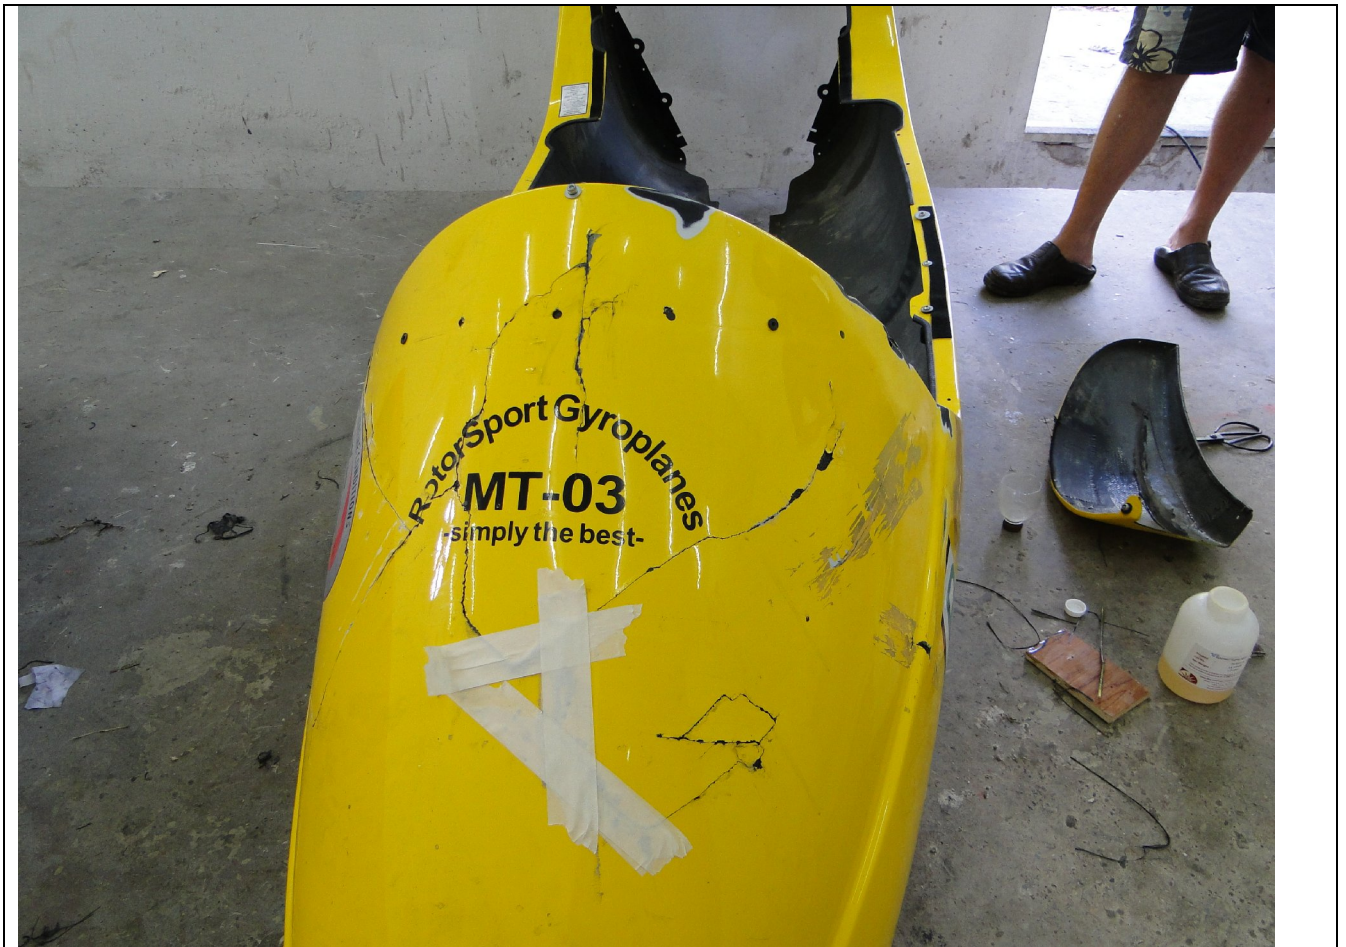
Aircraft has received significant airframe damage during impact into a lake in Thailand whilst circumnavigating the world. The owner wishes to continue the trip with the same aircraft. The enclosure suffered significant damage, but is not a structural part of the aircraft. A repair is proposed to allow the original enclosure to be repaired and retained on the aircraft.

Outside of the nose before repair

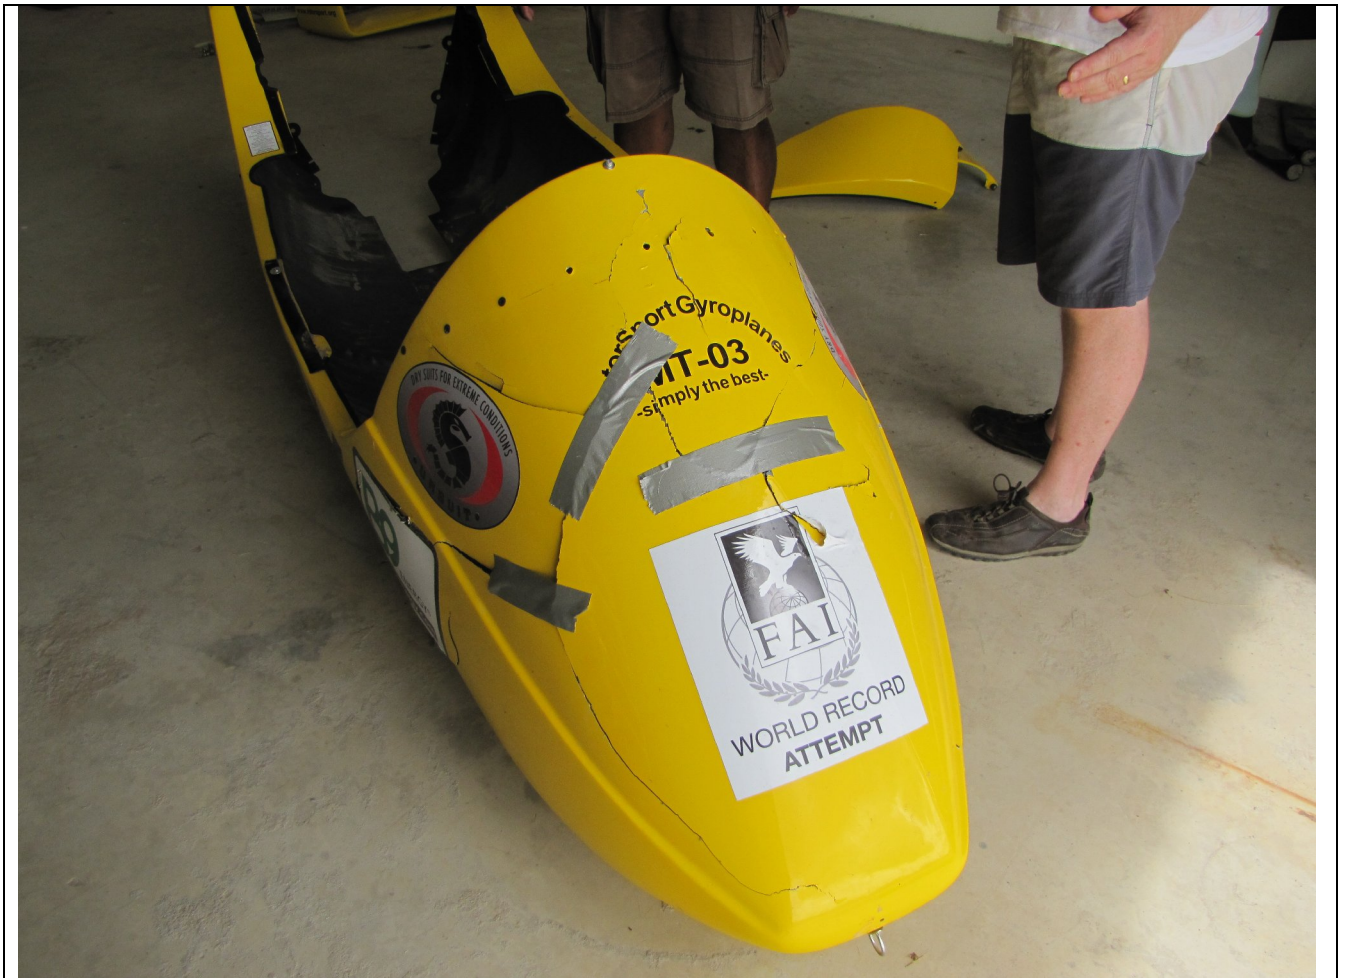
Enclosure nose before repair

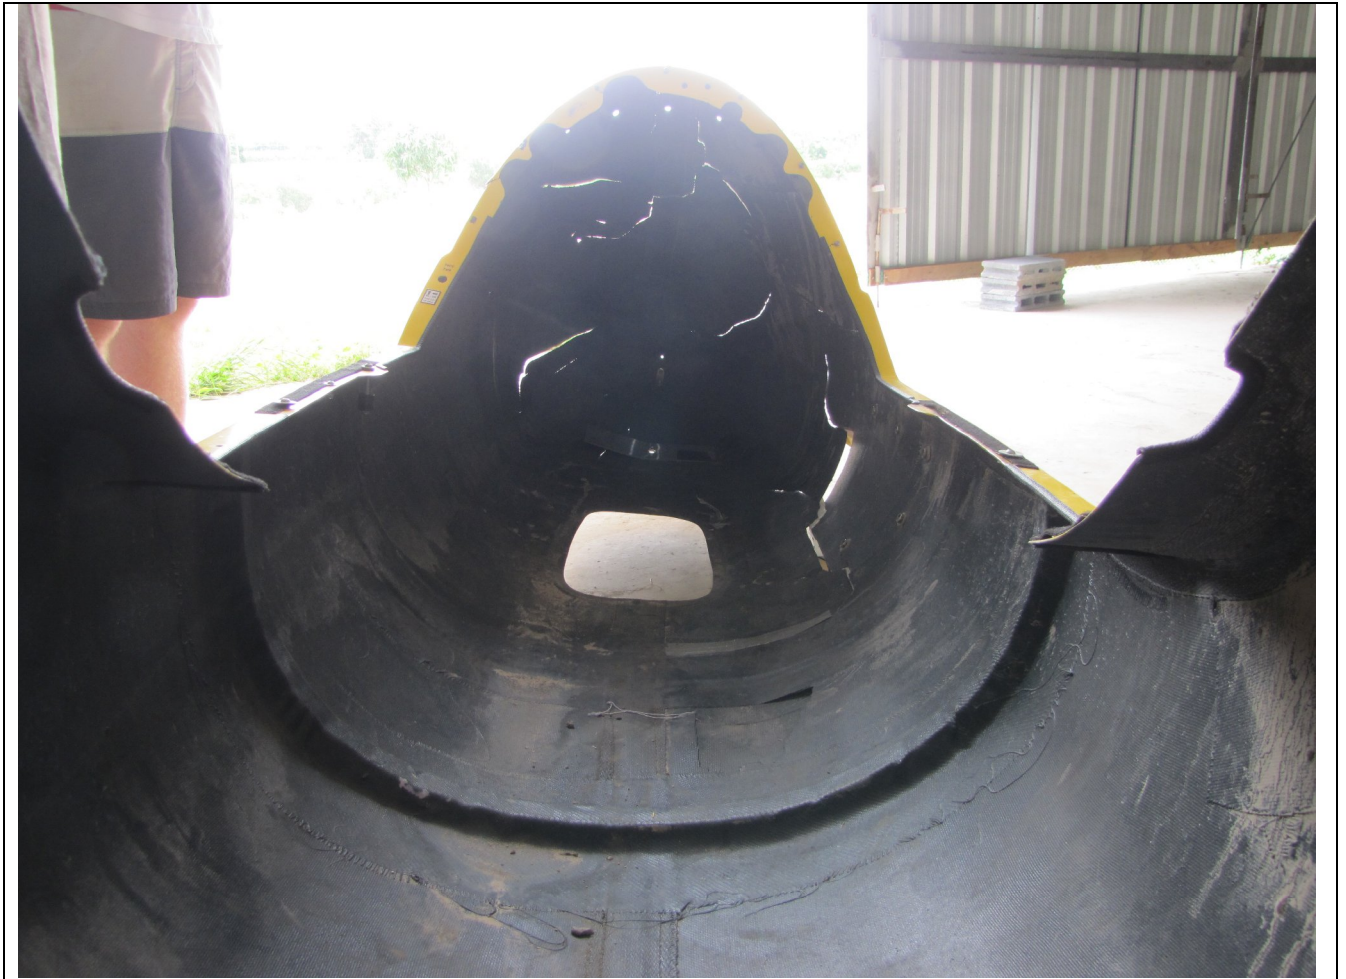
Notes: the area of damage is forward of the pilots seat, and therefore forward of the enclosure attachment points.

View inside before repair. From this and the other photos it can be seen that the attachment points to the airframe are sound, and that the damage is limited to the nose section only.

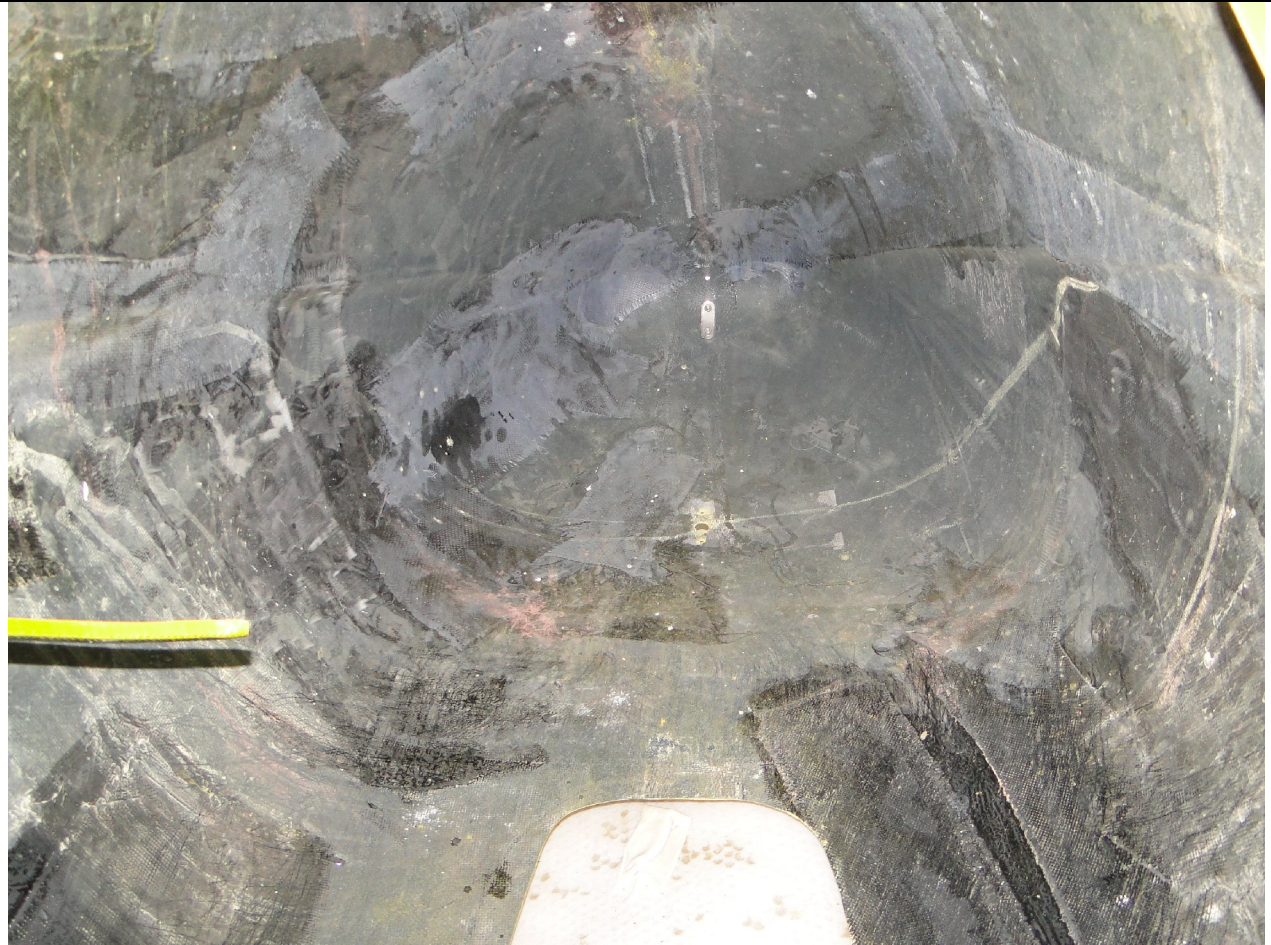
View inside the nose of the enclosure

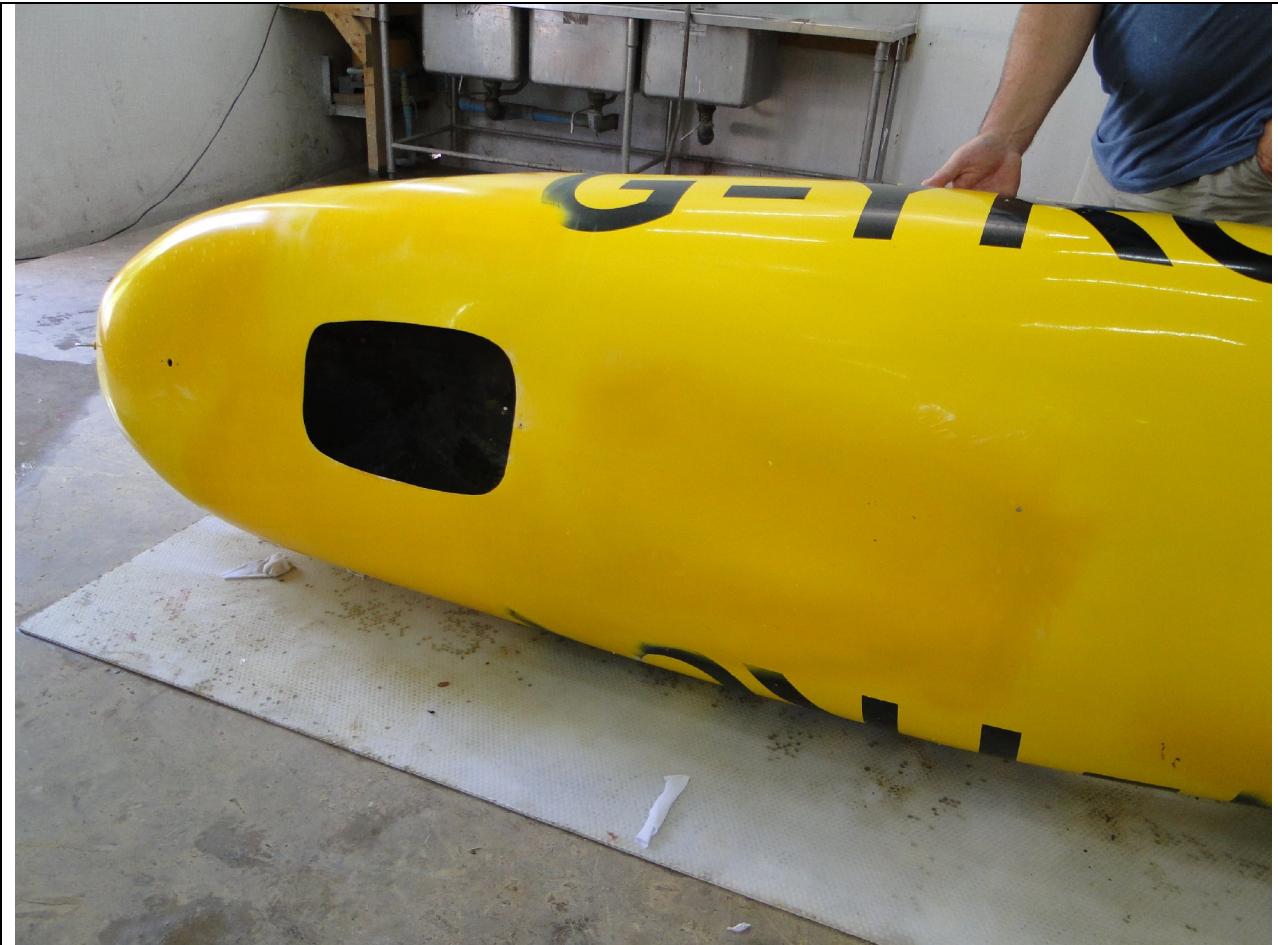
View of the underside after repair

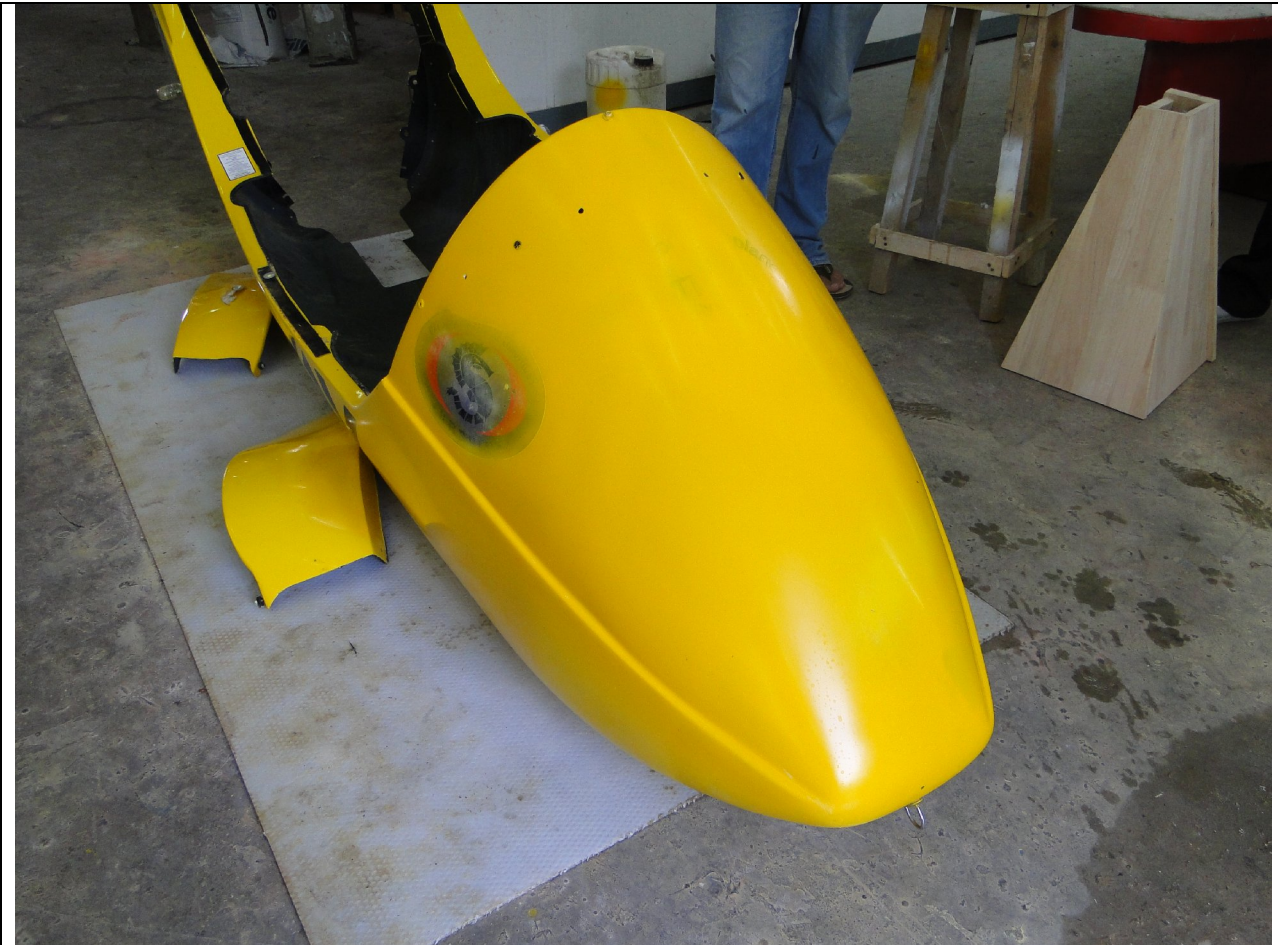
View of the aircraft nose

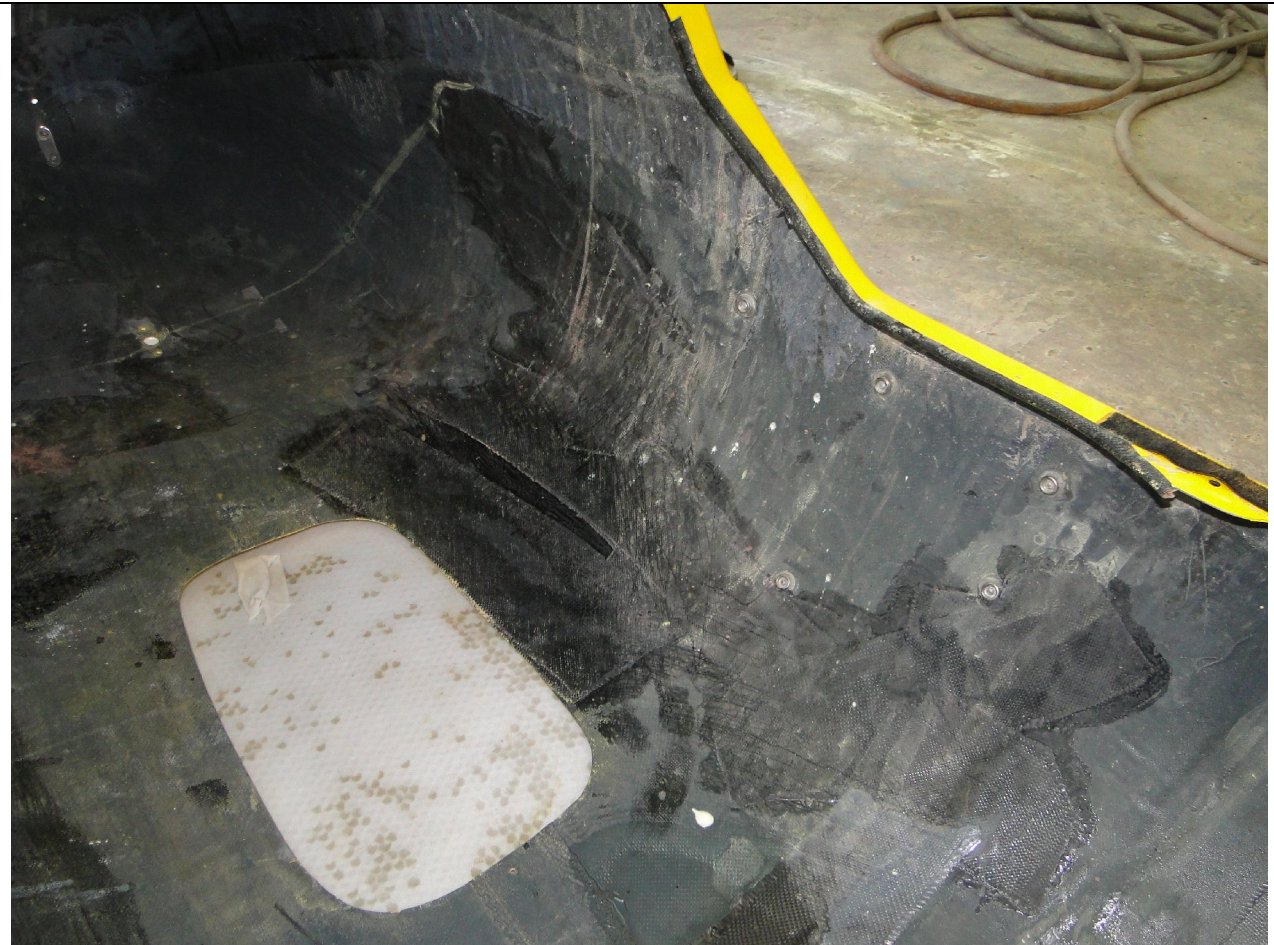
View of the repairs inside

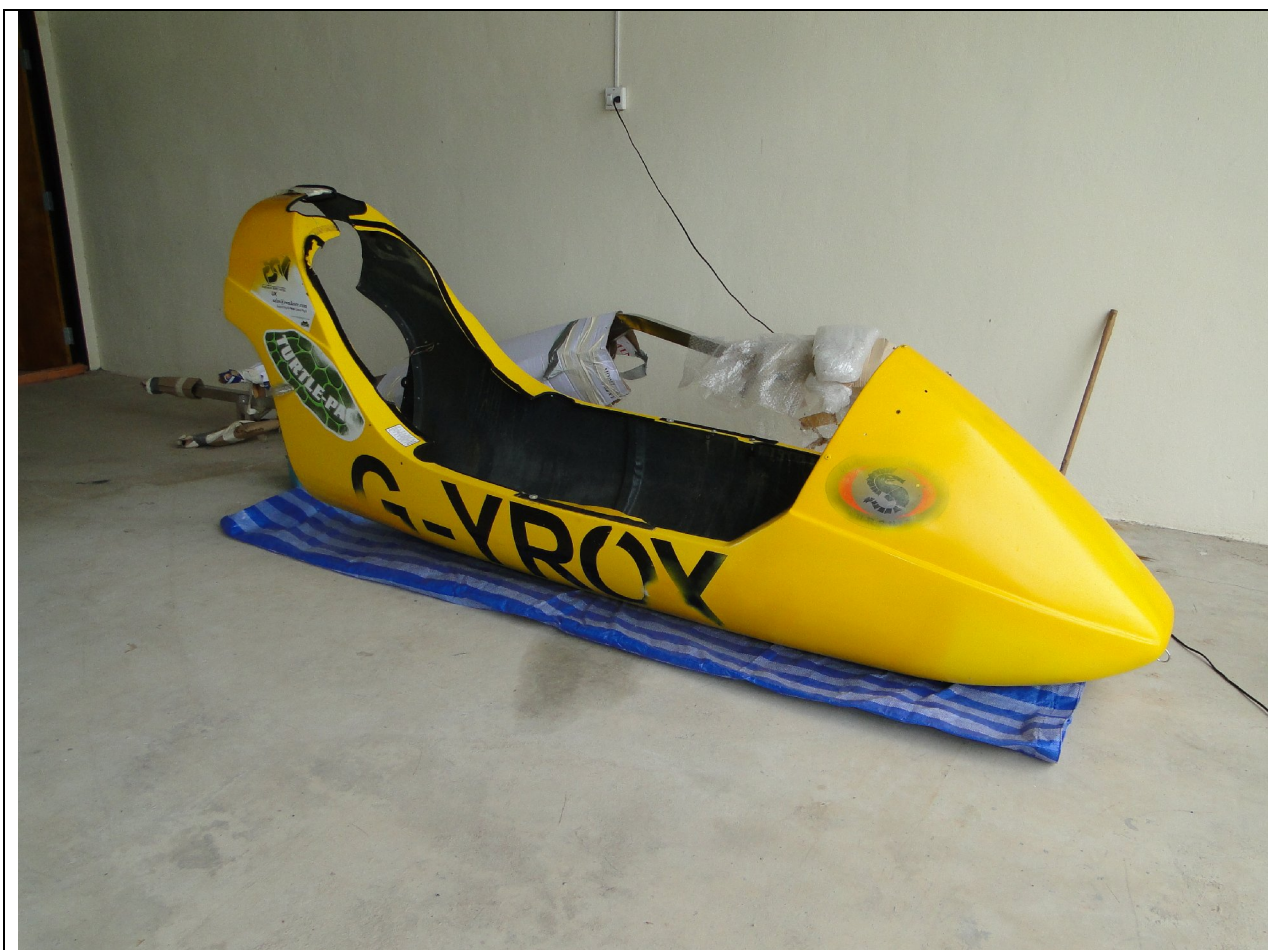
View of repaired enclosure. The paint is a rough match only, and has still to be cleaned off the registration letters

Ensure no cracks are left uncovered. Fit to airframe and mating parts as per maintenance manual RSUK0012.
