# RotorSport UK Ltd

## Service Repair Request and Evaluation/Approval

Repair No.: <b>007</b> issue 1, 16/8/10	CCAR No.: None Mod approval No. MC-140	Repair classification: <del>MAJOR</del> <b>MINOR</b>
Aircraft type: MT-03	Aircraft serial No.: RSUK/4T-03/015

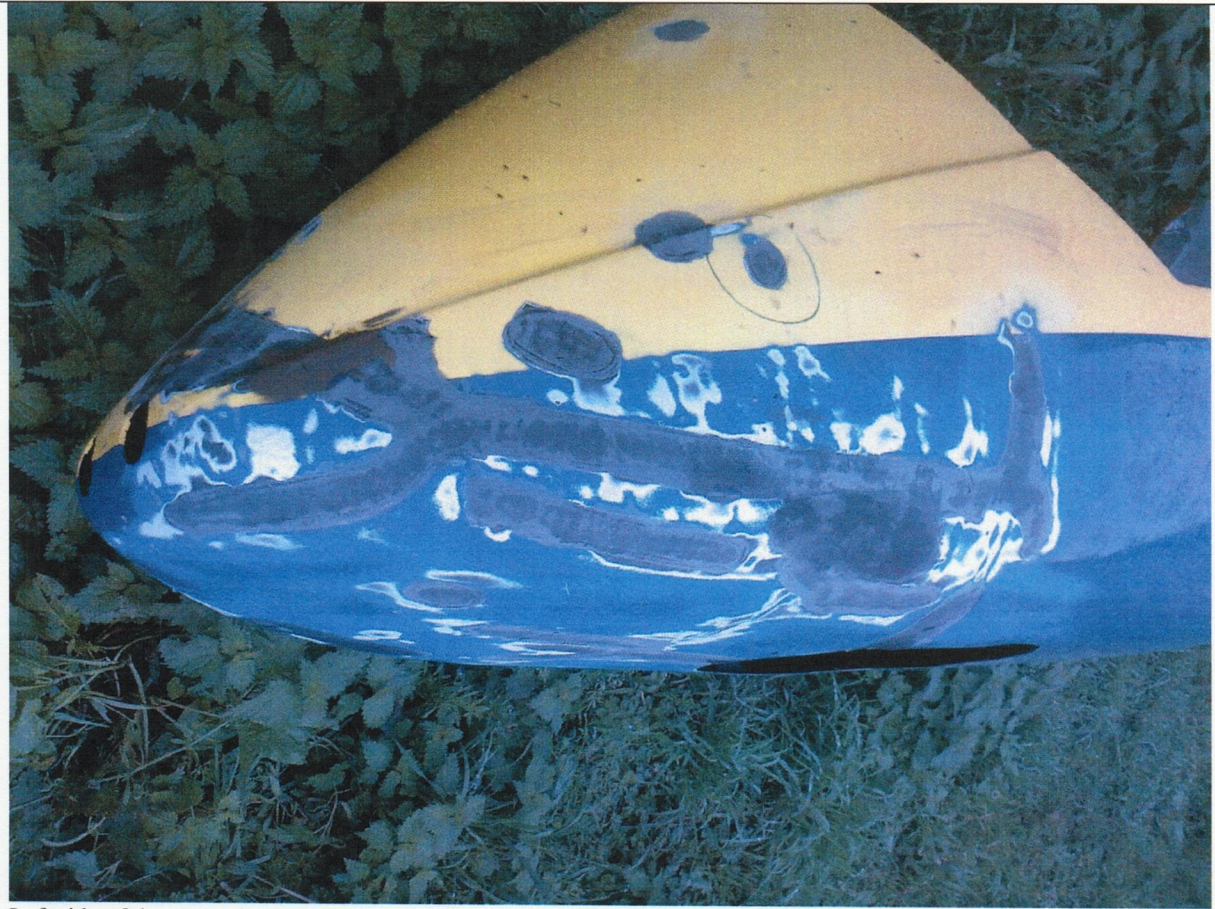
Repair problem description & cause of problem if known  
Aircraft has received some damage following a slow speed taxi rollover, in turn following the nose wheel entering mud or hole. There is no airframe damage. The nose of the pilot enclosure received some damage, resulting in it being unserviceable. The enclosure is an early MT-03 type, no longer available, and to keep costs down to the owner, it is proposed to repair the enclosure.

Left side of the nose after repair completion

1. The repair is in two parts – composite repair, and paintwork repair
2. To enable the repair, the enclosure is removed, and repair work placed with Roger Andrews (approval no BGA I/A/913), approved for composite glider repair, and LAA approved for complex composite repairs (approval no 759) to carry out.
3. Cracked areas scarfed to allow repair. Two layers of Eglass 92125 placed over each crack, top layer larger than the bottom. Repair patches to be applied to the inside of the enclosure, whilst the outside is retained in the proper shape. Note that the enclosure is manufactured from glass fibre, not carbon.
4. After composite repair the landing lamp mounting were upgraded to the latest approved design as per MC-125.
5. Then the enclosure is filled and painted in the normal manner.
6. The enclosure is reattached as per the maintenance manual RSUK0012.

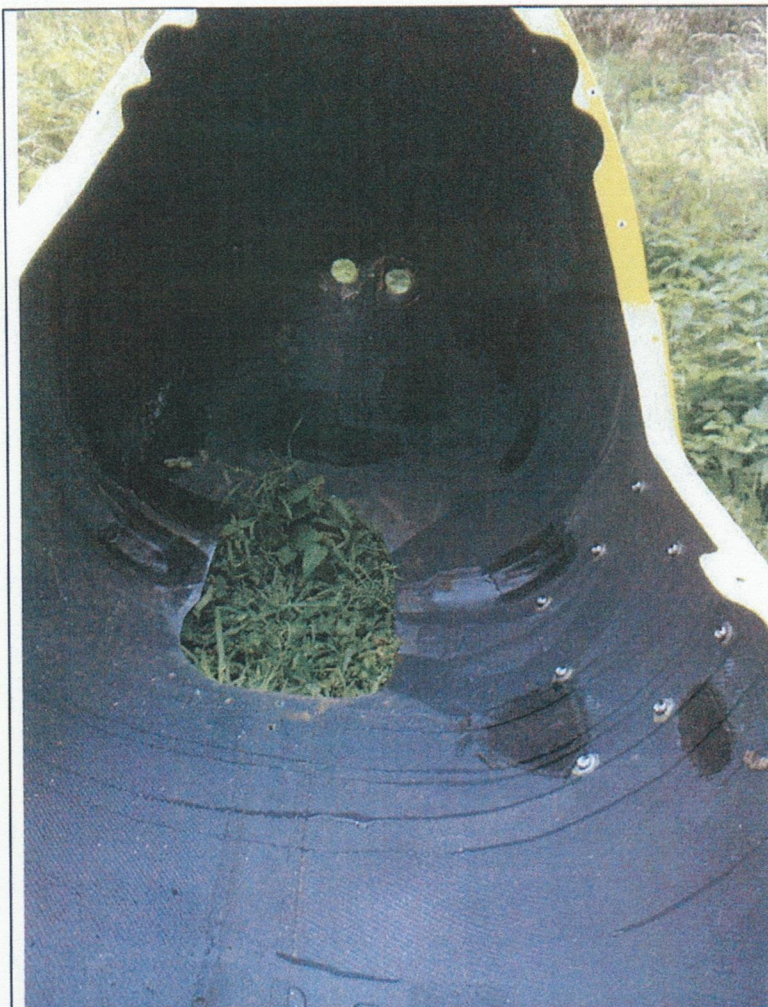
Inside of nose after repair
