RotorSport UK Ltd

Service Repair Request and Evaluation/Approval

Repair No.: 008 issue 2

Aircraft type: MTOsport

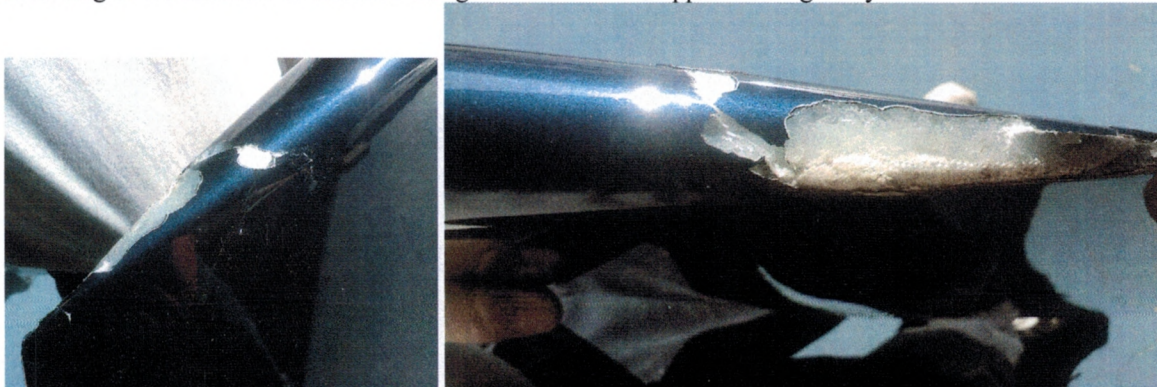
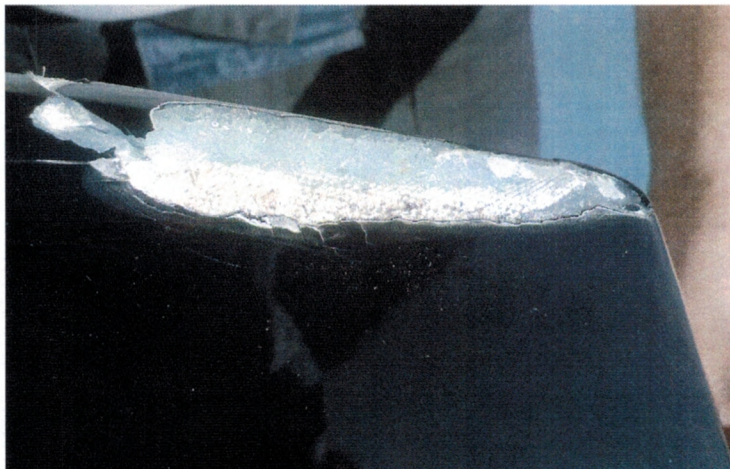
Contact between rudder rear upper tip and rotor whilst attempting a hand rotor start. Edge damaged.

This area of the rudder is not considered structural, as it does not connect any two parts together, and carries little loading. There was no sign of any delamination between the two rudder halves. Inspection of the rudder shows no loosening of the fasteners or inserts. Damage is limited to the upper rear edge only.

Views of the upper rudder rear edge. This edge is composed mainly of 'Mumba' a type of filler

Clean back area to base fibreglass. Repair with resin. Fill, sand as required to return to original form. Repaint blue LC5U and laquer.

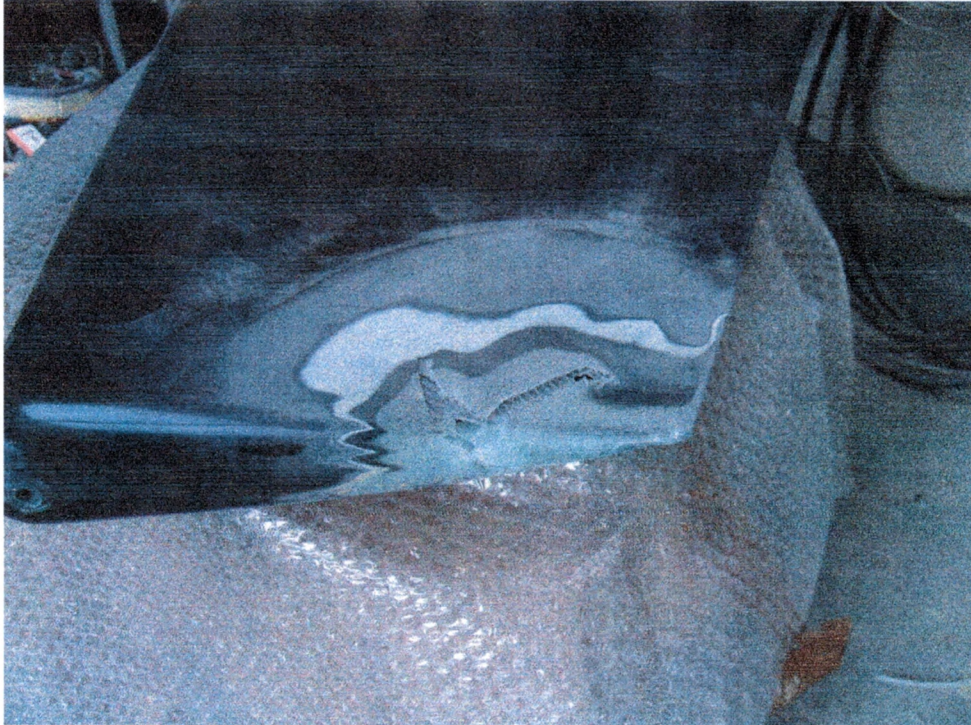
View after cleanup and ready to fill. Damaged glass matt exposed for good bond to new resin. Note this is NOT a honeycomb material, just glass fibre mat.

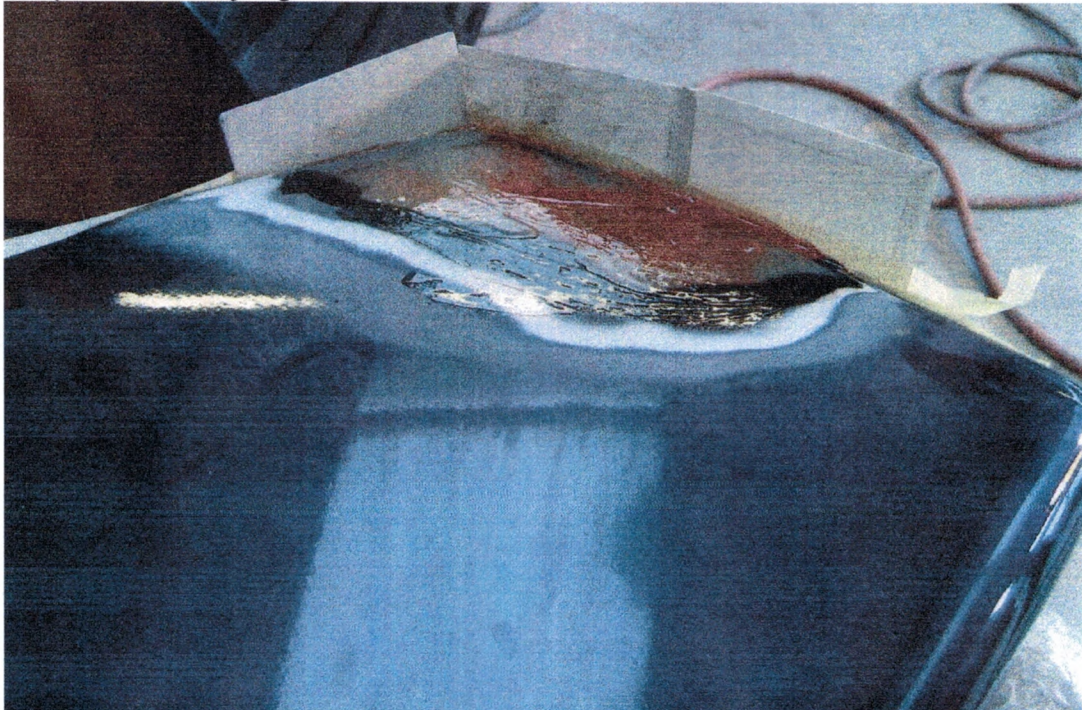
Area resin filled, original outside profile maintained.

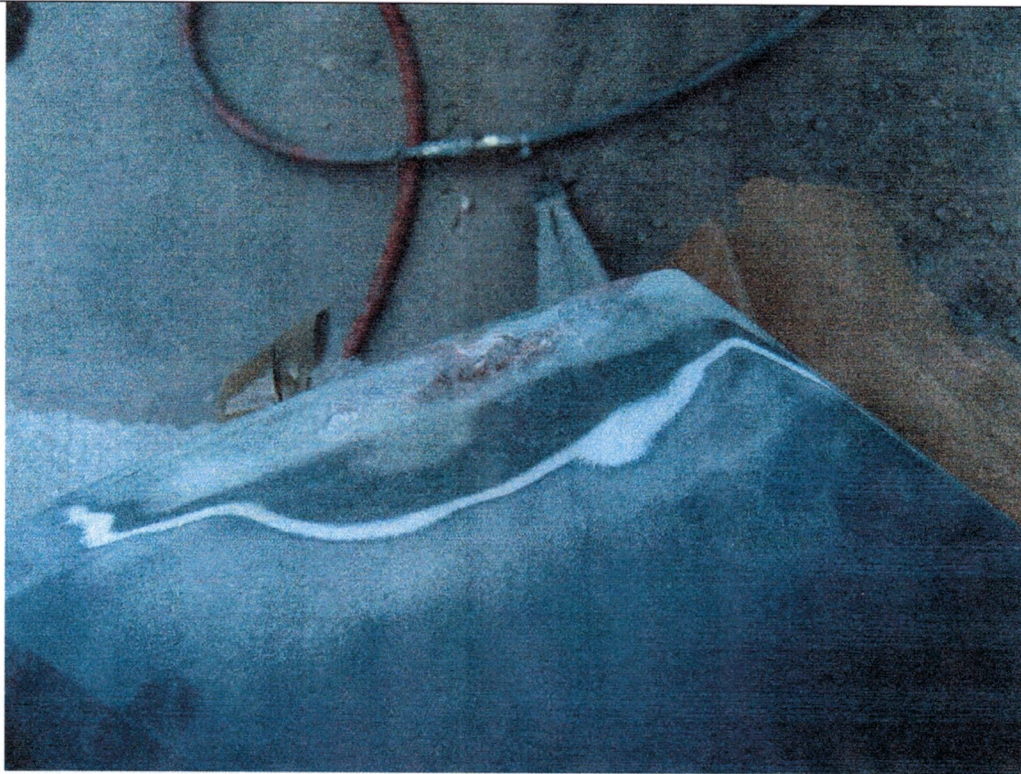
After surface repair

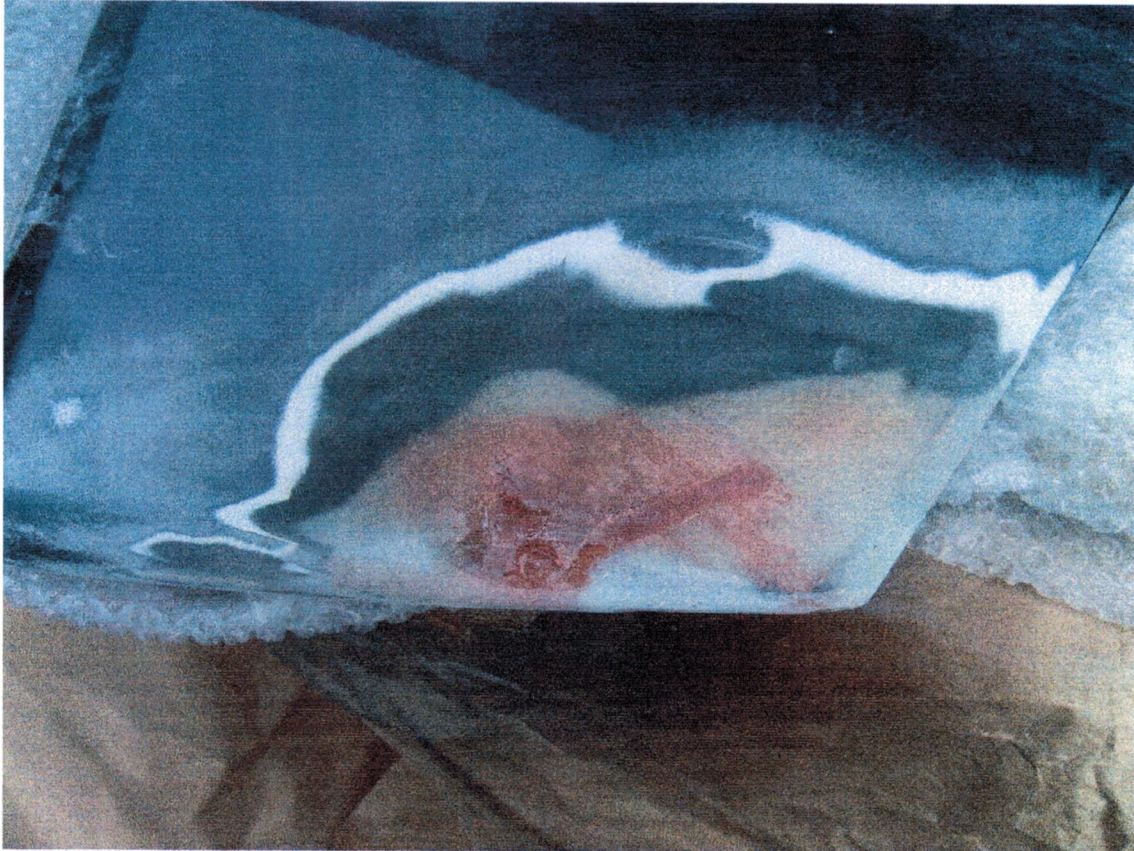
After surface repair, ready for surface filler and paint

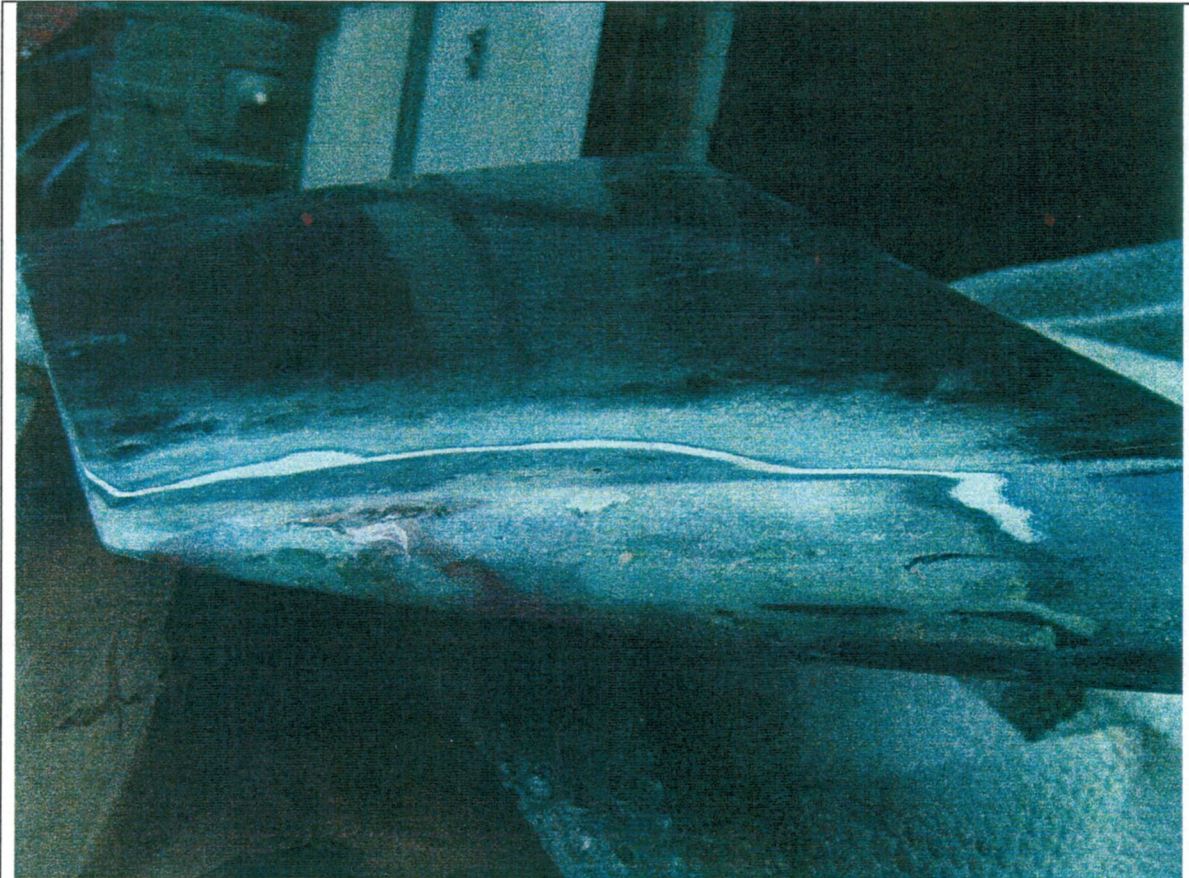
Ready for filler.
