RotorSport UK Ltd

Service Repair Request and Evaluation/Approval

Repair No.: 012 Issue 1, 11/10/11	CCAR No.: None Mod approval No. MC-203	Repair classification: MAJOR MINOR
Aircraft type: MT-03 and MTOsport (all aftermarket only)	Aircraft serial No.: OPEN (first application G-CGGV RSUK/MTOS/022)

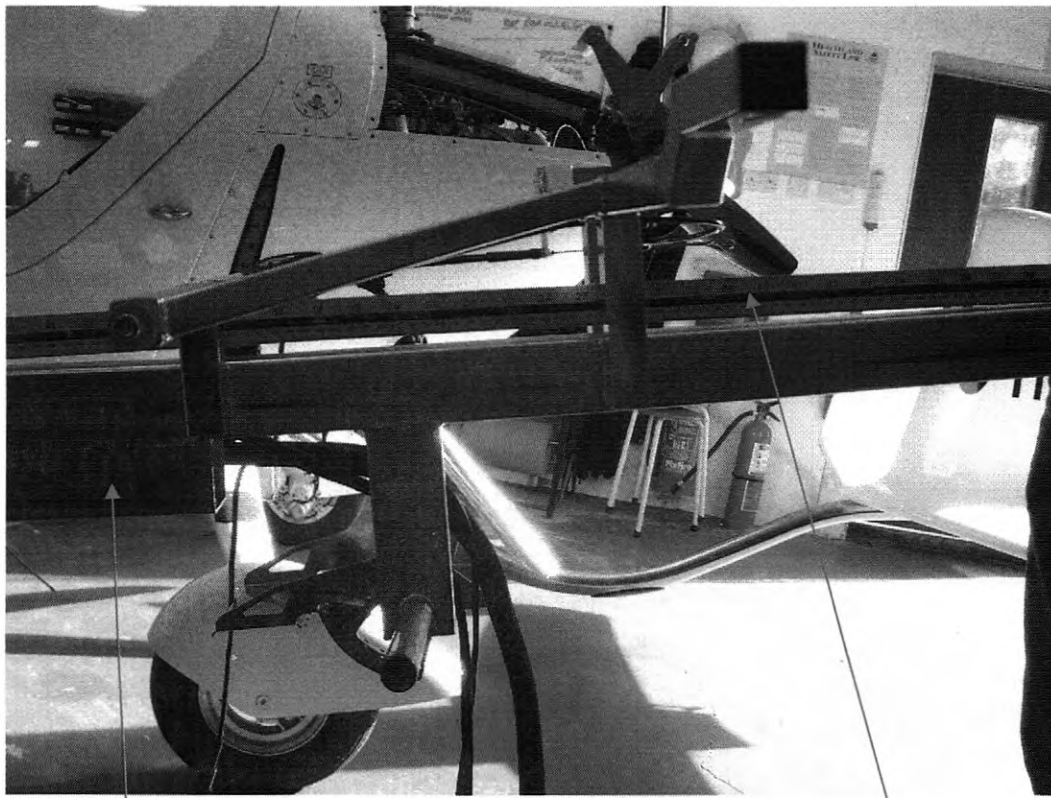
The keel has been bent upwards by the load from a nose-heavy landing. The extent and position of the bend can be seen by use of a straight-edge. There may also be a visible witness showing the origin of the bend just fwd of the keel doubler. The gap under the straight-edge at this point is 10mm and the bend angle is 2 degrees. The welds around the upper and lower nose-wheel fork bearing-mountings have been visually inspected and no defects found.

Keel doubler

Upward bend of keel

Straight-edge

A substantial stand (with protected top) is placed under the front section of the keel, and an automotive trolley-jack placed at the point at which the re-bend will occur.

Mass-bags are placed on the front of the keel, distributed so that there is no secondary bending or torsion induced.

Balancing bags are similarly placed at the rear of the aircraft. The height of the jack will be increased until the keel is seen to bend upwards and is monitored by means of the visible gap under the straight-edge. A slight over-bend is created so that when the jack is removed the inherent spring-back of the keel steelwork results in a straight structure.

After bending, the keel section straightness (as assessed by the straight-edge shown in the first photograph) shall be within 1mm, there shall be no visible buckling of the side-walls of the keel tube-section and there shall be no cracks visible when examined with a x10 magnifier.

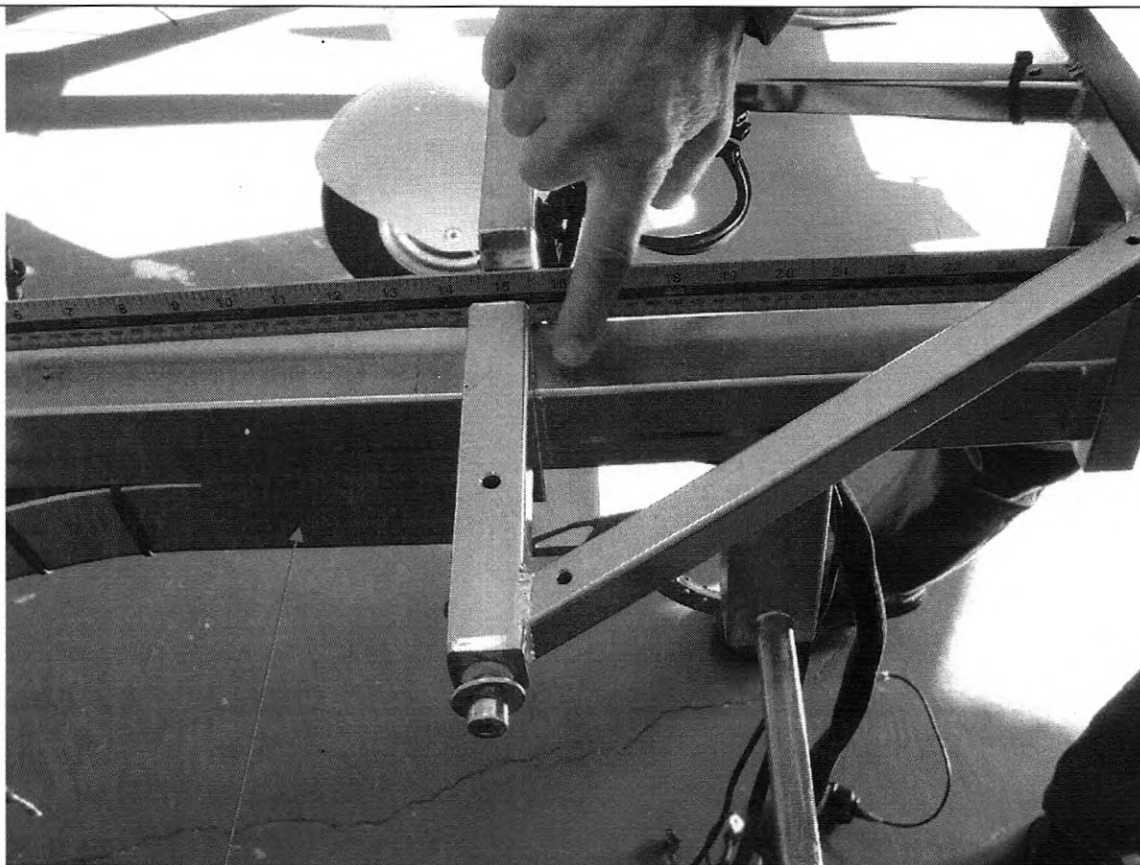
Keel doubler

Visible witness location

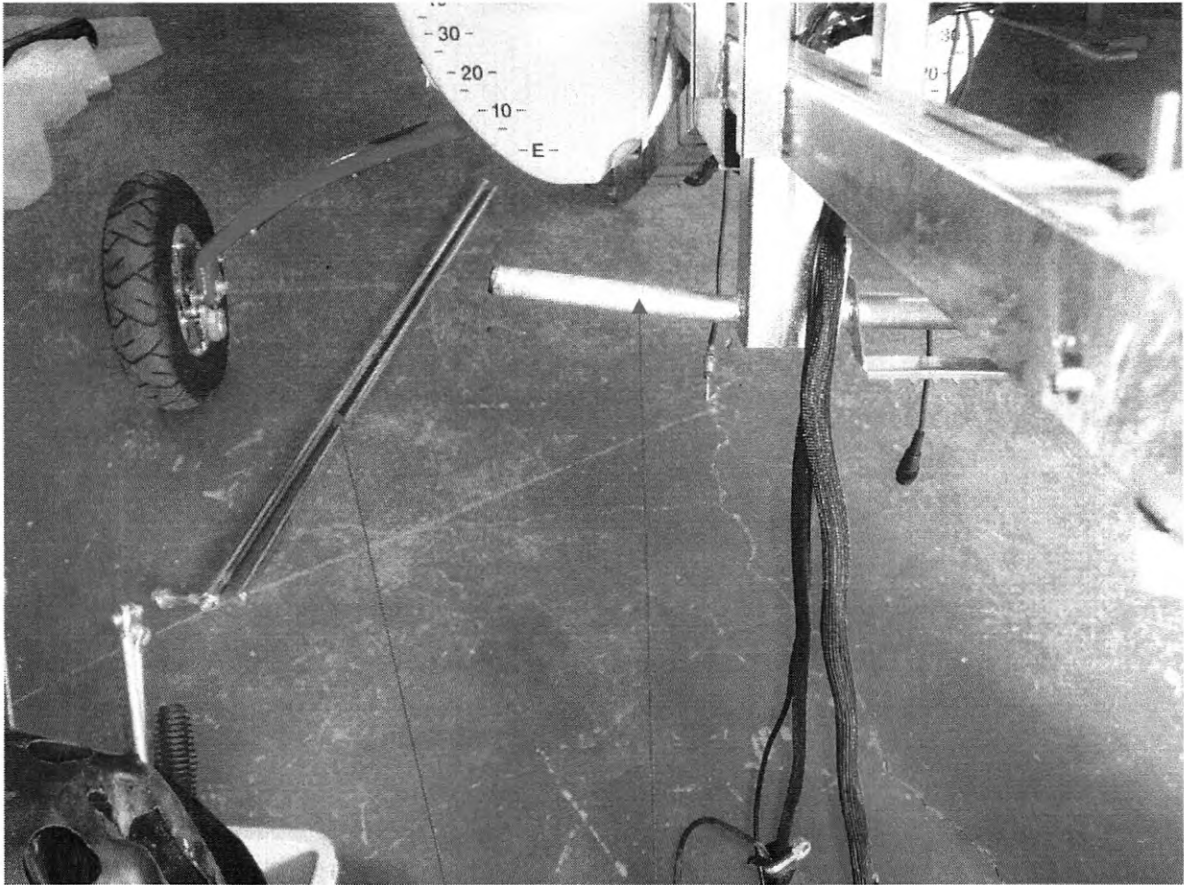
The right front rudder pedal mounting tube has also been bent upwards 5.5 degrees and the main control rods have a very slight, barely visible bend in the whole length.

Damaged control rods and bent rudder-pedal mounting

The stainless-steel pitch/roll control rods are mounted above the keel tube. The lower control tube pivots and the upper tube moves fore-and-aft. These will be straightened by means of a press and straightness verified by rolling on a flat surface. The welds around the welded-in inserts shall be visually examined with a 10x magnifier to confirm no cracks are present.

The rudder pedal mounting is a single tube that passes through the keel section, thus providing the pivot for both pedals. The bent right-hand section will be straightened by hand, using a close-fitting tube as a lever to ensure that the tube is kept straight during the re-bending operation. After re-bending, the weld to the keel box-section shall be examined with a 10x magnifier whilst applying an oscillating hand-load to open any potential cracks in the welded junction .
