# RotorSport UK Ltd

## Service Repair Request and Evaluation/Approval

<p>This form (Part 2 of 2) is the response from RotorSport UK Ltd to a Service Repair and Evaluation/Approval request, which specifies the company authorised repair method. Deviation from this method renders the authorisation ineffective.</p> <p>Upon completion of the repair the repairer must enter details into the logbook/worksheet with the repair number and sign as normal.</p> <p>If any problems with carrying out the work authorised, contact RSUK immediately on 44(0)1588 650769, or email <a href="mailto:info@rotorsport.org">info@rotorsport.org</a>.</p>		
Repair No.: <b>015 Issue 1, 13.12.12</b>	CCAR No.: None Mod approval No. MC-226	Repair classification: <del>MAJOR</del> <b>MINOR</b>
Aircraft type: MT-03 (all aftermarket only)	Aircraft serial No.: OPEN (first application G-CFBJ RSUK/MT03/042)	
Repair problem description & cause of problem if known: Aircraft G-CFBJ suffered a bent top pivot plate during a tail strike. This is to provide a field repair, to be undertaken at RotorSport UK Ltd.

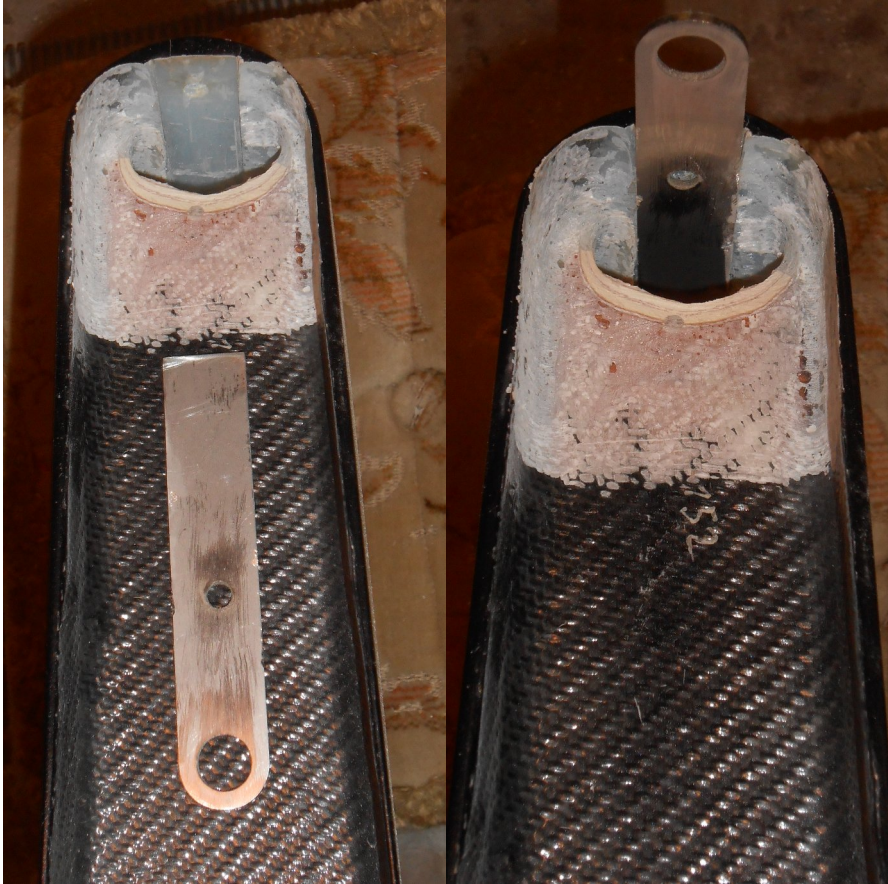
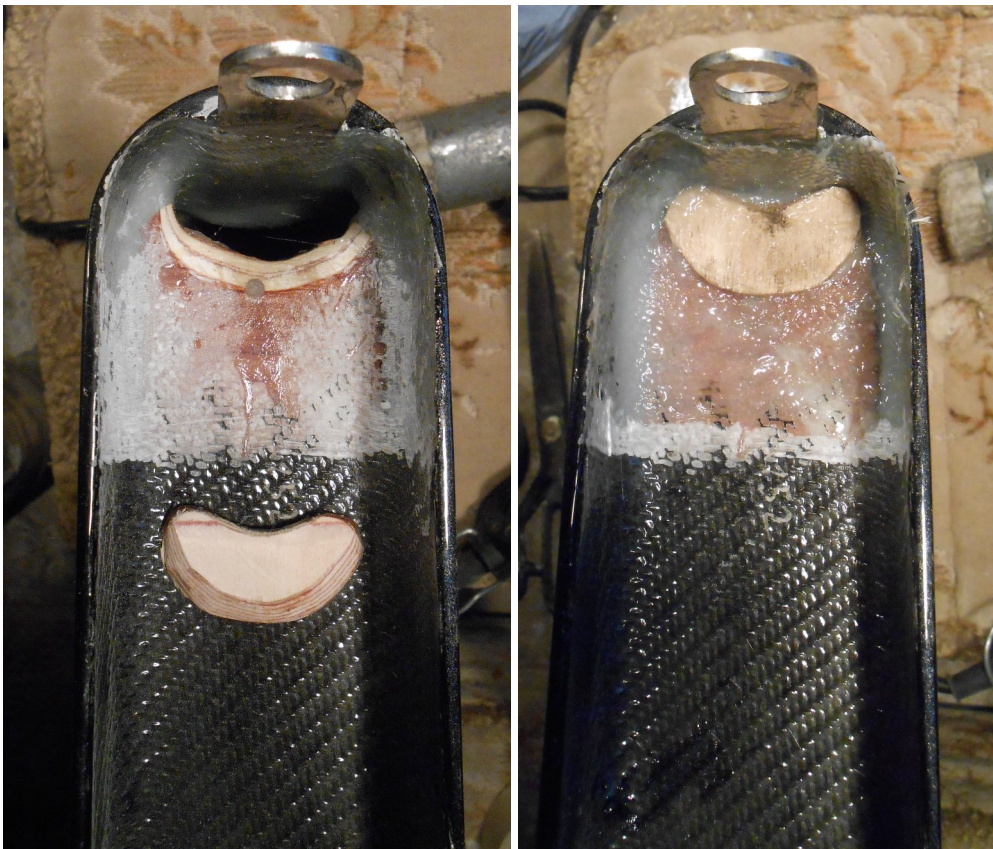
Photos of repair stages.

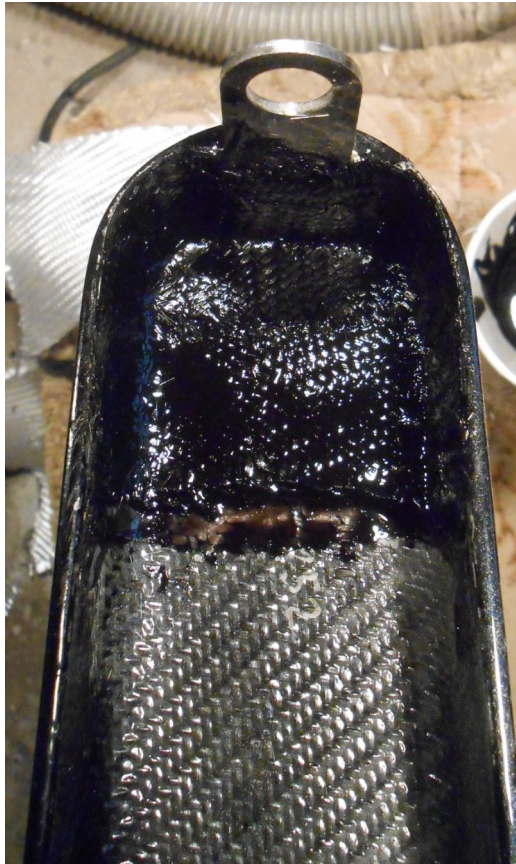
Completed repair ready for final trim and fitment to the aircraft.
