RotorSport UK Ltd

Service Repair Request and Evaluation/Approval

Repair No.: 016 Iss2, 30.11.18	CCAR No.: CCAR-044 Mod approval No: MC-234	Repair classification: MAJOR or MINOR
Aircraft type: MT-03 and MTOsport (all aftermarket only)	Aircraft serial No. OPEN (first application G-CEHN RSUK/MT03/008

Repair problem description & cause of problem if known:

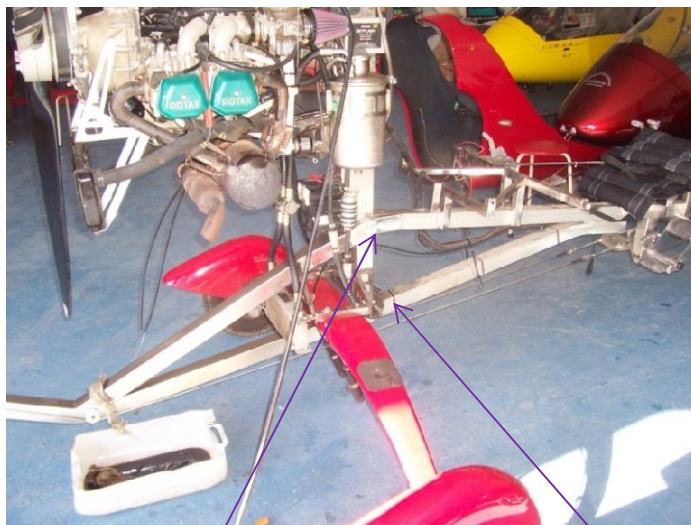
Location of Upper keel/mast interface and Lower keel/mast interface

It has been found that aircraft used for flight-training and therefore subject to a large number of take-offs, landings and ground movements may be subject to cracks at the base of the mast, these being visible during the required 100hr/Annual inspections. It is believed that high undercarriage loads transmitted through the keel have increased the stresses in the upper keel/mast interface and caused fatigue cracks. No visible cracks in the lower keel/mast interface have been found at this time.

Accomplishment instructions – preliminary inspection/typical crack appearance

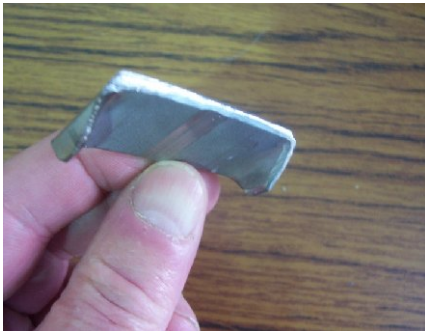
Gusset prepared

The gusset is manufactured by hand from a section of 2mm wall thickness 50mm square box-section stainless-steel 1.4301 and is welded in place with compatible filler wire (see Welding requirements below)

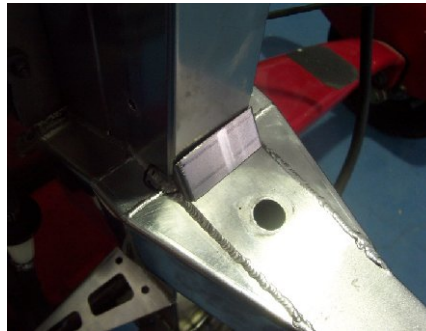
in position at base of mast

(ii) Check the mast alignment (and adjust if necessary), then make good the crack and add the reinforcing gusset at the upper mast/keel interface (by the method previously approved under MC-115/SRA-004).

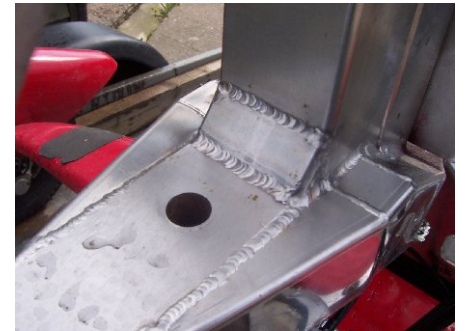
gusset welded

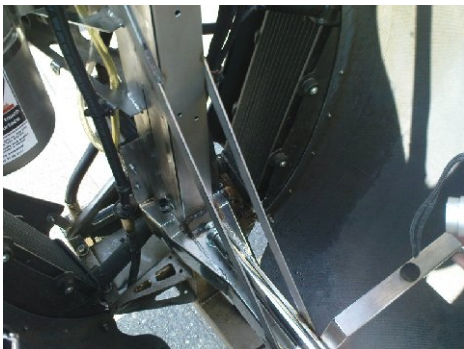
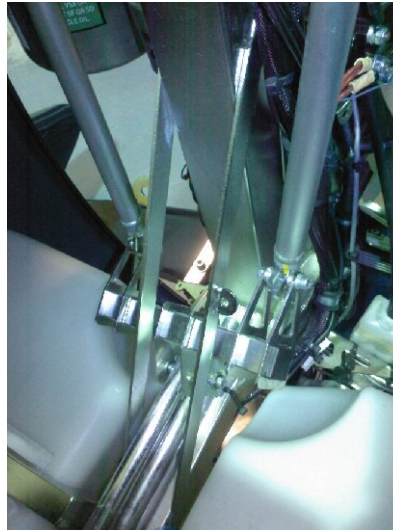
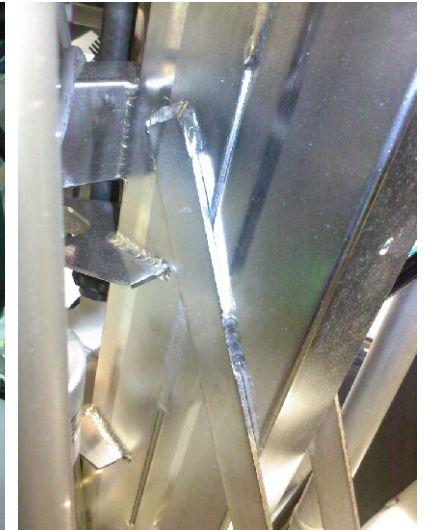
View of straps welded in place The straps are welded at 35 degrees to the mast, as detailed in RSD7178.

(iii) Add the reinforcing straps between the mast and keel (by the method previously approved under MC-115/SRA-004, also forming part of the upgrade from 450kg to 500kg MTOW approved under MC-070). Detail instructions are given in the drawing RSD7178 below

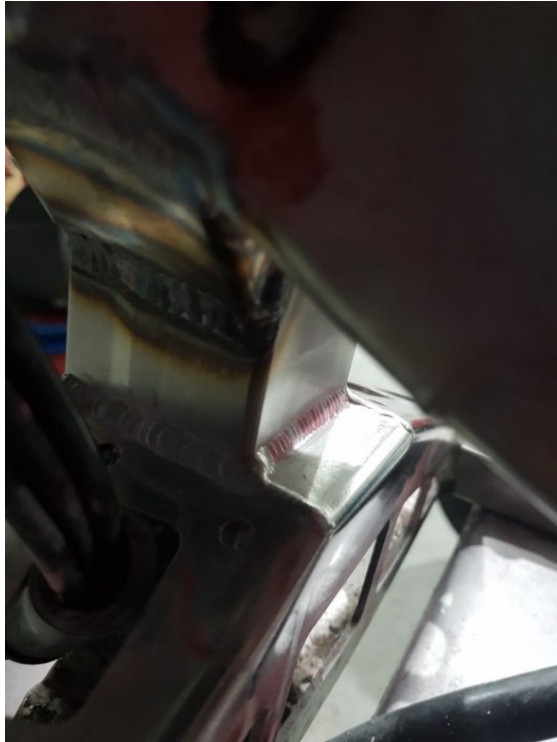
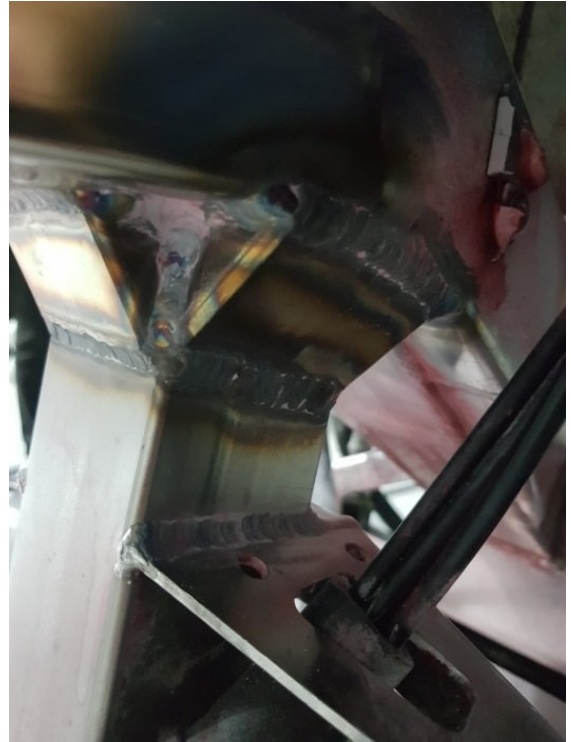
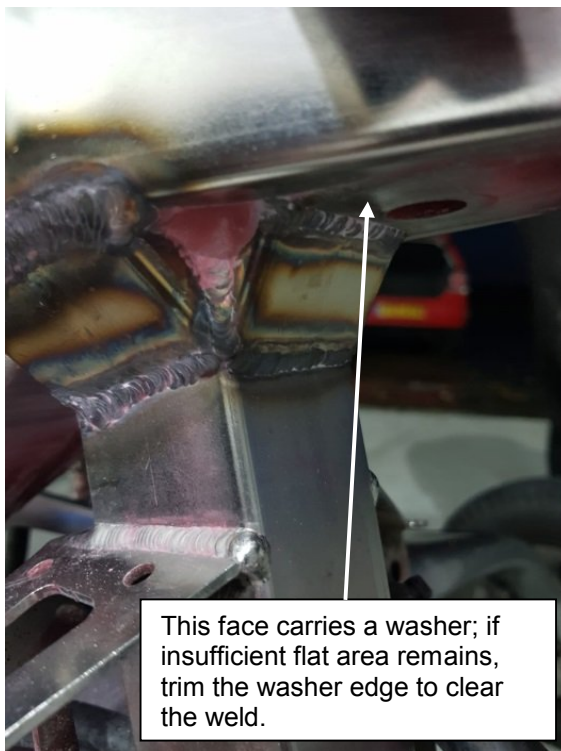
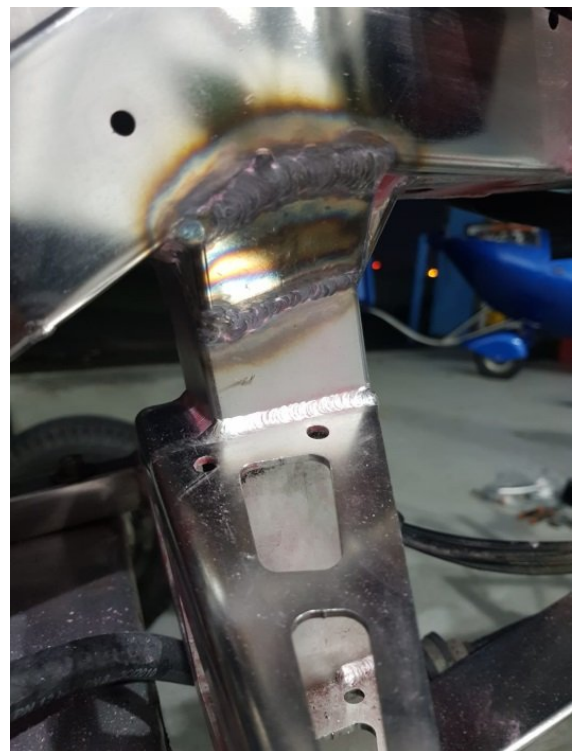
Issue 2 content - alternative lower gusset arrangement when a native MTOS airframe is under repair.

The MTOS airframe (which is approved for 500kg MTOW with the uprated suspension bow) already has the reinforcing straps between the keel tube and main mast section. It is therefore permissible to delete the requirement for items (ii) and (iii) above provided there are no cracks at the base of the mast (i.e. where the upper gusset would be placed). In this case a stronger arrangement of four lower gussets is used, changing the detail of item (i). The gusset set used is RSD1139 "Mast repair alternative lower gusset set". These are triangular pieces cut from a section of 50 x 50 x 2mm stainless-steel box section (same as the mast section, alloy 1.4301) as shown on page 9 and when in place surround the lower mast/keel-tube interface, as can be seen in the photos below. Adjust the length to clear the weld, and shape to suit the area to be welded. The gusset vertical angle should be 30-45deg.
