RotorSport UK Ltd

Service Repair Request and Evaluation/Approval

These are modelled on the previous successful repair of G-CGOT under MC-197/SRA-010

Present Modification Classification the subject of this SRA-017 is MC-246.
Similar previous Modification Classification MC-197/SRA-010.
Auto-Gyro process sheets for Body (complete) C.KU01.01.01
(these are too complex to embed in this document but were made available during preparation for the repair)

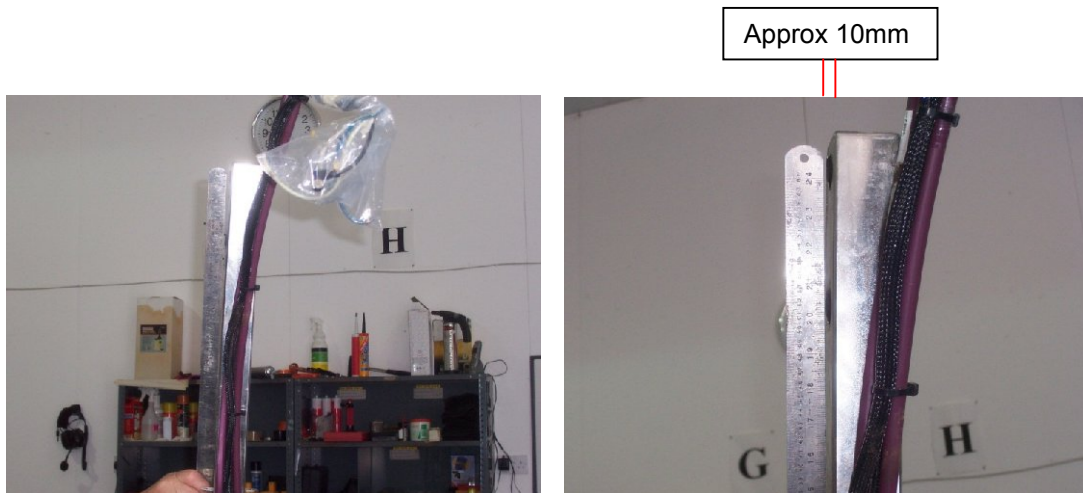
Extent of bend shown at top of mast

The mast section of the airframe bent laterally (progressively and without evidence of buckling).

The mast section is doubled in the area of the bend (which is between the welds as shown)

The mast is jig straightened using hydraulics. Correct straightness is measured using straight edges between the upper and lower sections of the mast, and twist by clamping a straight edge on the upper mast and visually aligning with the keel.

After rebend the integrity of the box section and adjacent welds is to be inspected as noted below. This is confirmed by completion of the worksheet at the end of this document SRA-017.

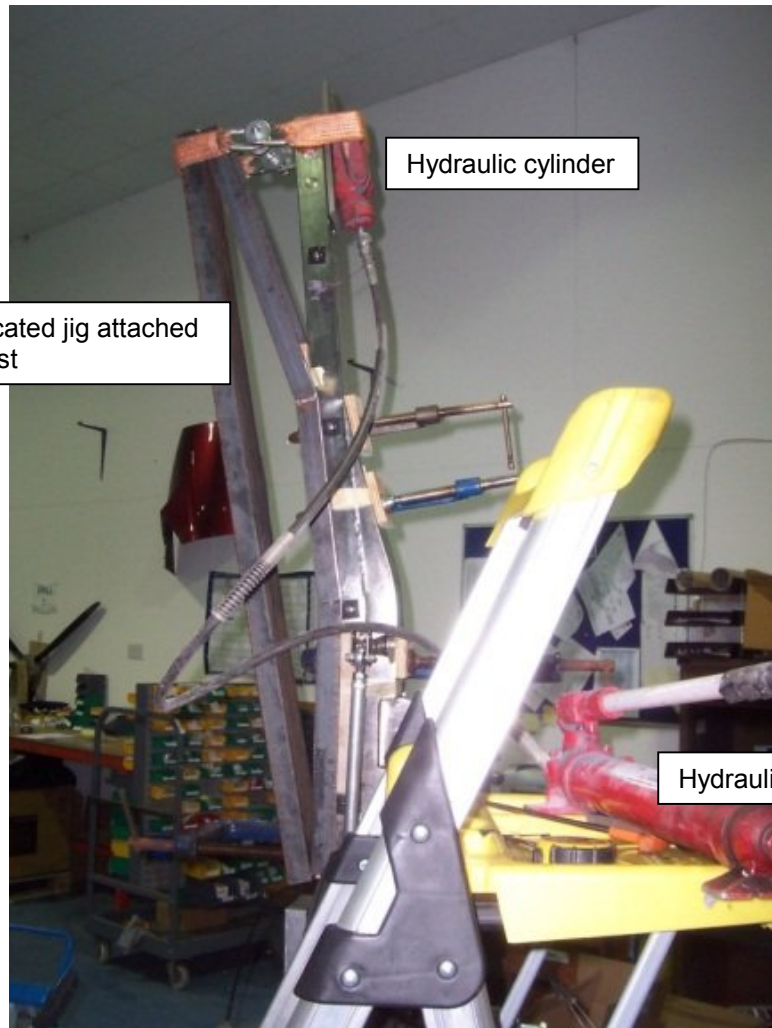
Principal of re-bending force application as completed on an MTseries gyroplane

- (i) For mast straightening construct a special disposable fabrication from rolled-steel-angle and channel sections (see photo below for guidance)
- (ii) During sanding and painting wear appropriate PPE
