RotorSport UK Ltd

Service Repair Request and Evaluation/Approval

**Repair No. and Issue: SRA-021 Iss1
MT-series keel closure plate weld**

**Aircraft type
MT-series**

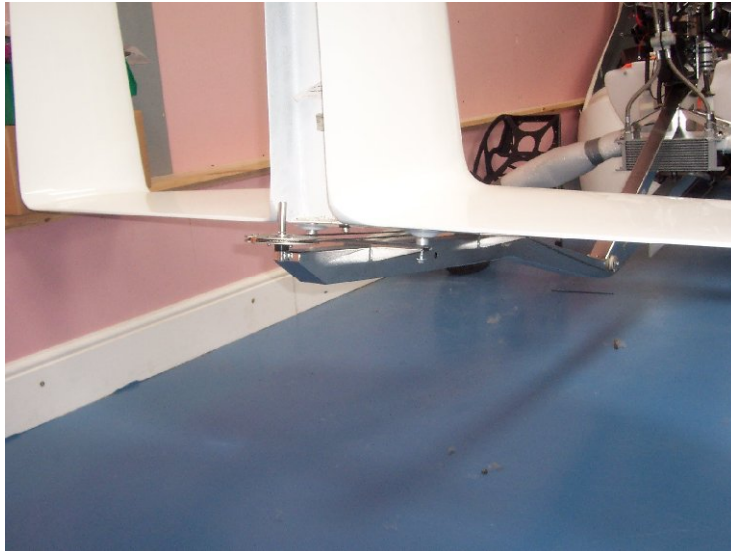
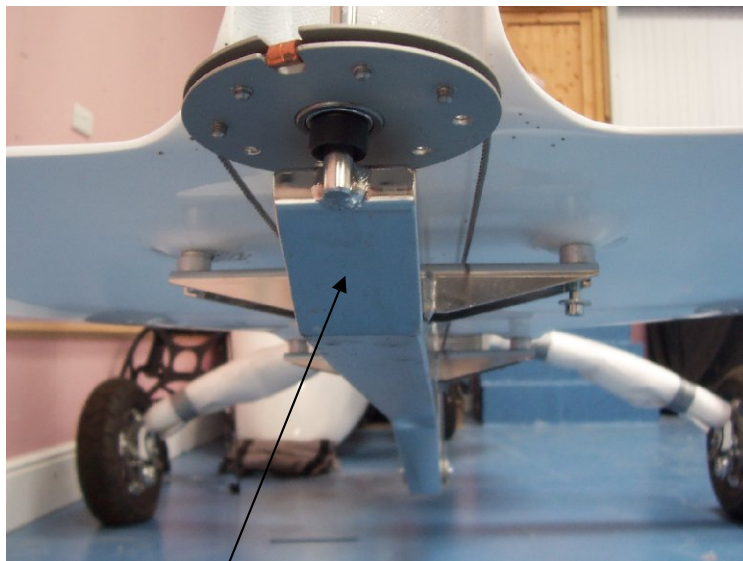
MT-03 and MTOsport gyroplanes have a keel-tube constructed from 50mm box-section of 1.4301 stainless steel. The rear of the keel is chamfered and closed by a 2mm plate fillet-welded in place.

Closure plate (rudder not fitted)

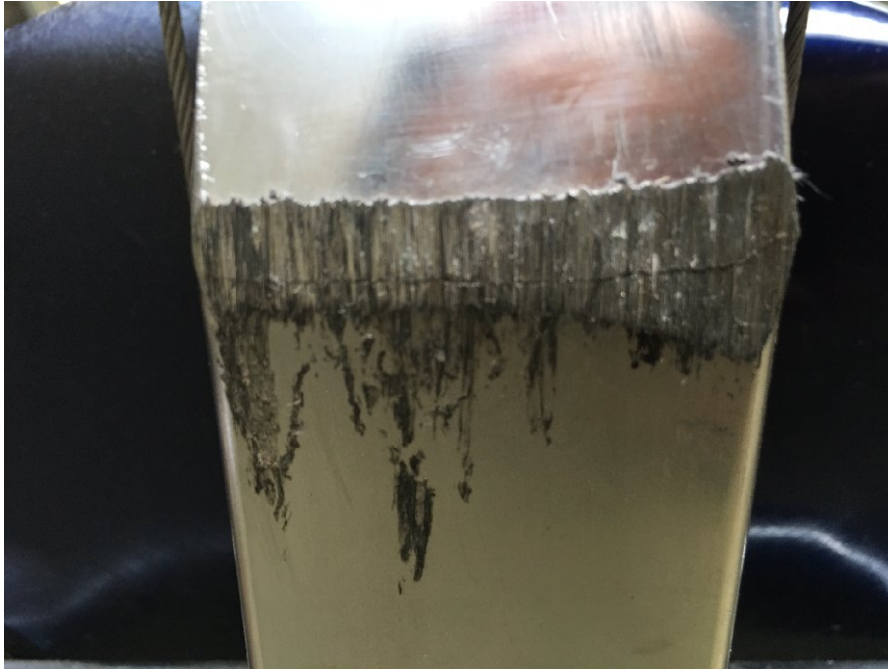
During a training sortie in MT-03 G-MEPU, while demonstrating a nose-high ground run the tail was dragged on the tarmac runway resulting in the lower horizontal fillet weld being ground away. Subsequently a crack was found in the weld area, i.e. a gap between the tube and the plate lower edge.

The crack must not have propagated into the vertical welds and the plate must not be distorted. If found such contact RotorSport UK Ltd.

Under this SRA-021 the damaged area may be cleaned-up and the horizontal fillet weld reinstated

- 1) Protect the rudder cables/cullisse and paintwork of the rudder and tail by suitable non-flammable covering. To aid access it may be found advantageous to move the rudder to one side.
- 2) Using a small angle grinder and/or hand-file clean-up the scuffed area. Inspect the plate interface and establish that the crack has not propagated into the vertical weld. Stop-drill the crack 2.0mm at the corners
- 3) Using a Dremmel-type tool with small grinding wheel (typ 0.75mm thick) progressively grind-out the length of the crack. Remove all grinding debris and clean-up with Amberclene LO30.
- 4) Weld-up the prepared crack in one continuous pass (see below for welding requirements)

Using an electrode 2.4mm diameter, filler metal 316 stainless steel and heat-setting 60-70amps produce a continuous fillet weld in a single run.
