RotorSport UK Ltd

Service Repair Request and Evaluation/Approval

Repair No. and Issue: SRA-023 Iss1 Calidus suspension bracket bow repair	CCAR No.: 075 Mod approval No: None	Repair classification: MAJOR or MINOR
Aircraft type Calidus	Aircraft serial No. RSUK/CALS/005 First application: G-YROZ

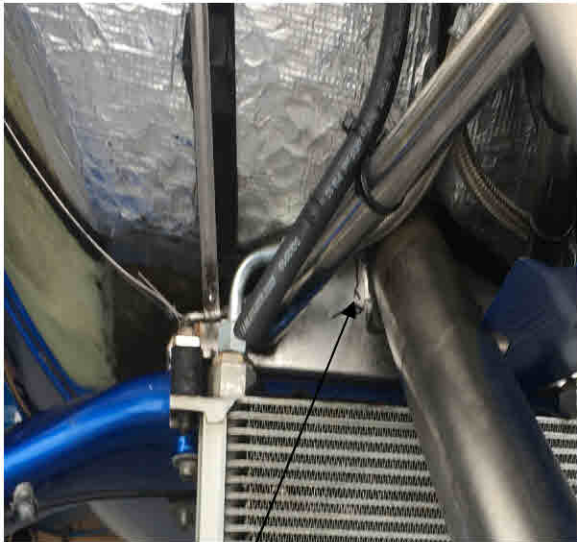
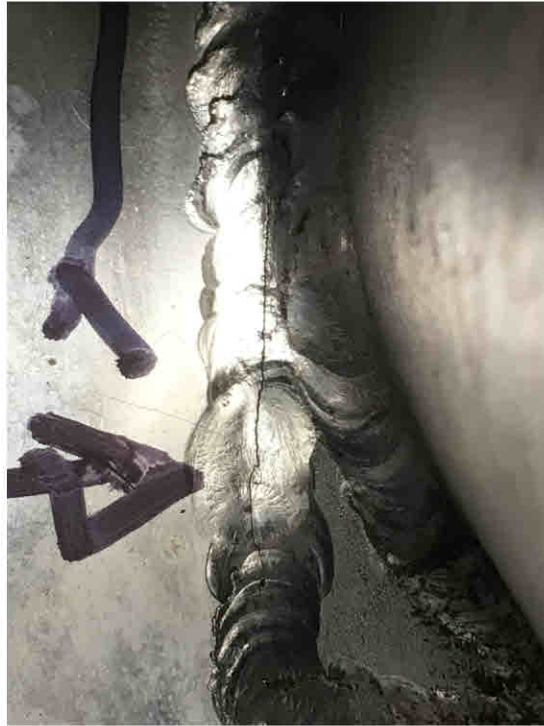
The Calidus suspension bow is attached to the aircraft by way of a 'U' shaped bracket that is welded to the mast structure. During inspection a crack was found in the vertical fillet weld attaching the left rear vertical face to the mast.

Crack position (could be either side of the mast)

Organisation Approval Ref: DAI/9917/06.
Tooling required. Conventional hand tools and TIG welding equipment only
Weight and balance. Not affected
Manuals affected. None affected
Previous modifications affecting this SRA. None
List of materials required to complete this SRA: Weld filler rod only
List of components required to complete this SRA: None
Interchangeability: Not applicable
Parts disposition: Not applicable
Accomplishment instructions/details of the repair: <ol style="list-style-type: none">1) Remove the fuel tanks and protect any adjacent cables by suitable non-flammable covering.2) Using a Dremmel-type tool with small grinding wheel (typ 0.75mm thick) progressively grind-out the length of the crack. Remove all grinding debris and clean-up with Amberclene LO30.3) Inspect the plate interface and establish that the crack has not propagated into the mast or keel tube weld.4) Weld-up the prepared crack in one continuous pass (see below for welding requirements).5) Place an additional vertical weld fillet on the forward side of the plate for the full available length.6) Place an identical weld on the other side of the mast, such that both the bracket to mast connection has been symmetrically reinforced with the weld. <p style="text-align: center;"><u>Welding requirements (to be carried-out by CAA authorised welder only)</u></p> <ol style="list-style-type: none">1. Final preparation of weld area (immediately before welding) Remove any deposits by cleaning with a lint-free cloth and halogen-free solvent (Amberclene LO30). Remove any surface debris by brushing with a stainless-steel wire-brush.2. Welding Set the TIG welder for job +ve, electrode -ve. Using an electrode 2.4mm diameter, filler metal 316 stainless steel and heat-setting 60-70amps produce a continuous fillet weld in a single run.

<p>produce a continuous fillet weld in a single run. Ensure that filler metal is present in the whole welded length so that a joint "fused only" is not created.</p> <p>3. Clean-up Remove burn marks from the weld and areas adjacent using a stainless-steel wire-brush followed by Scotchbrite pads or rubbing blocks if required. Do not use any acid treatment for clean-up. Do not dress the weld by grinding, leave the visible fillet intact.</p> <p>4. Inspection Using a magnifying glass at least 4x and good illumination inspect the weld to ensure that there is a high build for the whole length of the weld with no inclusions or voids present and that the start and end of the run are of uniform shape.</p>									
<p>Reference to other documentation:</p> <p>No modification has been raised as it is considered that this repair reinstates the joint to the original specification.</p>									
<p>Test and inspection records:</p> <p>Complete attached worksheet</p>									
<p>Special Tools & Health and Safety requirements, and/or components required for repair:</p> <p>No special tools or components required</p>									
<p>Quality Inspection requirements after repair:</p> <p>Visual inspection required as described above</p>									
<p>Flight test requirements after repair:</p> <p>No flight test required</p>									
<p>Documentation completion:</p> <ol style="list-style-type: none"> 1. Complete the SRA worksheet attached 2. After embodiment of this repair SRA-023 the authorised engineer/welder must make an entry in the airframe logbook white pages stating that the repair has been embodied. 									
<p>Service repair authorised by: (name, signature, and date of signature)</p> <table border="1" style="width: 100%; border-collapse: collapse;"> <tr> <td style="width: 20%; padding: 5px; vertical-align: top;"> <p>Quality Control Manager</p>   </td> <td style="width: 20%; padding: 5px; vertical-align: top;"> <p>Engineering Manager</p>   <div style="font-size: 8px; margin-top: 5px;"> <small>Ukman Shan Sep 28 2017 11:39 AM</small> </div>   </td> <td style="width: 20%; padding: 5px; vertical-align: top;"> <p>Chief Test Pilot (where an effect on flight performance or safety)</p> <p>None required</p> </td> <td style="width: 20%; padding: 5px; vertical-align: top;"> <p>CVE</p>   <div style="font-size: 8px; margin-top: 5px;"> <small>David Starkey Sep 28 2017 4:24 PM</small> </div>   </td> <td style="width: 20%; padding: 5px; vertical-align: top;"> <p>Head of Airworthiness</p>   <p style="font-size: 1.2em; margin-top: 5px;">29/9/2017</p> </td> </tr> </table>					<p>Quality Control Manager</p>  	<p>Engineering Manager</p>   <div style="font-size: 8px; margin-top: 5px;"> <small>Ukman Shan Sep 28 2017 11:39 AM</small> </div>  	<p>Chief Test Pilot (where an effect on flight performance or safety)</p> <p>None required</p>	<p>CVE</p>   <div style="font-size: 8px; margin-top: 5px;"> <small>David Starkey Sep 28 2017 4:24 PM</small> </div>  	<p>Head of Airworthiness</p>   <p style="font-size: 1.2em; margin-top: 5px;">29/9/2017</p>
<p>Quality Control Manager</p>  	<p>Engineering Manager</p>   <div style="font-size: 8px; margin-top: 5px;"> <small>Ukman Shan Sep 28 2017 11:39 AM</small> </div>  	<p>Chief Test Pilot (where an effect on flight performance or safety)</p> <p>None required</p>	<p>CVE</p>   <div style="font-size: 8px; margin-top: 5px;"> <small>David Starkey Sep 28 2017 4:24 PM</small> </div>  	<p>Head of Airworthiness</p>   <p style="font-size: 1.2em; margin-top: 5px;">29/9/2017</p>					
<p>Document effectivity date:</p> <p>26th Sept 2017</p>

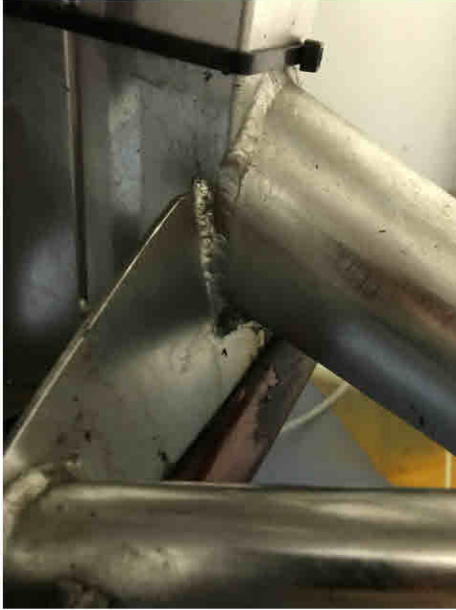
View of the bracket to mast weld area on the first UK Calidus frame. Note that the bracket is welded to the mast, not to the keel tube.

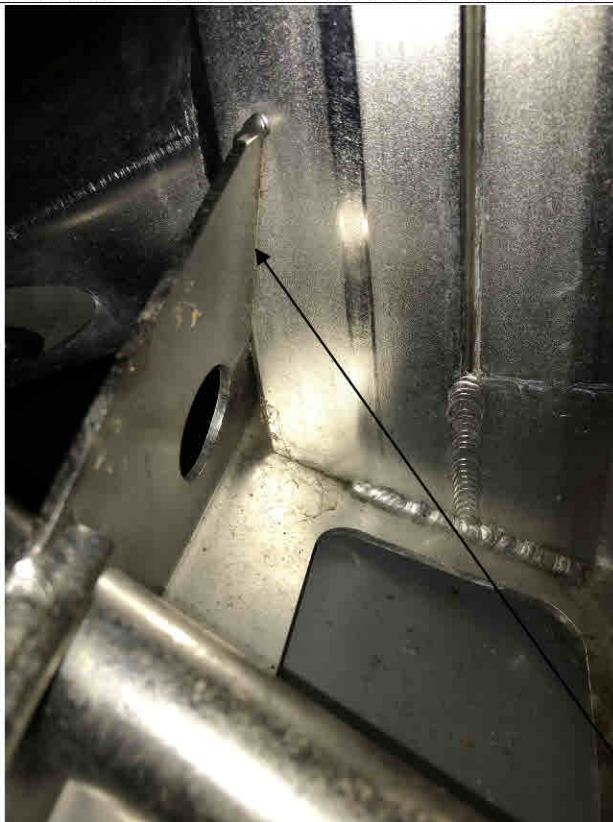
Weld crack is on the other side of this face, on the mast left side.
View of the inside of the suspension bow bracket (right side).
Run a seam weld along this vertical face, both sides of the mast.

The crack must not have propagated into the mast or keel tube weld and the plate must not be distorted.
