Title: MTO2017 Thermostat Oil temperature Sensor Re-positioning		
AG-SB-2021-04-B-EN	Effective Date: 16 June 2021	Compliance Category: A – MANDATORY B – RECOMMENDED C – OPTIONAL
Applicability		
Aircraft type & model: AutoGyro MTO2017	Affected Serial number(s): AutoGyro MTO2017 912/914 fitted with an oil thermostat II incorporating an oil temperature sensor	
The maintenance manual to be referenced is this stated or subsequent issue.		As per AutoGyro website
<p>This form is the response from AutoGyro GmbH either against a problem found in the product in service requiring a containment or rectification action, or as service information for aircraft modification incorporation. For help, contact AutoGyro on 49(0)5121 88056-00, or email airworthiness@auto-gyro.com.</p>

Reason and overview of the Service Bulletin

AutoGyro has developed and released a single thermostat III assembly (47543) and hose set (47422) for the MTO2017 912/914.

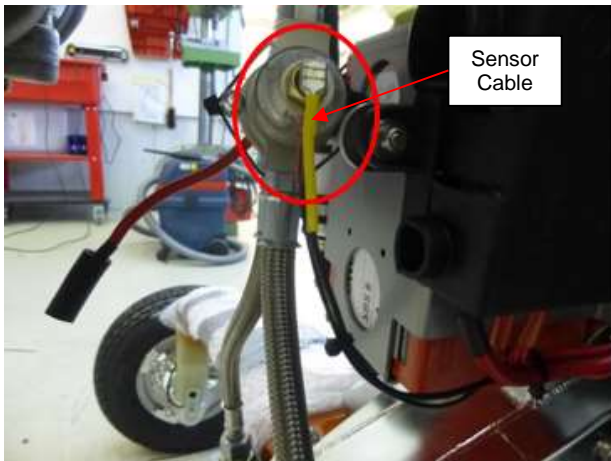
Pic. 1

1. Remove the sensor cable from the sensor (Pic. 1) and carefully remove the oil temperature sensor from the old thermostat assembly housing. Heat may be required to release the Loctite bond. Clean/degrease threads using Loctite 7063 (Pic. 2).
2. Cut the cable shoe from the end of the ground cable, protect with heat-shrink and secure suitably (Pic. 2).

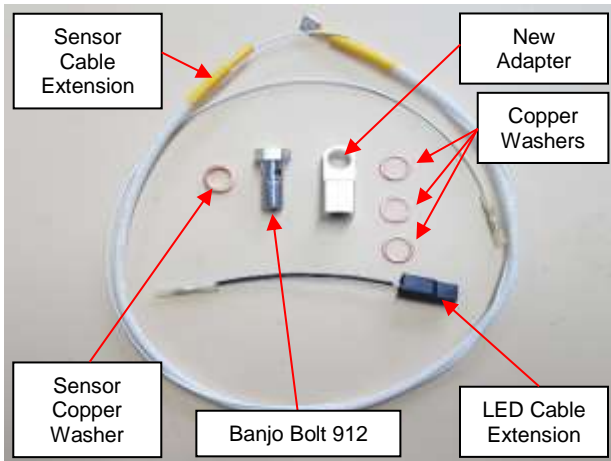
3. Connect the oil temperature sensor cable extension (Pic. 3) to the existing cable and suitably re-route to run across the top of the engine to the rear right side of the engine (the current position of the low oil pressure LED sensor, Pic. 4). Ensure the cable connection is insulated with heat shrink or similar once connected.

4. Remove the low oil pressure LED switch & adapter from the engine (Pic. 4).
5. Remove the switch from the adapter. Clean the threads of the sensor and the (now open) engine mounting position with Loctite 7063. Assemble the switch into the new adapter (Pic. 3) using 1 x copper washer (Pic. 3). NOTE: The adapter has been modified – the item in Pic. 3 is correct, the item in Pic. 10 is the older version.

9. Remove the plug from the engine oil pump housing (Pic. 8). Clean the internal threads in the housing using Loctite 7063.
10. Apply Loctite 542 thread sealant to the threads of the banjo bolt (Pic. 3) and assemble the pressure switch/adaptor assembly, banjo bolt and 2 x copper washers (Pic. 3) to the engine. Ensure a copper washer is assembled either side of the adapter. The third copper washer in Pic. 3 is only required for 914 assembly.
11. Connect the low pressure LED switch extension cable (Pic. 3) to the existing pressure switch cable and suitably re-route between the propeller gearbox and oil pump housings to the new sensor position. Connect to the sensor.

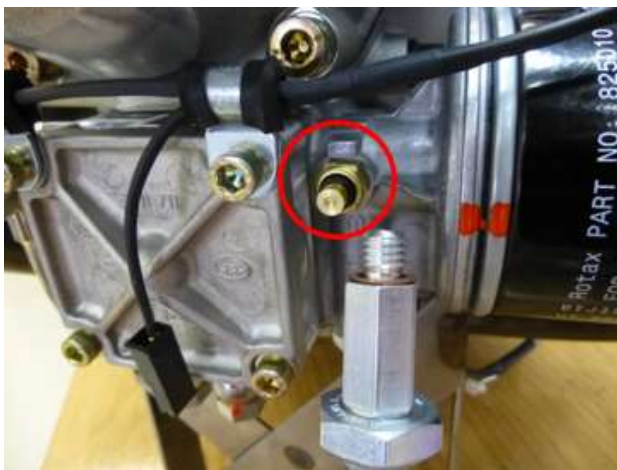
Pic. 5

6. Apply Loctite 542 thread sealant to the threads of the temperature sensor and assemble to the engine (Pic. 5).
7. Connect the temperature sensor cable to the temperature sensor (Pic.6).

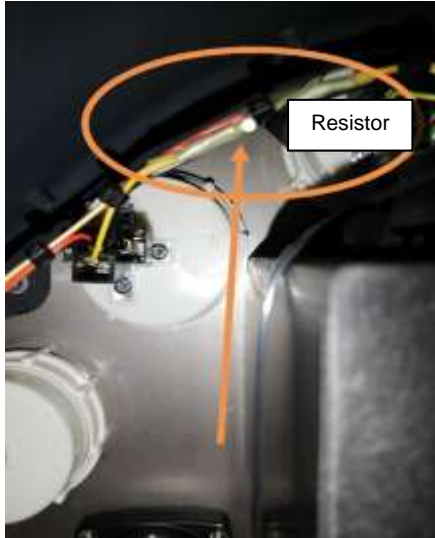
Pic. 7

8. It may be the case that the oil temperature gauge has a resistor installed. This can be verified by gaining access to the rear of the instrument and observing if an additional item in the signal wire between instrument and wire is visible (Pic. 7). If this is found to be present, the resistor should be removed and the wire re-joined with a suitable in-line connector.

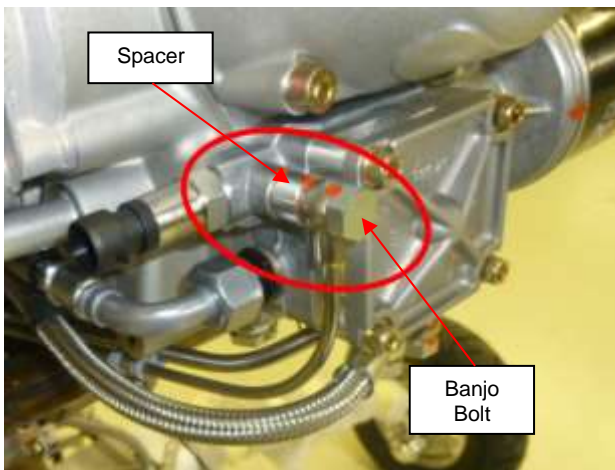
Pic. 9

12. Remove the banjo bolt securing the turbo oil line to the oil pump housing (Pic. 9). This item is re-used for the assembly of the low pressure switch.
13. Remove the spacer between housing and oil line (Pic. 9). Clean the internal threads of the housing and banjo bolt using Loctite 7063.
14. Apply Loctite 542 thread sealant to the threads of the original banjo bolt and assemble the pressure switch/adaptor assembly, banjo bolt, oil line and 3 x copper washers (Pic. 10) to the engine. Ensure new copper washers are assembled either side of the adapter and oil line (Pic. 10).
15. Connect the low pressure LED switch extension cable (Pic. 3) to the existing pressure switch cable and suitably re-route between the propeller gearbox and oil pump housings to the new sensor position. Connect to the sensor.
