## AG-MI-2013-14-B-EN – Pre-Rotator Clutch

Cavalon, serial numbers up to and including V00135

Further problems regarding pre-rotator clutch, especially in case of non-compliance with previous manufacturer information AG-MI-2013-02-B-EN – Pre-Rotator Clutch

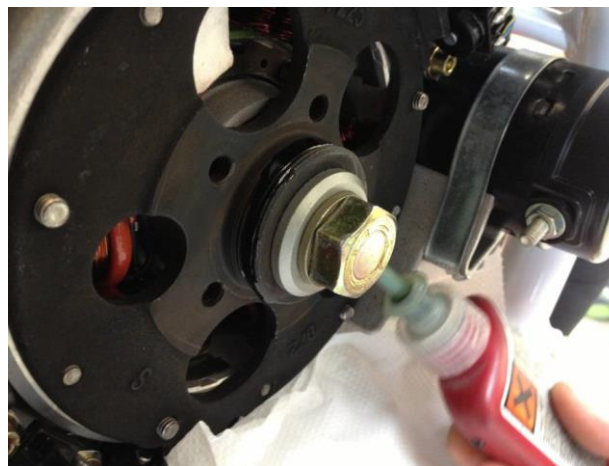
Fig. 4 – Loctite 648 on inner and outer thread

- 5 Demount dog clutch gear with 'Installation aid Carrier crankshaft'
- 6 Thoroughly clean the crankshaft and the driver stud with Loctite 7063
- 7 Apply Loctite 648 on inner and outer thread in sufficient quantity (Fig 4)

**WARNING Use Loctite 648 only! Use of other brands or alternative products excludes correct function.**
- 8 Screw dog clutch gear onto the thread  
**WARNING The dog clutch gear must be easy screwable (floating) up to the stop!**  
Remove excess Loctite

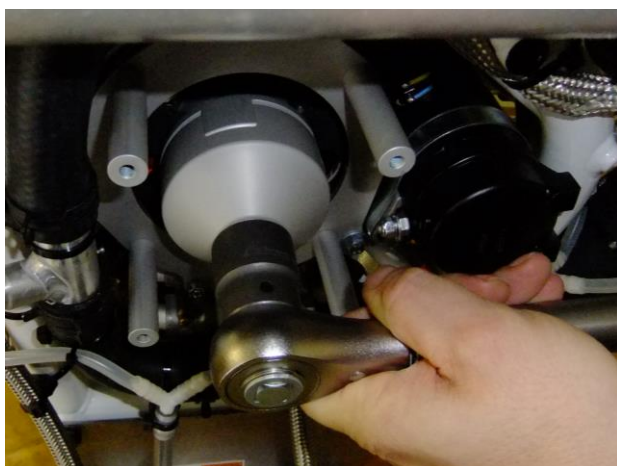
Fig. 5 – Torque dog gear with 140 Nm

- 9 Tighten dog clutch gear using 'Installation aid Carrier crankshaft' with a torque of 140 Nm. (Fig. 5) Clean driver free of Loctite residues.
- 10 Check with feeler gauge 0.05 mm whether dog clutch gear is contacted with the flywheel. Feeler gauge 0.05 mm must not be able to stick in between dog clutch gear and flywheel. (Fig 6)

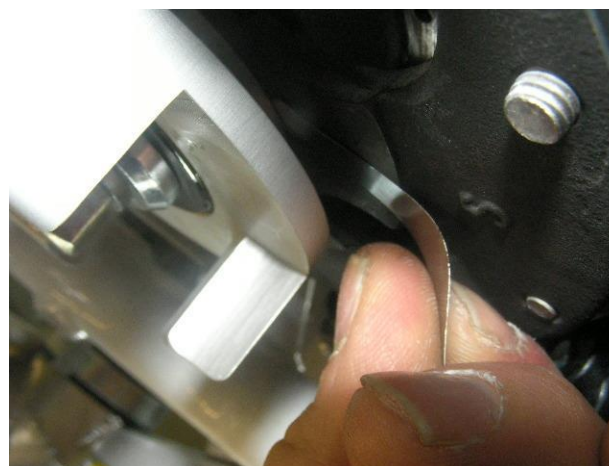
Fig. 6 – Correct mounting position
