RotorSport UK Ltd

Service Bulletin

SB No.: 044 Iss1 Calidus ground-cooling system	Related documents MC No: MC-194 CCAR No.: CCAR-014	Classification: OPTIONAL or RECOMMENDED or MANDATORY
Aircraft type & model (applicability) RotorSport UK Calidus	Aircraft serial Nos. effected RSUK/CALS/001 onwards

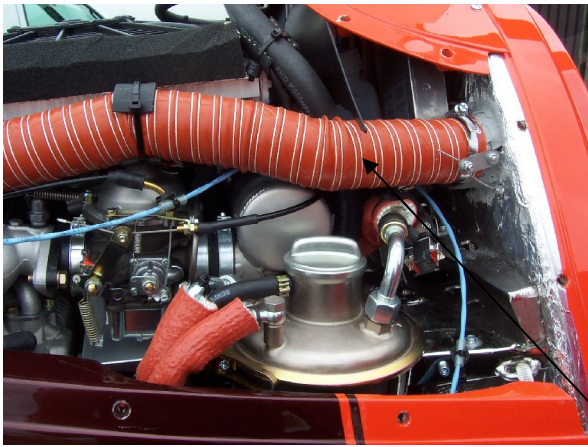
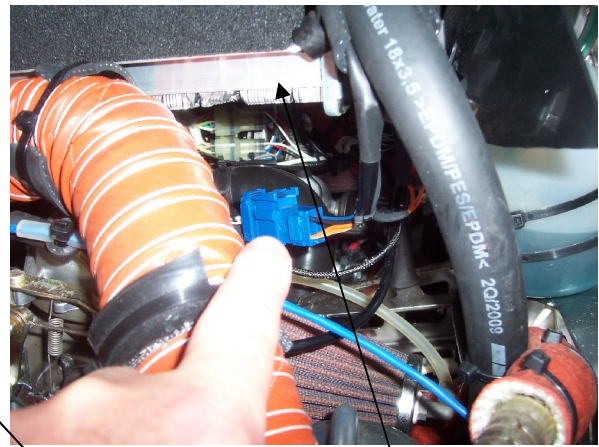
The blue 6-pole connector is behind the cabin-heat duct-pipe and beneath the radiator
(Left photo 914UL engine, right photo 912ULS engine)

3. Identify and move to an accessible position the blue 6-pole connector that is located under the coolant radiator. Release the plastic locking barb and separate the connector halves

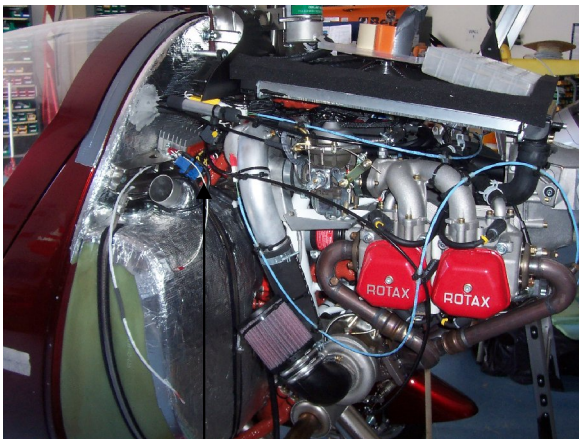
Rotax regulator location on LHS of engine

4. On the left-hand side of the aircraft gain access to the Rotax regulator by releasing the lowest screws of the mast cowling to enable flexure upwards. This will require disconnection of the fuel inlet and grounding cable and is aided by steadying the cowling edge with a piece of foam. Temporarily protect the fuel-tank inlet against loose debris by means of an external cover (e.g aerosol canister cap).

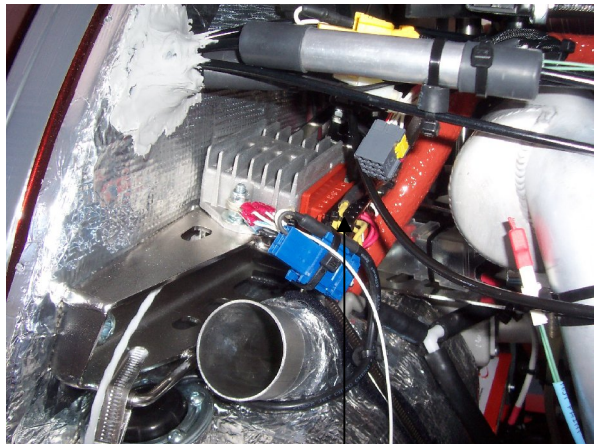
Black regulator connector

6-pole connector terminations

Loop-in/loop-out regulator terminations (magnified at right)

5. Release and move to an accessible position the black regulator connector. Remove the terminations from this connector's "L" (Rotax orange cable) and "C" (Rotax red cable) positions, using a flat jewellers screwdriver to release each locking barb. Install the female terminations of the new Regulator Harness to the regulator's terminals "L" (harness' orange/red-trace cable) and "C" (harness' red/orange-trace cable). Loop the short cables so that the harness male terminals engage with the Rotax female terminals maintaining the colour-code above. Insulate these connections with the heat-shrink sleeving provided in the kit. Replace the regulator connector and tidy the new cable installation using cable-ties.

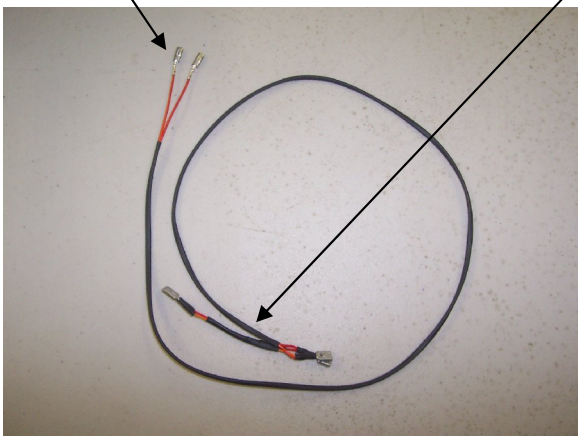
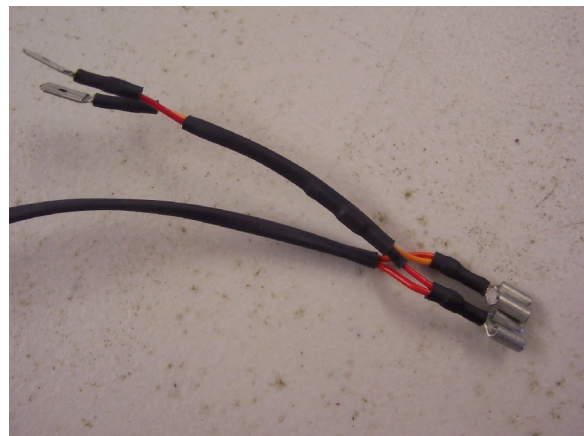
The regulator harness

6. Refit the mast cowling, fuel inlet and grounding cable after removing the tank protection and foam support.
7. Route the regulator harness across the aircraft to terminals 5 (harness' orange/red-trace cable) and 2 (harness' red/orange-trace cable). of the radiator 6-pole connector and insert the female terminals into the airframe side of the connector). Use 2mm cable-ties to attach the regulator harness to the throttle cable passing transversely under the coolant radiator.

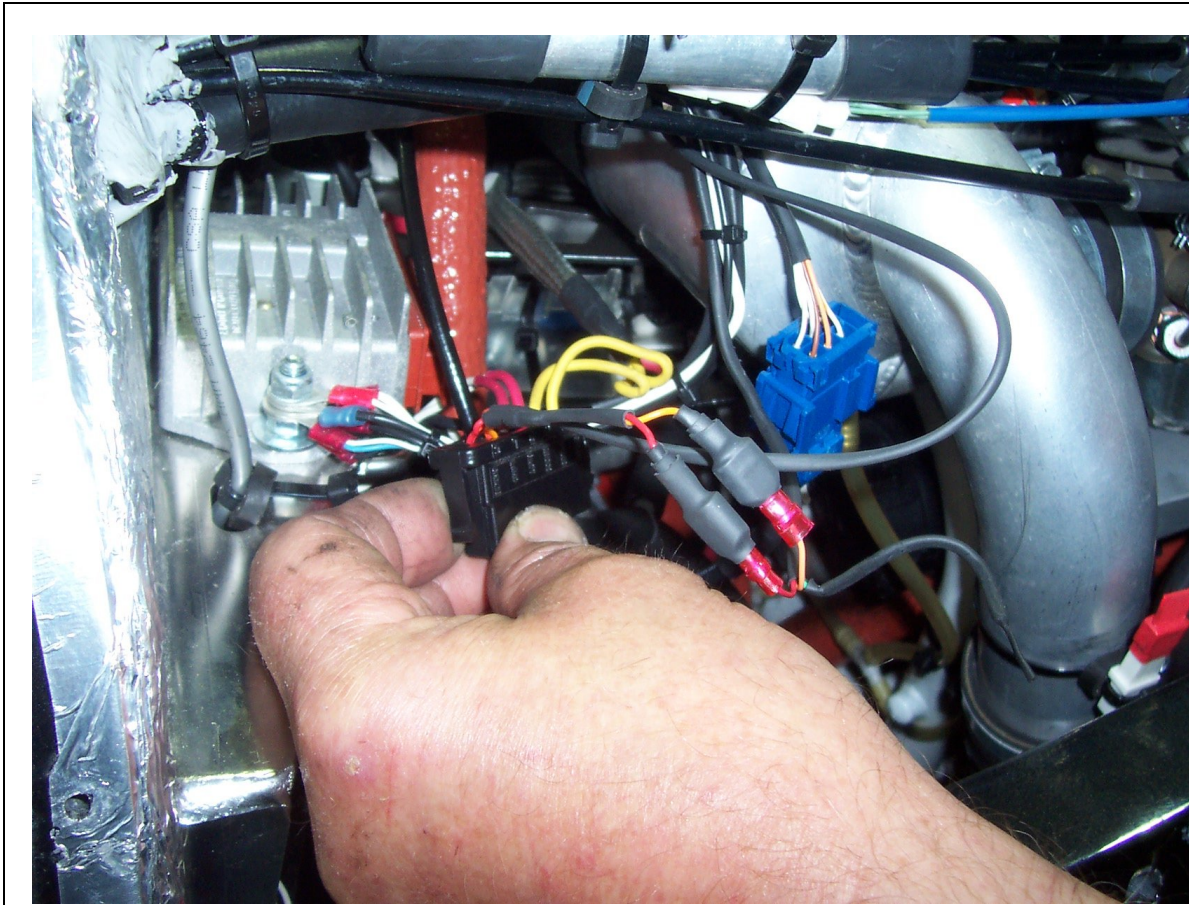
Regulator harness interconnections made and sleeved (see para 5)

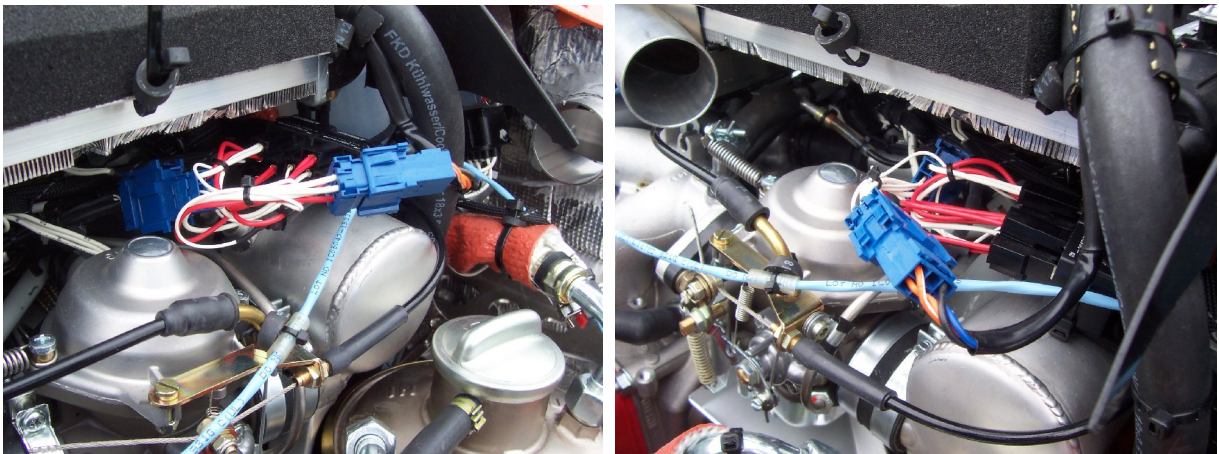
Relay module connected into wiring loom

8. Insert the relay module into the radiator wiring harness connector shells, neatly collate the cables and using cable-ties secure the module under the radiator by attaching to the air-box (914UL engines) or a simple stand-off (912ULS engines). Ensure that the relay module is not rubbing on the radiator fins then refit the cabin-heat duct-pipe.

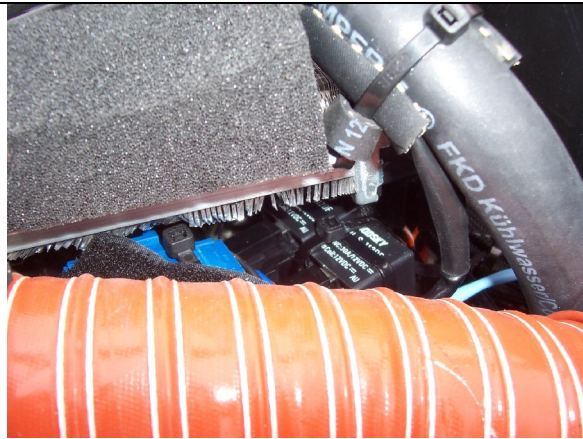
Finished installation with duct-pipe replaced

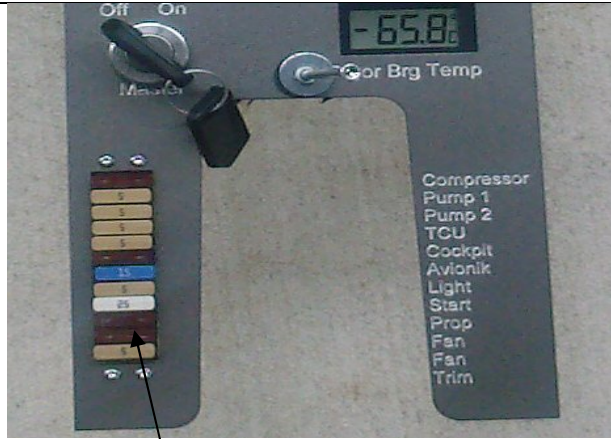
Fuse location on instrument panel
(second from bottom position)

9. In the cockpit change fuse F10 from 10A to 15A. (This is the penultimate fuse in the stack and provides maintained electrical power when the master switch is off.)

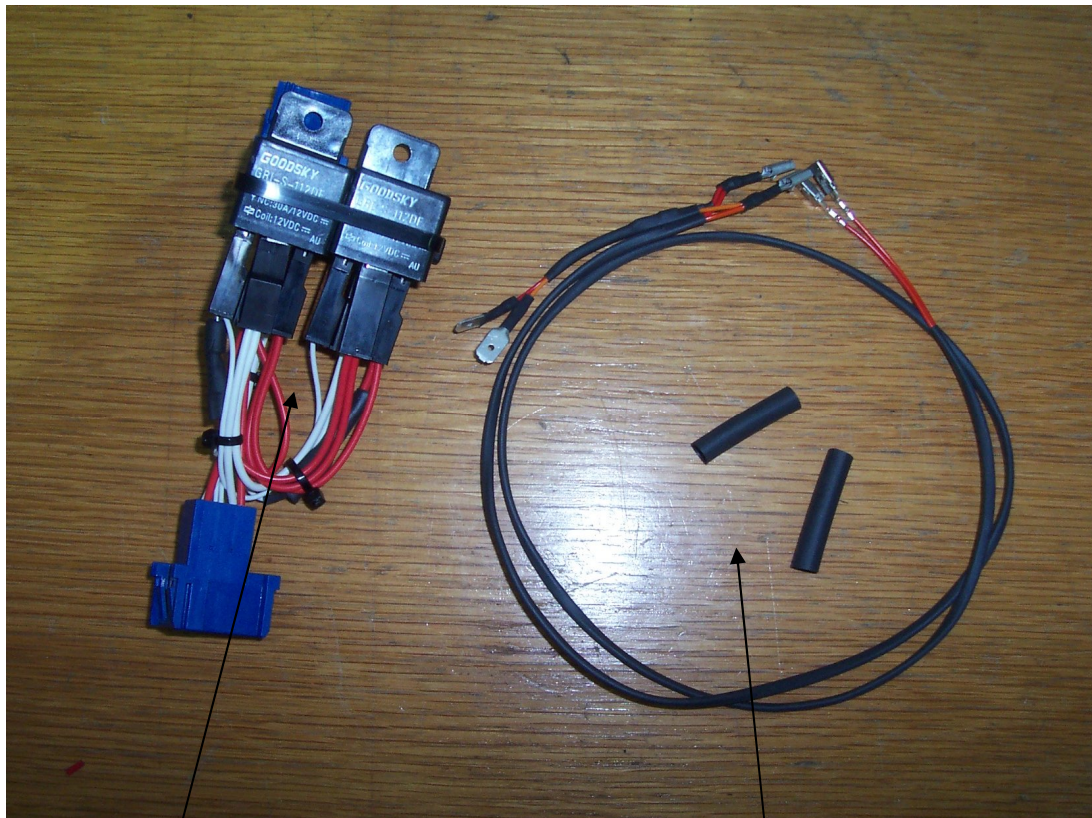
Relay module

Regulator harness with heat-shrink sleeves

Contents of Fan Reverse Kit BG3327

- 1-off Fan reverse kit C.EL01.37 (BG3327) including Regulator Harness RSD7214
- 1-off Blade fuse 15A RSD4479
- 2mm cable ties RSD4206 (as required)
- 4mm Cable ties RSD4207 (as required)
- 50mm length of scrap fuel-hose 6 or 8mm bore (for stand-off in 912ULS installation)
