# RotorSport UK Ltd    Service Bulletin

<b>Title: Calidus nose-wheel spat</b>		
<b>SB No.: 072 Iss1</b>	<b>Related documents</b> MC No: MC-262 CCAR No.: None	<b>Compliance Category:</b>  <b>OPTIONAL</b> or <b>RECOMMENDED</b> or <b>MANDATORY</b>
<b>Applicability</b>		
<b>Aircraft type &amp; model:</b> Calidus	<b>Aircraft serial Nos. affected:</b> RSUK/CALS/all

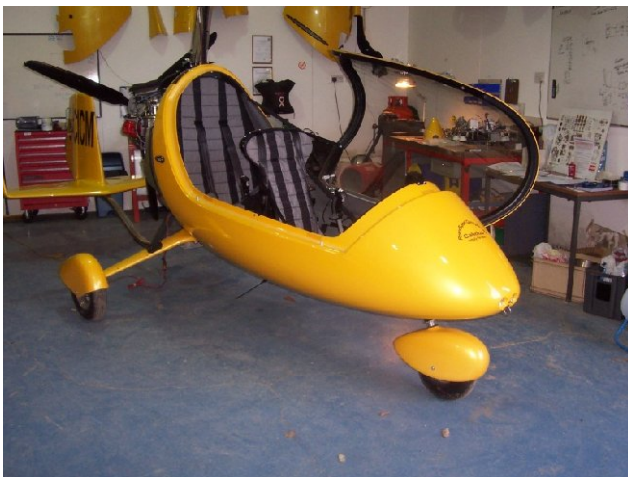
The optional nose-wheel spat fitted to Calidus aircraft is fitted around the centre stem of the fork fabrication and is attached by screws to two M6 nuts welded to the fork legs. A hole in the left side of the spat makes it possible to remove the wheel spindle nut then withdraw the wheel spindle, so releasing the nose-wheel without disturbing the wheel spat installation.

Nosewheel spat installed

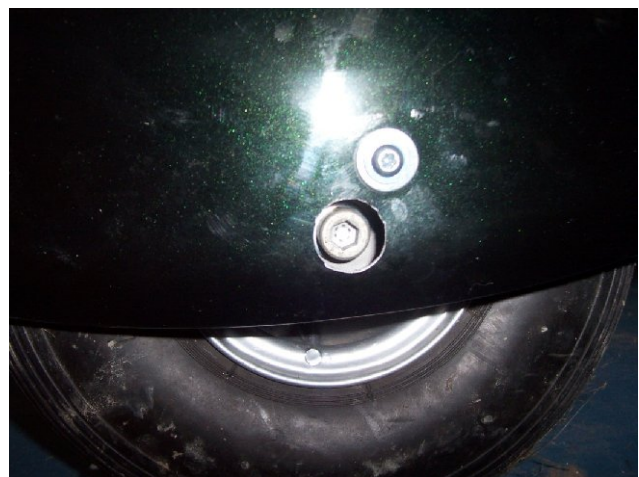
Access hole for wheel spindle removal
