RotorSport UK Ltd Service Bulletin (Permit)

Title: Calidus 15A compressor fuse		
SB-122 Iss1	Related documents Modification: MC-364 CCAR No.: None	Compliance Category: OPTIONAL or RECOMMENDED or MANDATORY
Applicability		
Aircraft type & model: Calidus	Aircraft serial Nos. affected: Strongly recommended for RSUK/CALS/031 and RSUK/CALS/032. Recommended for all other Calidus	
The maintenance manual to be referenced is this stated or subsequent issue.		RSUK0061 Iss: 6
<p>This form is the response from RotorSport UK Ltd either against a problem found in the product in service requiring a containment or rectification action, or as service information for aircraft modification incorporation. For help, contact RotorSport on 44(0)1588 505060, or email compliance@rotorsport.org.</p> <p>The technical content of this document is approved under the authority of the UK CAA Design Organisation Approval Ref: DAI/9917/06</p>

AG-SB-2017-02-C-EN – Calidus compressor fuse

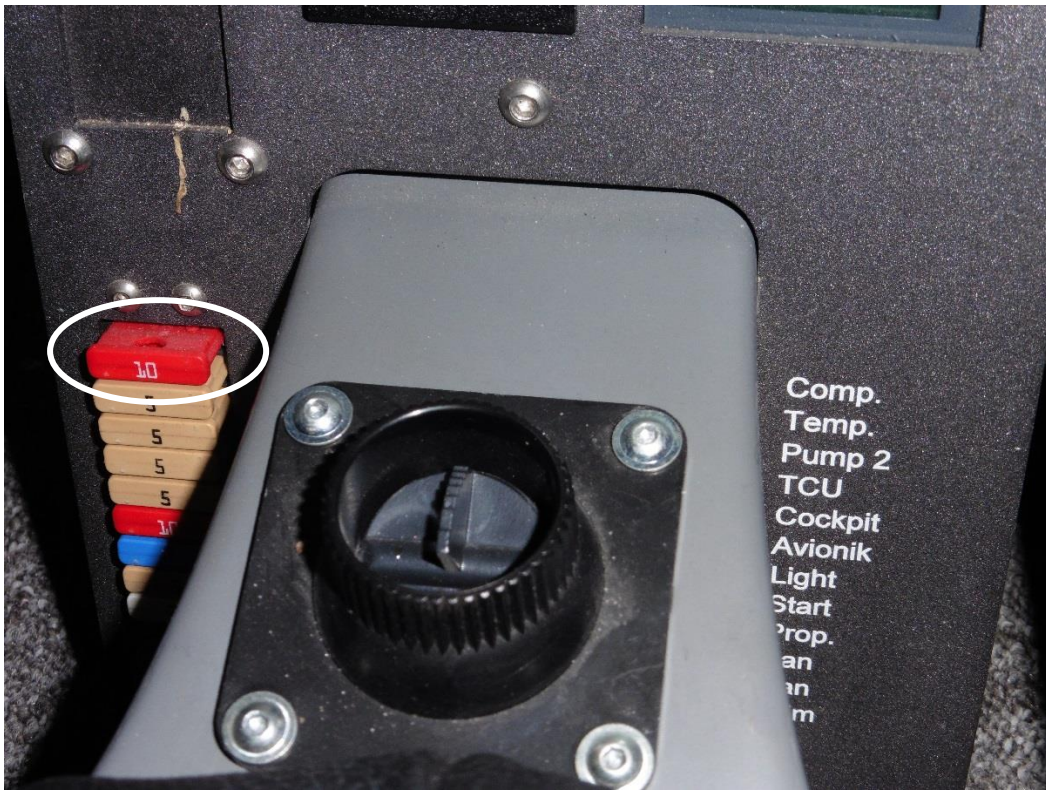
Production quality control checks have determined that variability in the current required to start the compressor could be in excess of the circuit 10A fuse, causing it to blow. Whilst there have been no recorded fuse blows in service, this bulletin highlights this potential and provides a preventative service fix.

Fig. 1: 10A Fuse Compressor

- 1 Remove the 10A fuse for the compressor from the slot.
- 2 Insert the 15A fuse into the compressor slot

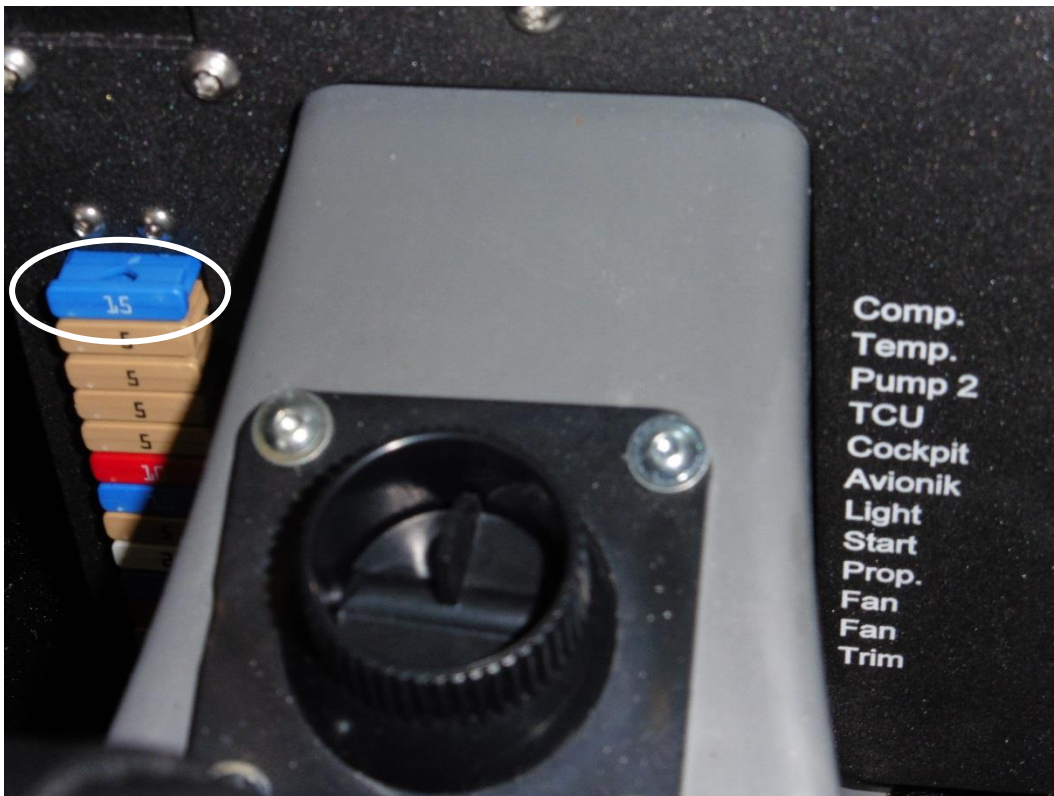
Fig. 2: 15A Fuse Compressor

Fig.	Pos.	Description	PC	PIT	Remark
2		Fuse 15A	1	22681
