RotorSport UK Ltd Service Bulletin

Title: Nose-wheel spat access hole		
SB No.: 070 Iss1	Related documents MC No: MC-261 CCAR No.: None	Compliance Category:
Applicability		OPTIONAL or RECOMMENDED or MANDATORY
Aircraft type & model: Cavalon	Aircraft serial Nos. affected: RSUK/CVLN/001 to 008	
This form is the response from RotorSport UK Ltd either against a problem found in the product in service requiring a containment or rectification action, or as service information for aircraft modification incorporation. For help, contact RotorSport on 44(0)1588 650769, or email info@rotorsport.org.		
<u>Reason and overview of the Service Bulletin (cause of problem if known)</u>		
The composite nose-wheel spat fitted to Cavalon aircraft is fitted around the centre stem of the fork fabrication and is attached by screws to two M6 nuts welded to the fork legs. In order to remove the front wheel it is necessary to release these two fasteners, disconnect the nose-wheel steering controls, lower the whole fork assembly and slide the spat off the centre stem of the fabrication. However, by furnishing a hole in one side of the spat it is possible to remove the wheel spindle nut then withdraw the wheel

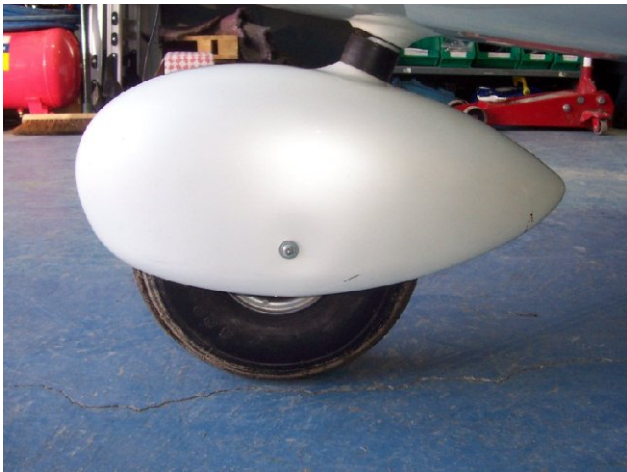
Cavalon nose-wheel spat unmodified

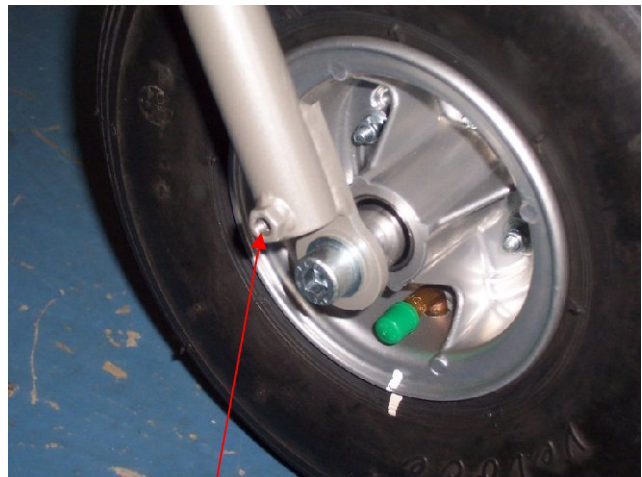
Attachment at fork fabrication

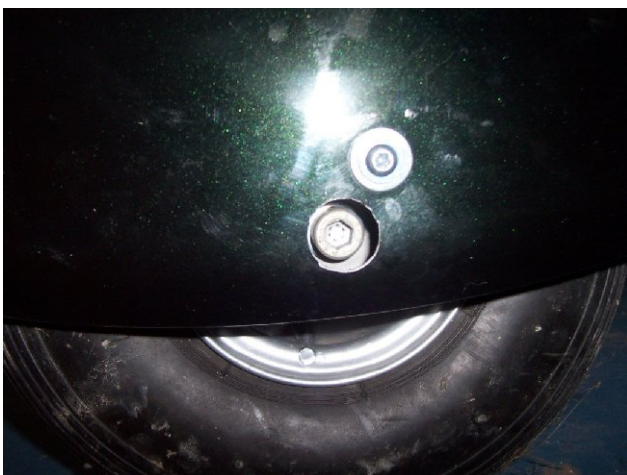
Hole cut into moulding

Title: Nose-wheel spat access hole		
SB No.: 070 Iss1	Related documents MC No: MC-261 CCAR No.: None	Compliance Category:
Applicability		OPTIONAL or RECOMMENDED or MANDATORY
Aircraft type & model: Cavalon	Aircraft serial Nos. affected: RSUK/CVLN/001 to 008	
<p><u>Accomplishment instructions (Action required to implement this bulletin):</u></p> <p>Effective date of SB is 06/12/2013. There is no relevant MPD or other outside body documentation to be referenced. Task limitations – may be carried out by RSUK, or any approved person having A3-7 authorisation.</p> <ol style="list-style-type: none"> 1. Examine the direction of the nose-wheel spindle, the socket head should be at the left of the aircraft and the hex-nut at the right. If not, it will be necessary to remove the spat in accordance with AMM RSUK0288 in order to carry-out further work. If the spindle is fitted from the left proceed as below. 2. Protect the nose-wheel spat with wide masking tape. 3. Sighting fore-aft and laterally, mark the centre point of the spindle. This should be 25mm from the base of the spat. Mark a 20mm diameter circle around this centre-point. 4. By hand cut a section of softwood to back-up the lower part of the spat. 5. Using a new or freshly sharpened 3.0mm bit, drill through the composite into the softwood backing. 6. Using minimum cutting pressure to avoid splitting the composite, progressively increase the size of hole to about 10mm then remove the wooden backing. Visually check that the hole is correctly aligned with the spindle centre – adjust if necessary with a Dremmel (or similar) hand-grinder. 7. Using a cone-cutter or large countersink drill bit increase the hole to 19.0/20.0mm diameter. 8. Dress the cut surface of the hole, remove the masking tape and carefully fit the grommet with smooth surface outboard. 9. Visually inspect that spat to verify that no damage to the composite has occurred. If in doubt refer to RSUK.

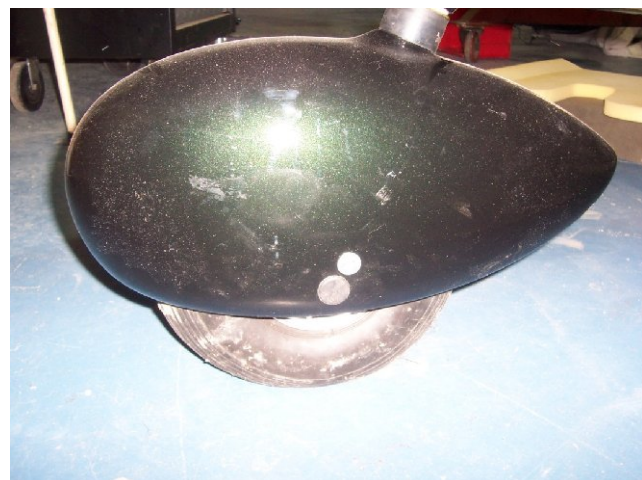
Blanking grommet in place

<p><u>Material information (Parts required to be made to implement this service bulletin):</u></p> <p>No parts need manufacture for embodiment of this SB</p>		
<p><u>List of components (with purchasable part nos)</u></p> <p>Blanking grommet RSD4784</p>		
<p><u>Interchangeability</u></p> <p>Not affected</p>
